CONSERVATION REPORT

- 1.1 This report was commissioned by Offaly County Council - the owners of the castle and of the park in which it is set.
- 1.1 The aim of the report is to record the surviving masonry, to establish the historical background and the evolution of the fabric and to identify the scope of works required to stabilise and conserve the upstanding remains of the building.
- 1.1 The preparation of a detailed programme of works to stabilise and conserve the remains will form part of a later Implementation phase of the project.

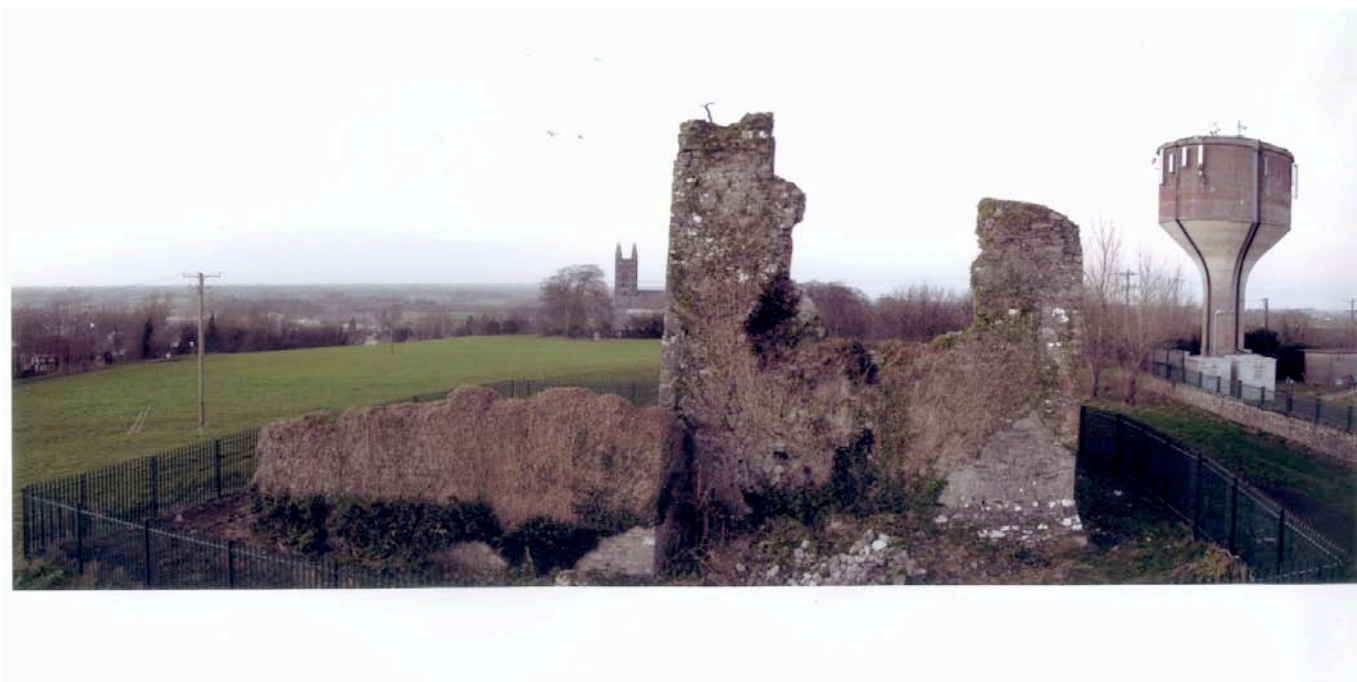
View from south with water tower and enclosure to the east and Church of Ireland in background. Note rubble from collapsed section of south wall

5.6 Some of the south gable wall fell at some stage in the 20th century.

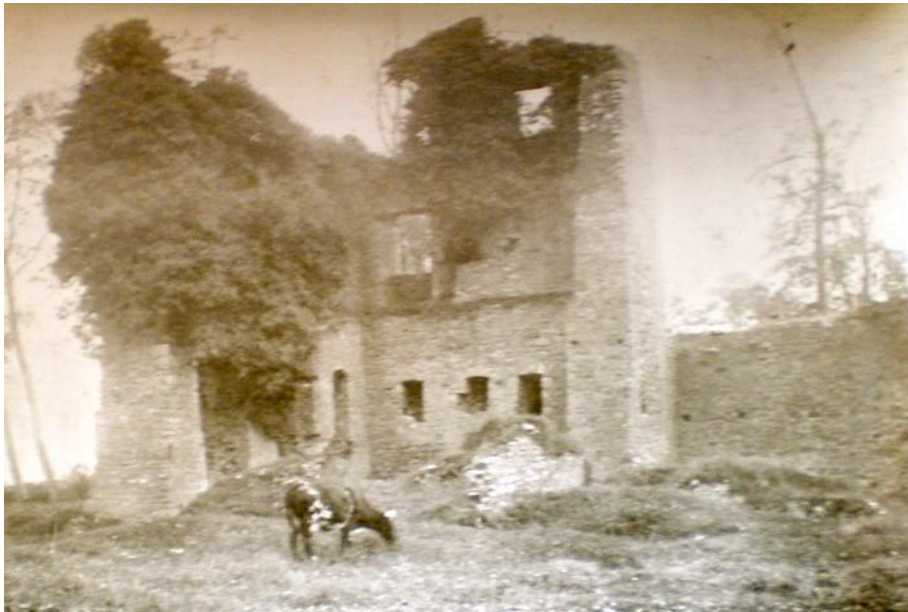
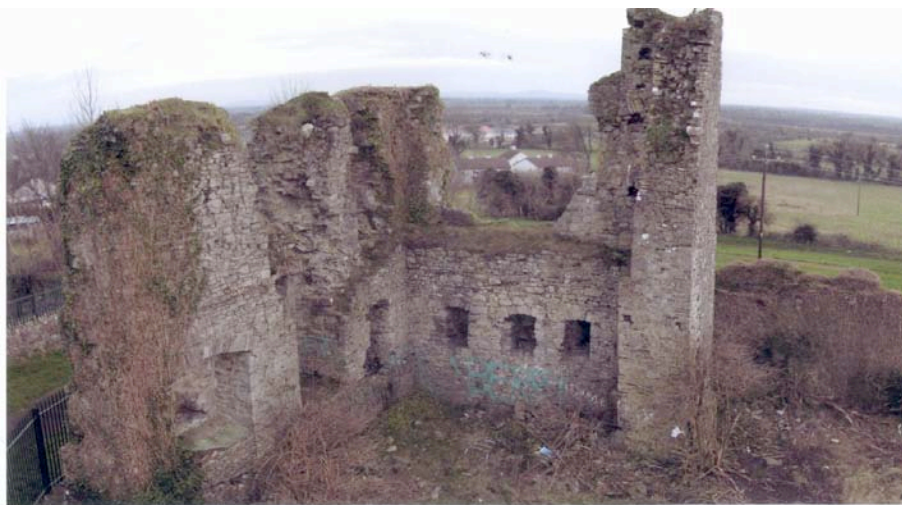
South wall today

The south gable wall has the remains of two embrasures on the first floor. The wall between the embrasures has fallen since a photograph was taken in the early 20th

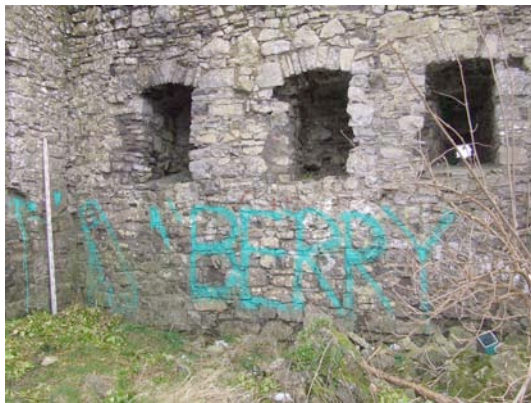
Lengthened aumbries and shortened loop, S wall inside

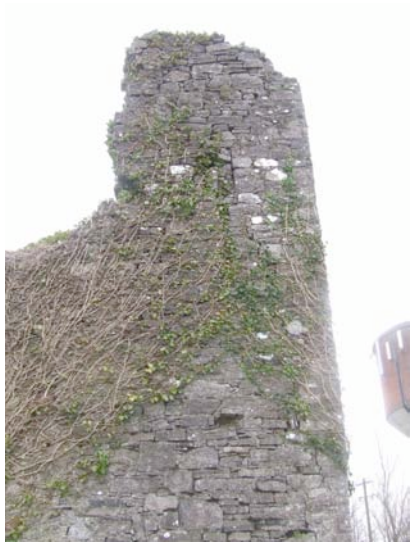
Blocked light, first floor, SE corner, from S.

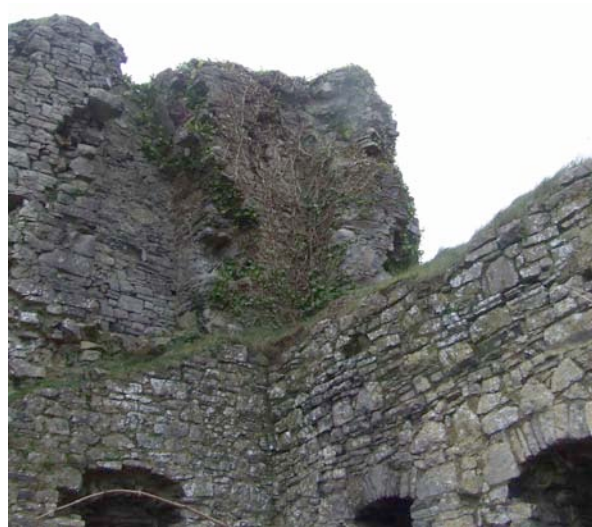
Blocked mural passage/ stair, SE corner, from NW.

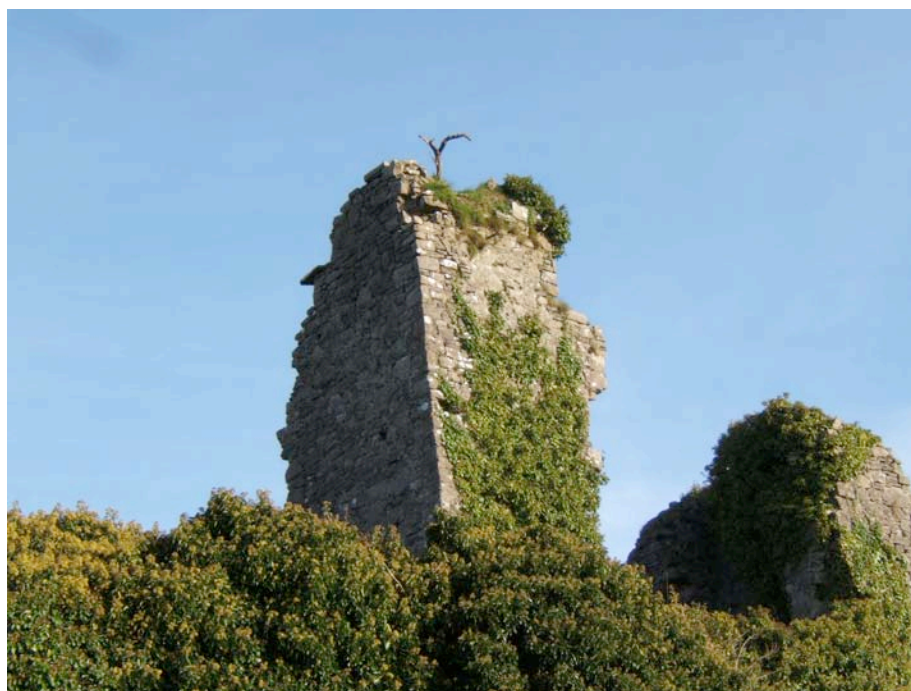
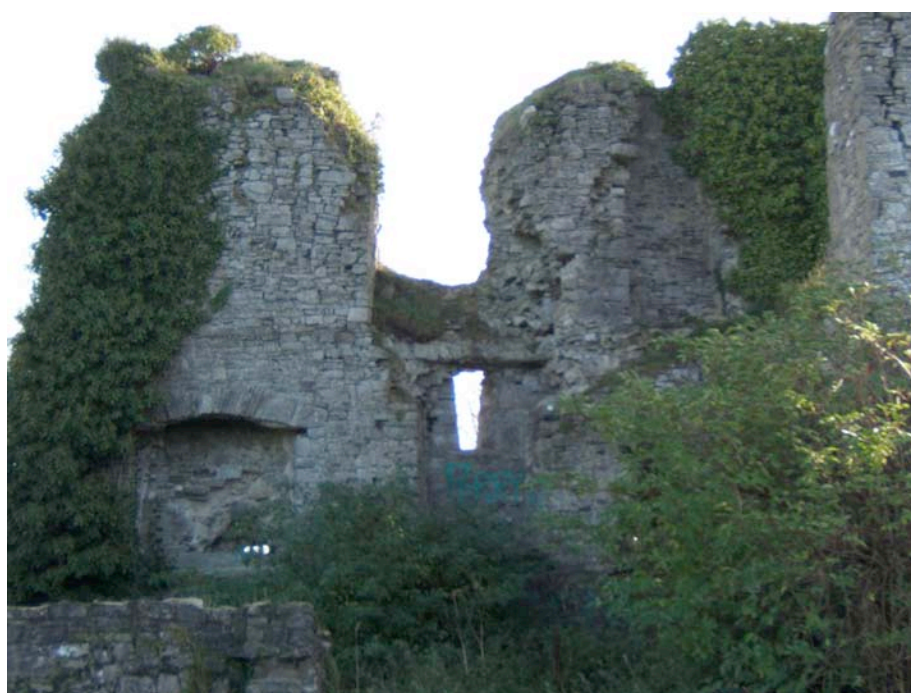
There is profuse growth of trees, brambles and ivy in and around the monument. The masonry has been and is still being damaged by ivy growth and other vegetation. Ivy growth may have played a part in the collapse of part of the south wall in recent years. Ivy can in some cases provide a protective screen on intact sound walls. However, on ruined masonry, where cavities exist, it can do serious damage by growing within the wall and displacing masonry. It must be treated and removed. It is essential however that funds and a programme of works are in place before treatment and removal.

Extent of vegetation prior to cutting back - exterior south wall (top) and interior east wall (bottom)

Treat vegetation with approved systemic treatment. Repeat if necessary. Cut back but do not remove until dead. Treatment must be subject to availability of funds and certainty regarding works being put in place. In some cases, treatment can take up to two years to be fully effective. The treatment can be fitted in with a phased programme of works.

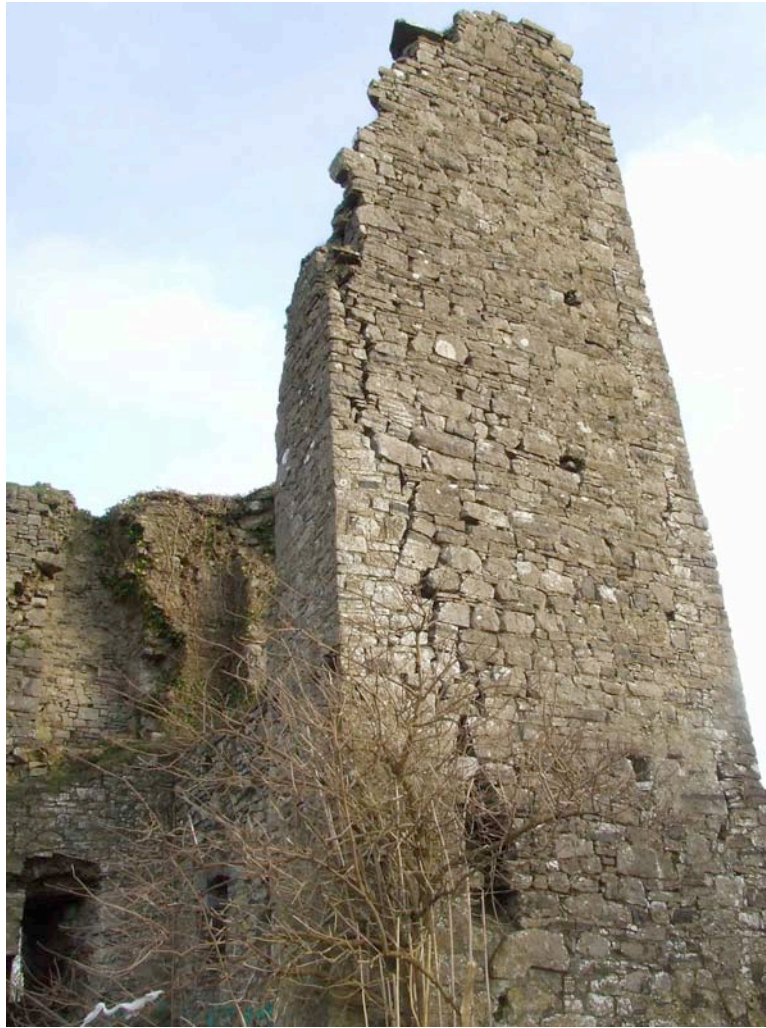
Serious structural cracking is present, particularly at the south west corner. Wall-tops and broken wall-ends are open to the weather. Pointing mortar has washed away or been forced out by vegetation growth. In some areas, where the pointing is in very good condition, the actual bedding mortar at wall bases has washed out and led to the loss of packing stones and pinnings. Weathering has caused partial loss to features such as the imprint of wickerwork centering at heads.

Structural cracking and voids west wall on line of patching of masonry

Stabilize masonry where cracking occurs - at corners and other areas where the structure is discontinuous. If any disassembly is necessary, a full detailed record of the area must be made to supplement the general survey.

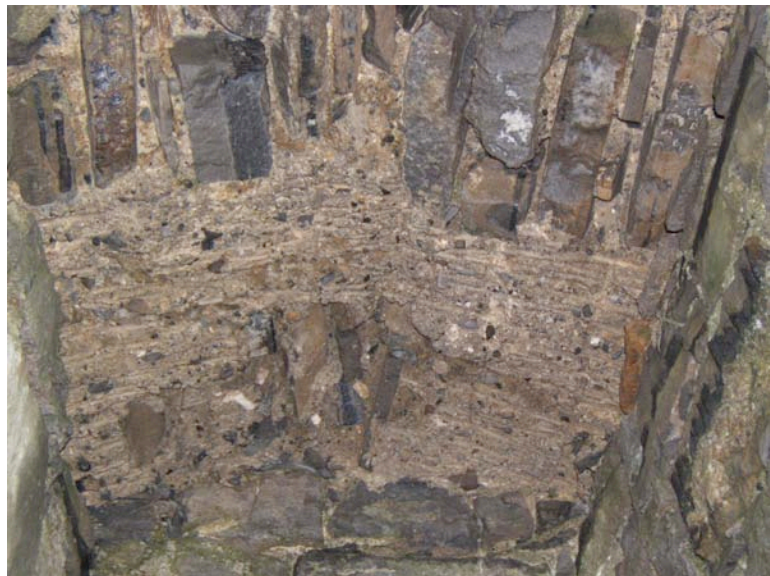
Traces of wickerwork centering still in place on head of opening east wall

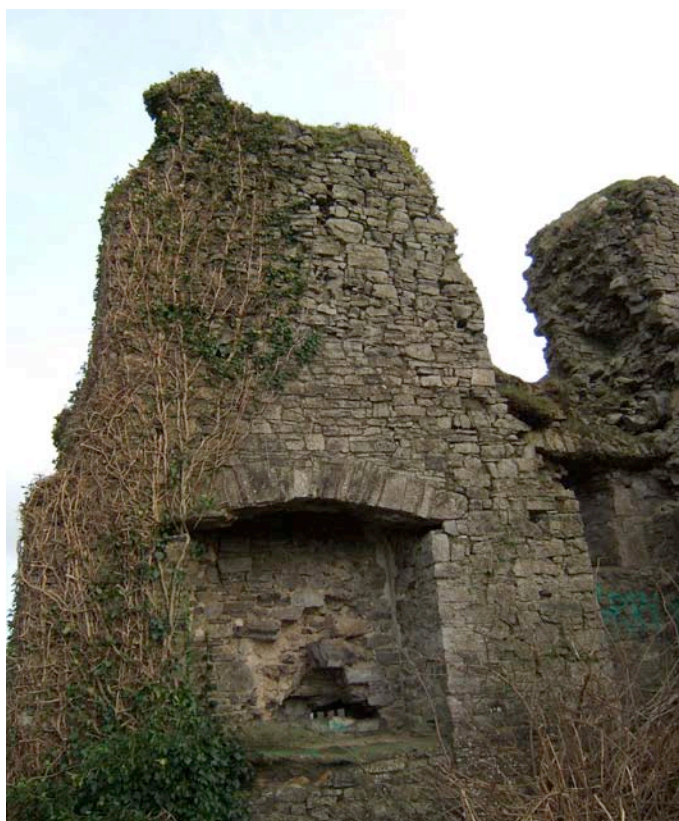
Condition of masonry inner face of east wall

Fill empty joints, including pinnings etc. taking particular care at foot of walls and areas around breaches in masonry. Close joints at broken wall ends.

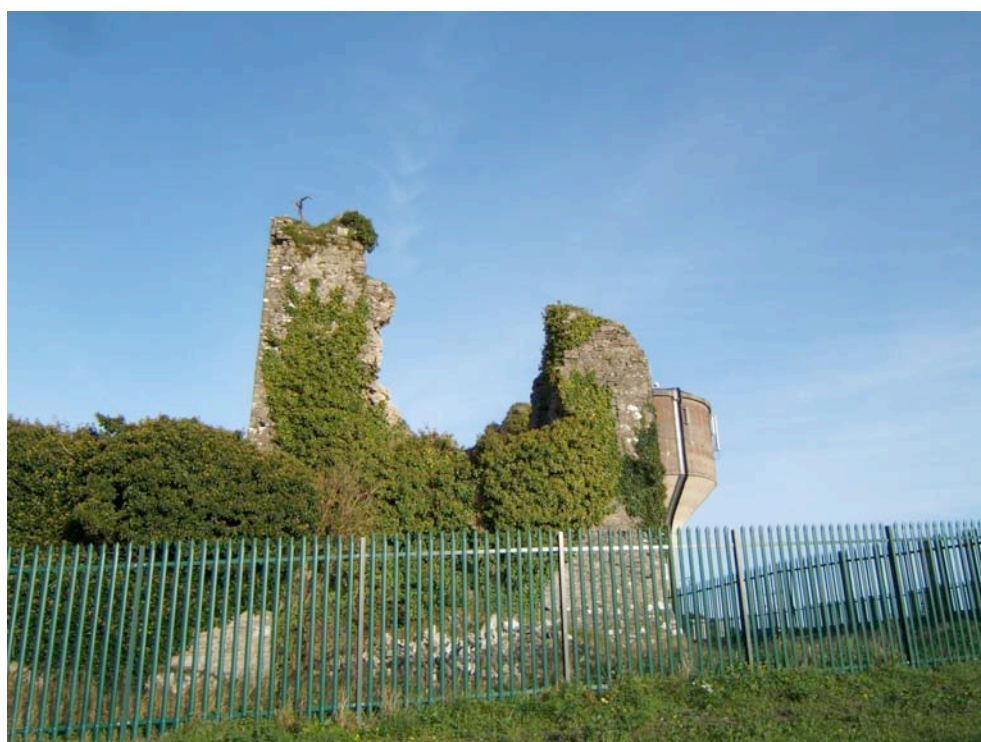
Palisade fencing and water tower in background would benefit from screen planting
