TOWER ON MULLAGH HILL, CO. OFFALY
PRELIMINARY ARCHITECTURAL REPORT

Margaret Quinlan Architects RIAI Grade 1 Accredited in Conservation

THE TOWER ON MULLAGH HILL

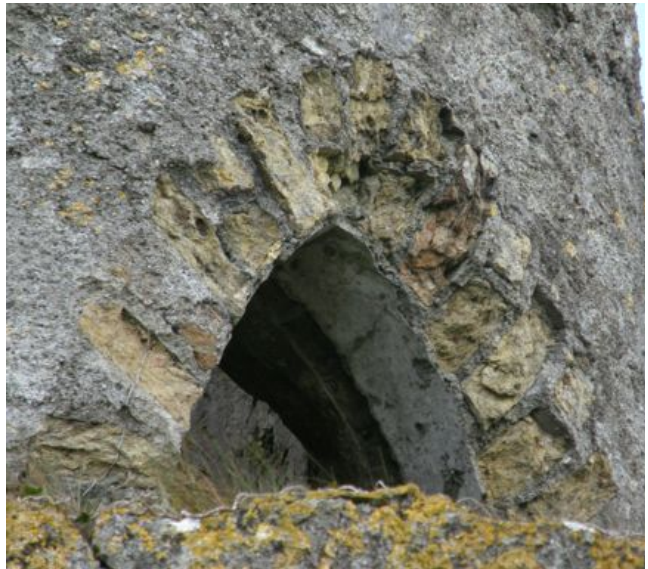
17

- 4.2 There has been loss of fabric around most openings, where yellow brick has been damaged at the reveals. Generally, the brick is soft and is degrading with exposure to the weather. The external render had been providing the necessary protection but has been lost from the brickwork and also, is itself wearing away with exposure. The opening at the entrance door has lost much fabric.

Degraded brickwork
damaged by weathering

- 5.4 Carry out repair work around damaged openings, particularly the entrance door, using a suitable matching brick. This may consist of simple rough racking, sufficient to prevent further loss. The exposed brick should receive a light scud shelter coat.

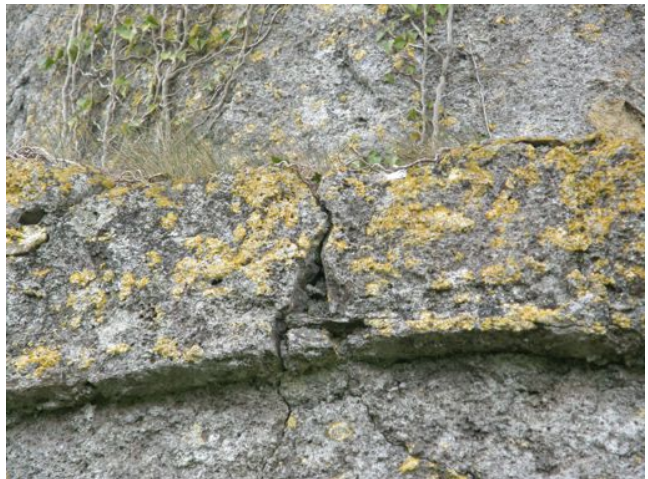
18

- 4.1 The tower is in reasonably good structural condition. The mortar is sound. There is some cracking in the masonry, most visible at parapet level. Many of the masonry joints at ground level have had the mortar washed out. Generally, there is no strong growth of vegetation, but there are small strands of ivy at parapet level.

Cracking at projection

- 5.2 Fill empty joints with mortar. Lack of mortar is most noticeable at parapet level and just above ground level.
- 5.3 Replace all decayed and missing lintels. Vulcanise top and ends by bonding a bituminous type sheet to upper surface and wrapping around, bearing ends to protect endgrain

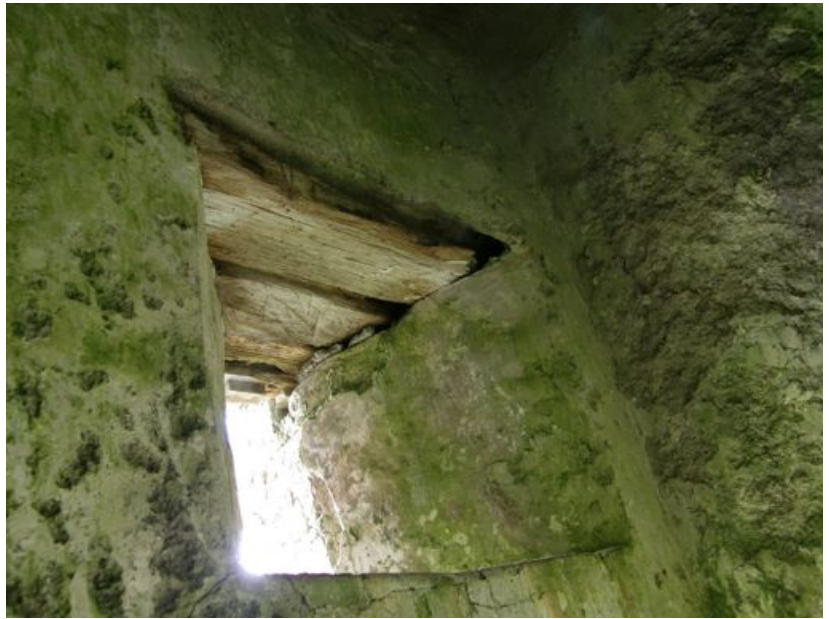
19

- 4.4 All the timber lintels are decayed and some are missing completely. The openings are small and the masonry structure does not appear to have yet been compromised by the loss.

Loop over entrance door
Note decayed lintels in
place

- 6.7 Provide new timber lintels where decayed or missing. Timber to match the existing in section and to be of oak if possible, salvaged pitch pine or douglas fir. The tops, sides and bearing surfaces of the timber lintels to be vulcanised by torching on an appropriate material such as polyester roofing felt.

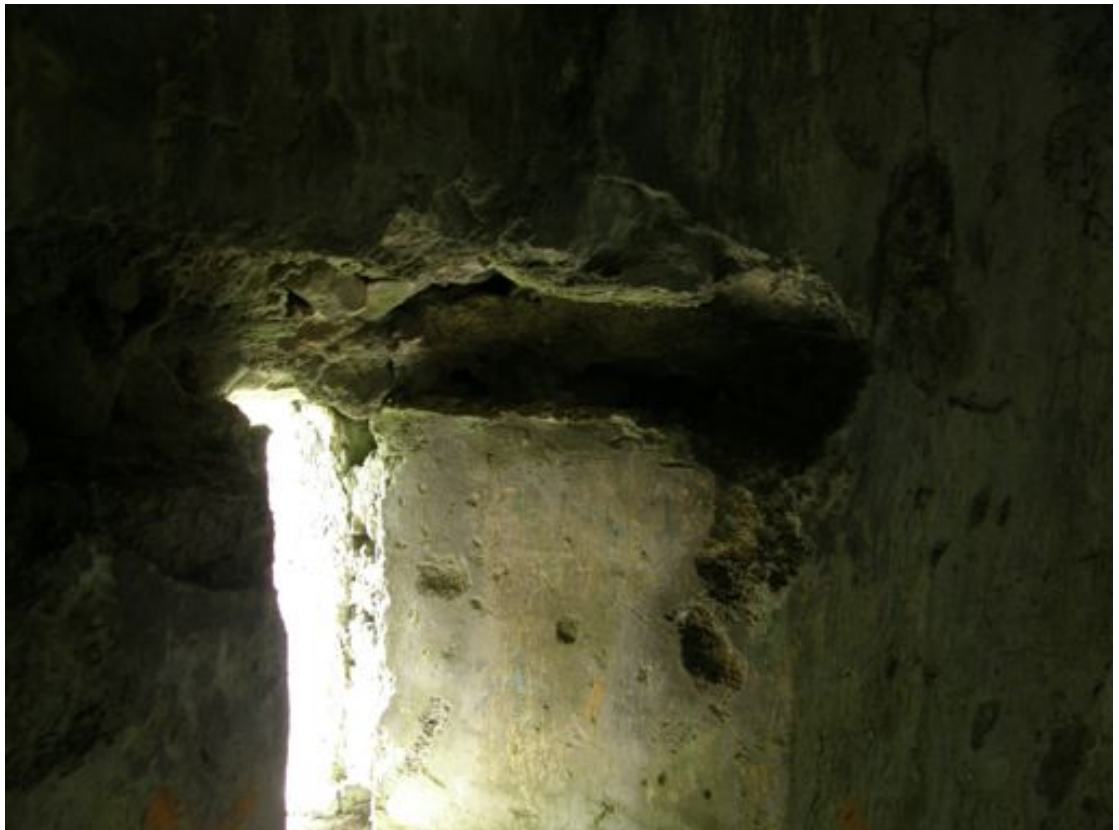
24 Loop showing socket for timber lintol
