REPORT

**ACRES FOLLY,
TULLAMORE
CO. OFFALY**

OFFALY COUNTY COUNCIL

December 2018

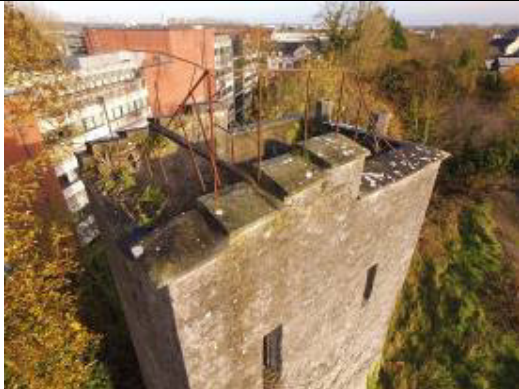
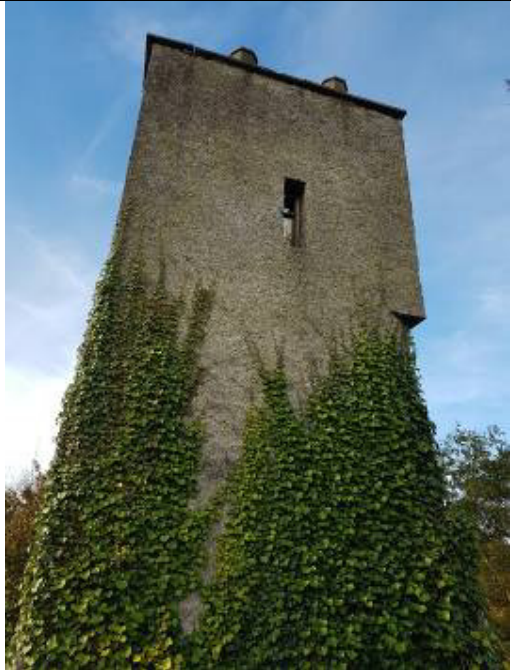
Ivy establishment and condition of parapets

<p>Minor Ivy growth is evident at the top of the structure and there is a capping missing from the South West elevation. Iron to be removed (Source Drone survey: National Monuments 2018)</p>	<p>Ivy establishment at base level to be treated and ivy removed from the wall as shown in Appendix B</p>

- Ivy should be treated in accordance with the methodology and specification in Appendix B
- A new stone capping is required for the South West elevation parapet wall as shown below. Existing perpendicular joints should be re-pointed in 1 :2.5 NHL 3.5 lime sand mortar.
- It is suggested that the old iron handrails at parapet level are carefully removed.

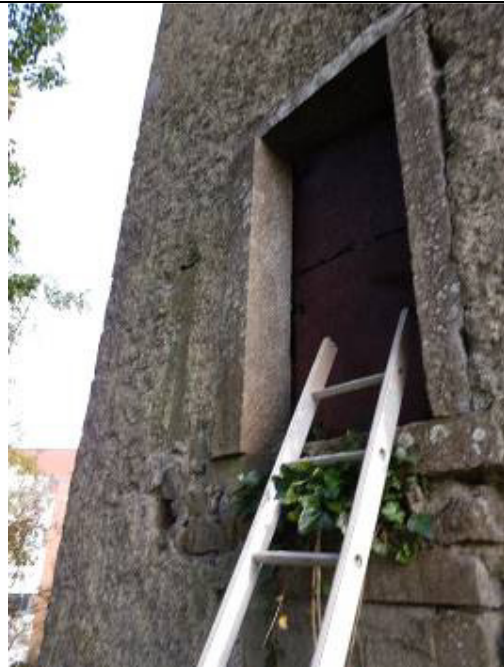
South West ladder access where
external stairs is missing

- Exterior plaster is in good condition and should be cleaned with a hot steam conservation cleaning system such as 'Doff' and then treated with 3 coats of limewash
- New grilles should be provided for the windows
- New doors should be provided to the South West elevation at ground and basement level. These could be hardwood doors or metal gates, depending on budget and security considerations.
- A new external staircase in stone in the style of the original staircase and scar should be provided

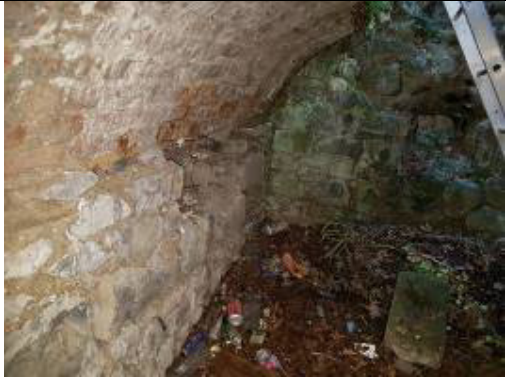
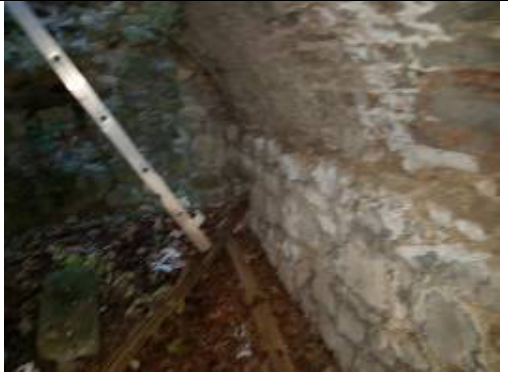
Basement vault to NW. Clear out debris	Basement vault to SE. clear out debris

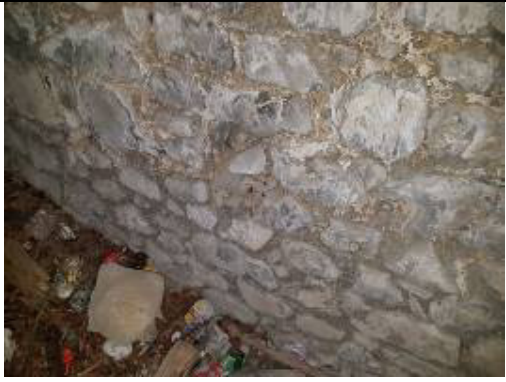
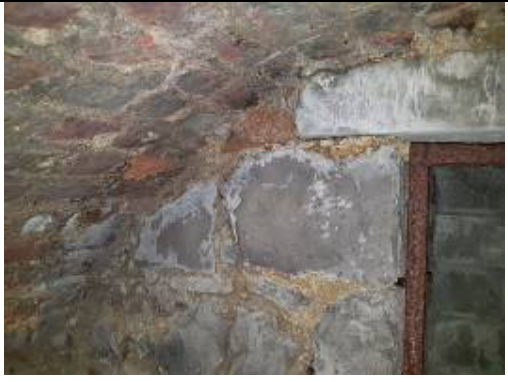
Masonry to walls in good condition	Masonry to vault in generally good condition towards entrance on SW wall. Entrance to be opened with new hardwood door for access for maintenance only

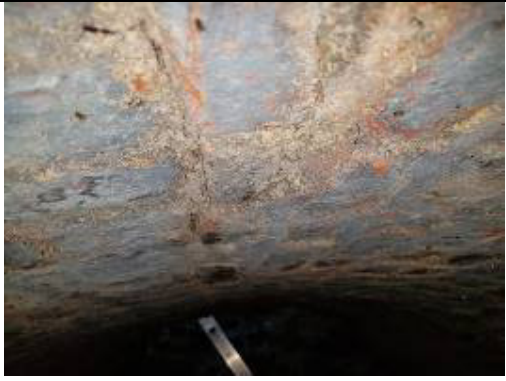
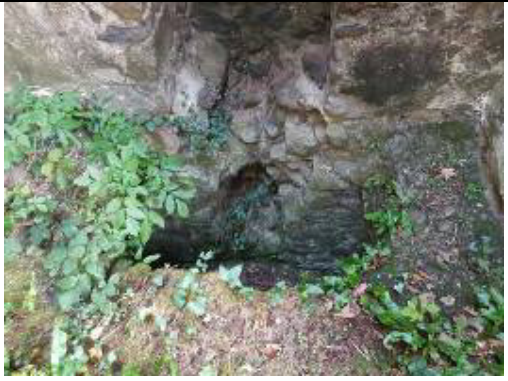
Top joint of arch requires some structural pointing	View of missing vaulted masonry from the ground floor to be replaced in brickwork /stonework in NHL3.5 lime mortar

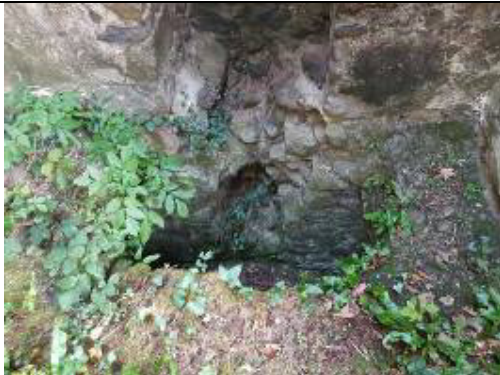
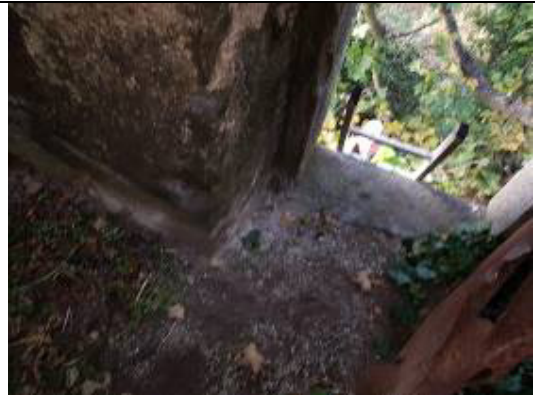
<p>Once vault restored, the ground floor is to have a gravel finish with weep holes to basement level. Slate hearth stone to be provided</p>	<p>Slate threshold to be provided. Remainder of ground floor to be finished in gravel</p>

- Maintain plaster finishes
- Remove any timber elements and replace lintels and build up masonry to windows doors and fireplace in precast concrete to avoid deterioration
- New gravel floor on Terram 1000
- Weep holes to drain water to basement level
- New hardwood door and frame for security. Slate to threshold and fireplace

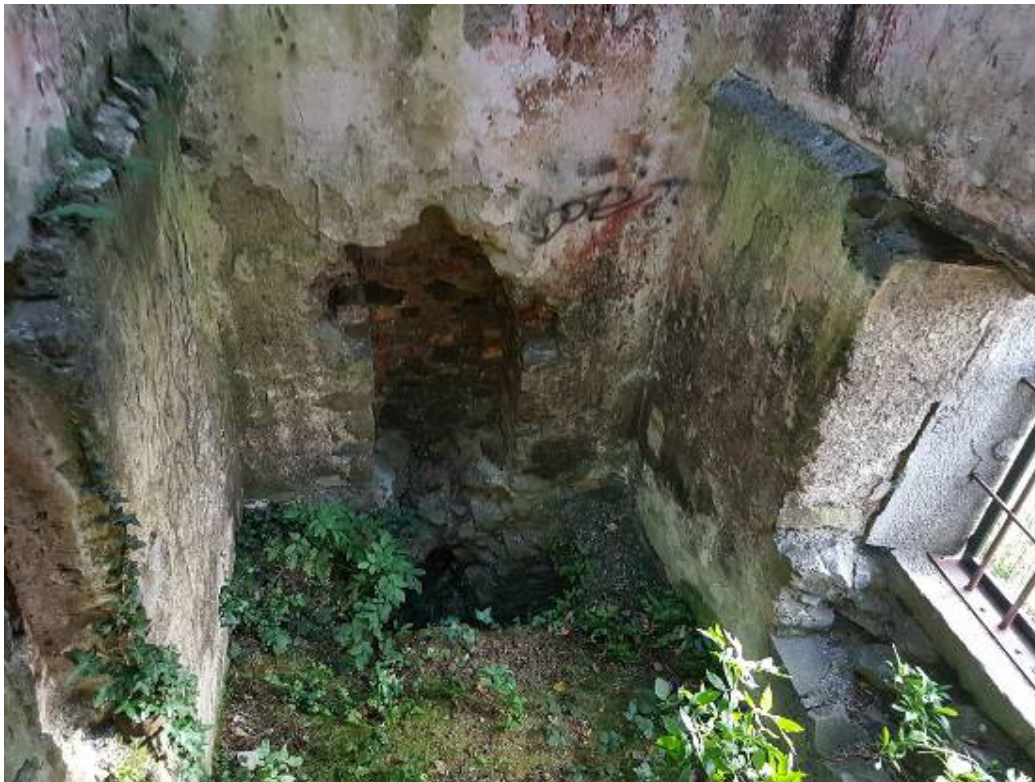
Lintels to be replaced over window openings and at fireplace, Masonry to be built up to original profiles. Minor vegetation treatment internally.

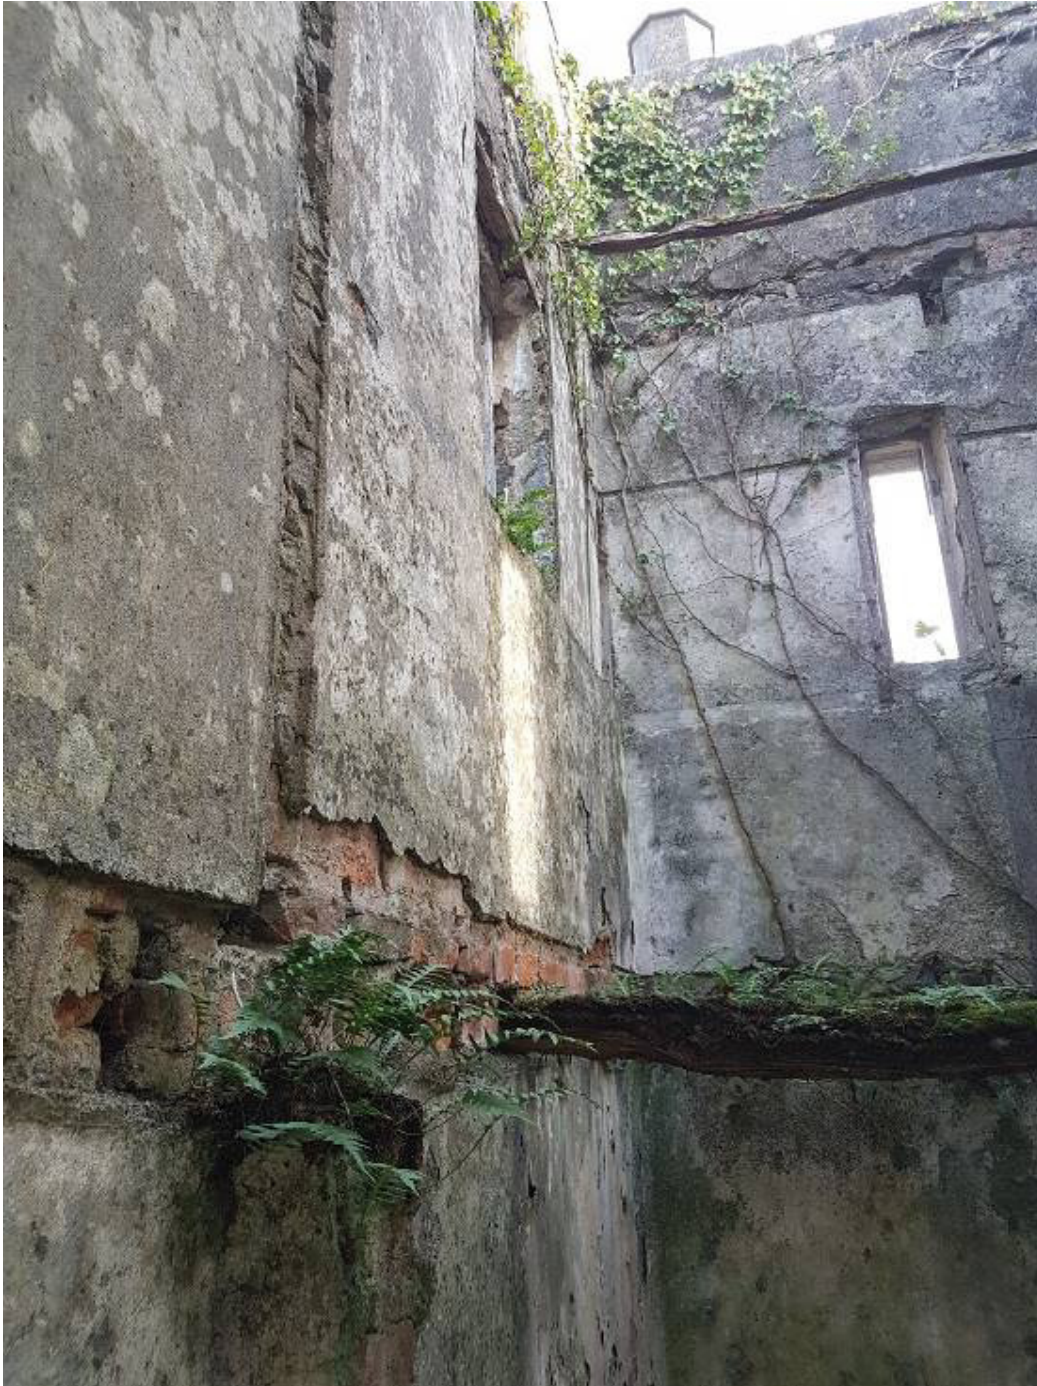
General view of first floor level. Ivy and vegetation -minor treatment. Timber joists to be removed lintels to be replaced in precast concrete. Plaster to remain unless unstable.

- Minimum work to plaster finishes
- Joists to be removed
- Lintels to be replaced and masonry built up in fireplaces door and window openings. Precast concrete recommended for durability
- Minor Ivy and vegetation treatment

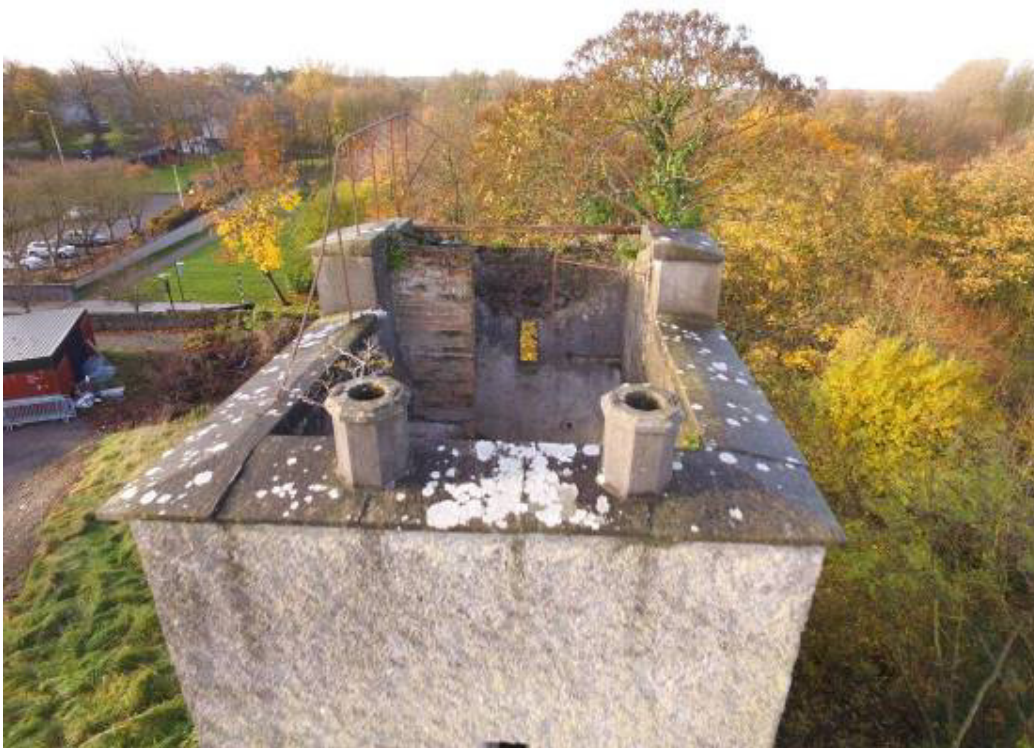
Chimney stacks

These appear in reasonable condition and allowance made for patch pointing only (Source Drone survey: National Monuments 2018)
