# **Post Works**

## **Photographic report**

**Bloomfield Mausoleum,  
Borrisnafarney Church of Ireland,  
Ballycormick,  
Monegal,  
Co. Offaly**

***June 2022***

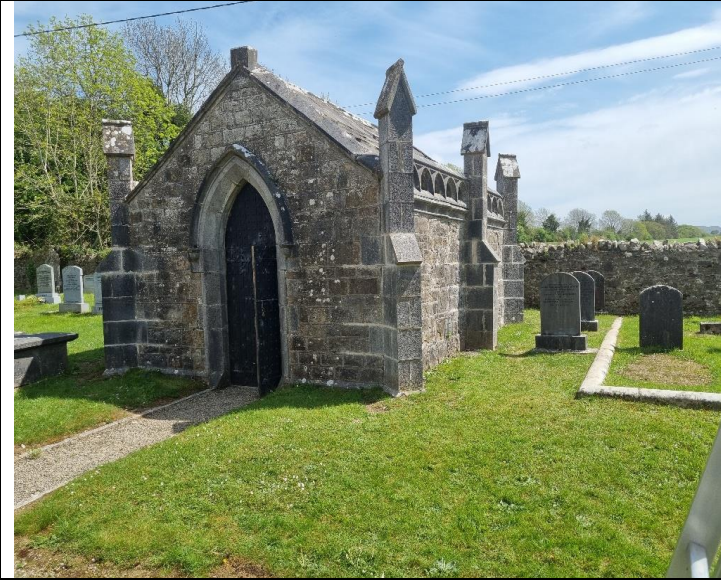
1. The completed project for phase 1 which has had the temporary ties removed.

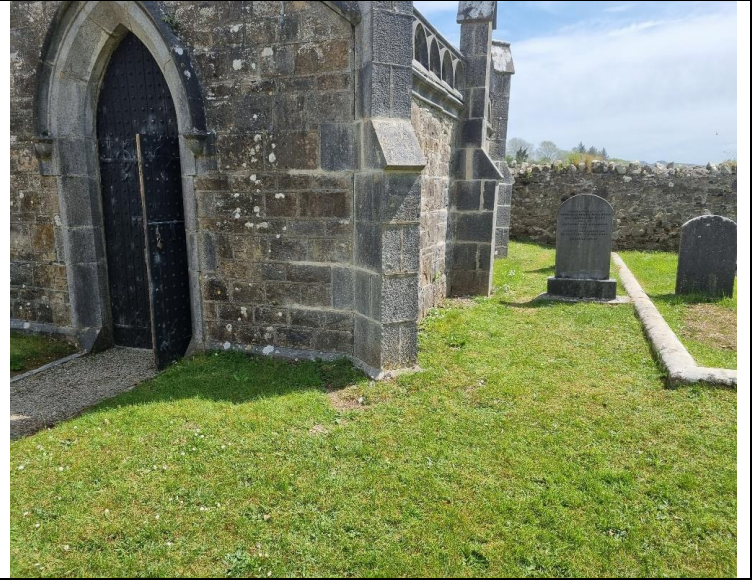
2. Typical buttress which has had helibars ties and stainless-steel threaded rod tying at kneeler position

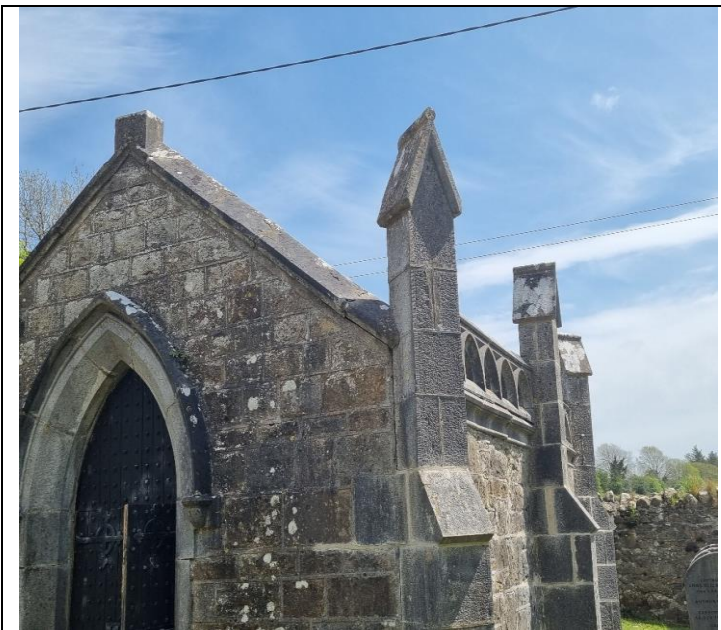
3. The decorative stonework was attached

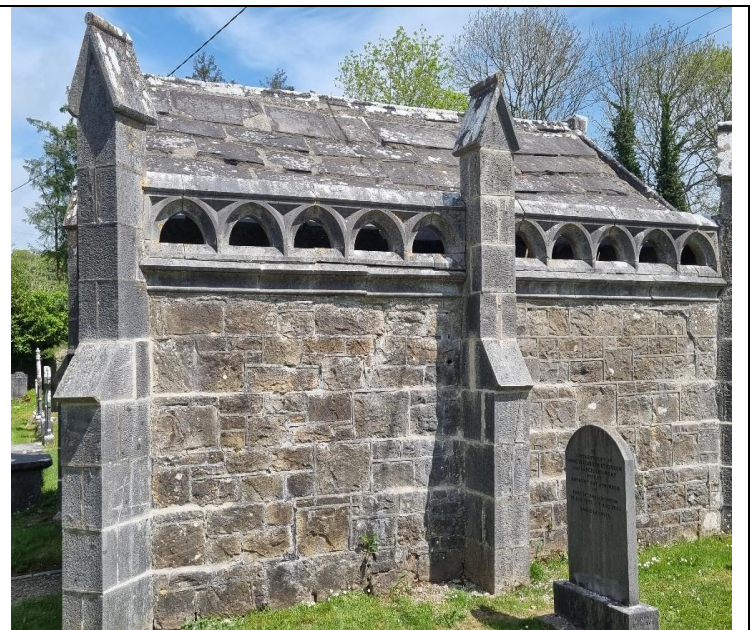
4. The high level tracery has been fixed historically with wrought iron cramps which have corroded causing opening of cracks

Further works in the next year or further years in a Phase 2 are recommended and should focus on the replacement of iron dowels to the arcade stones on either side of the building and rebedding of these stones on new mortar tied with stainless steel dowels. The end coping stones will need resetting and the upper sections of several of the buttress would require repointing and repair.

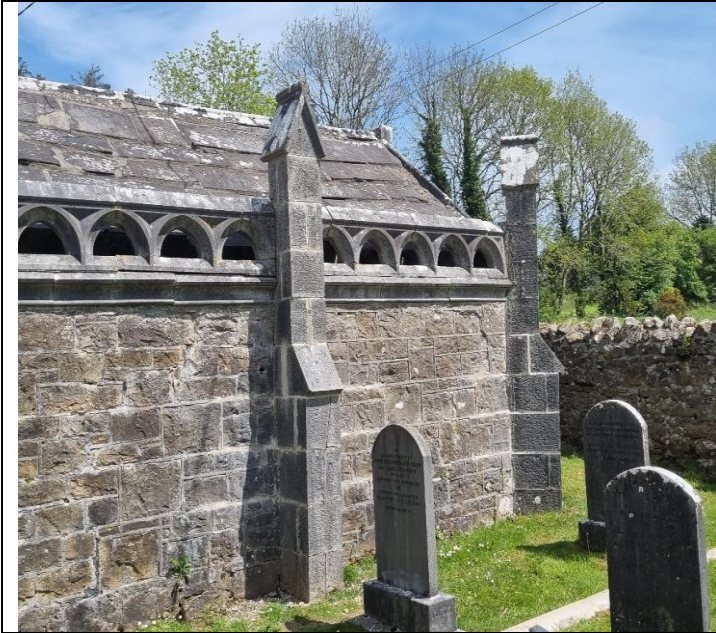
5. All cast iron cramps will need to be removed and the stonework numbered and rebuilt in phase 2

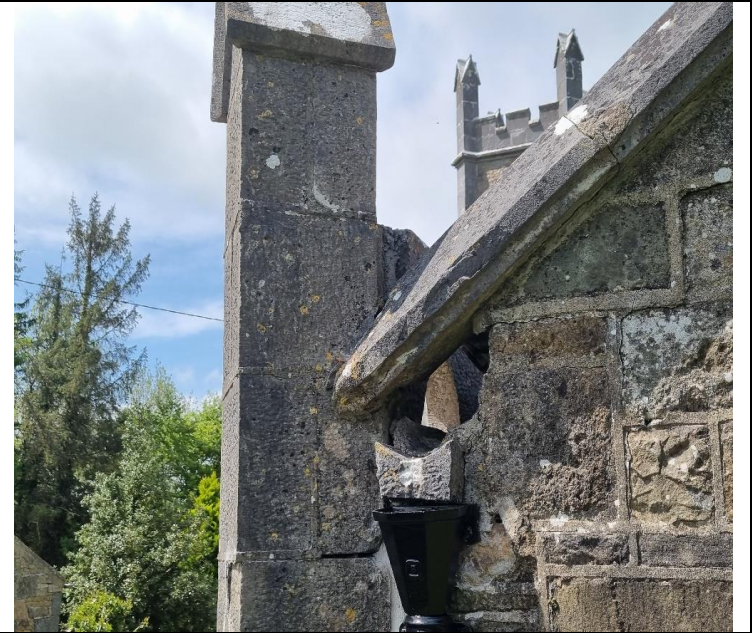
6. The upper level of the SE buttress has also displaced from Iron cramp corrosion and will need rebuilding in phase 2

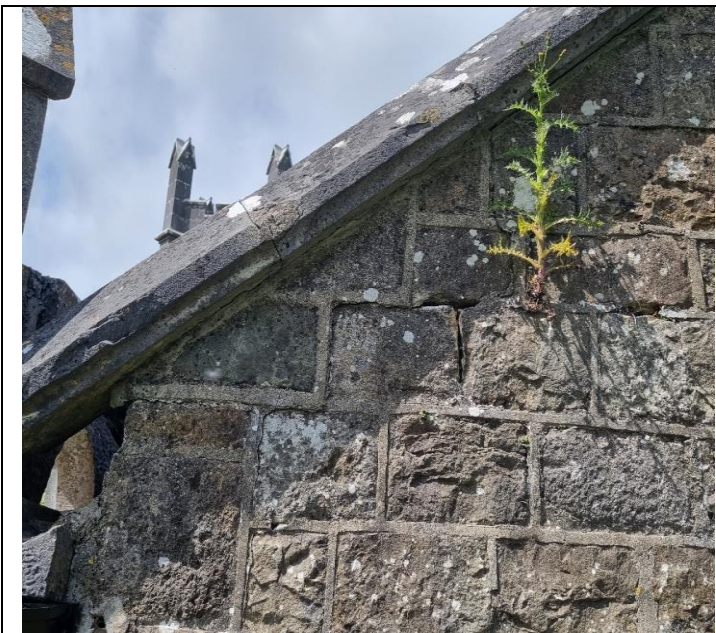
7. End coping stones to be rebuilt in phase 2

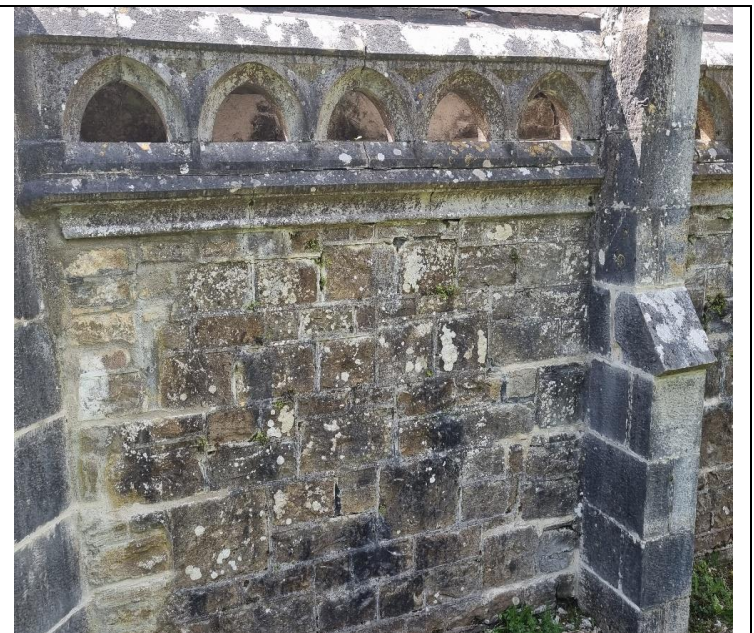
8. Note the top course of rubble masonry has moved due to iron cramp expansion to be addressed in phase 2

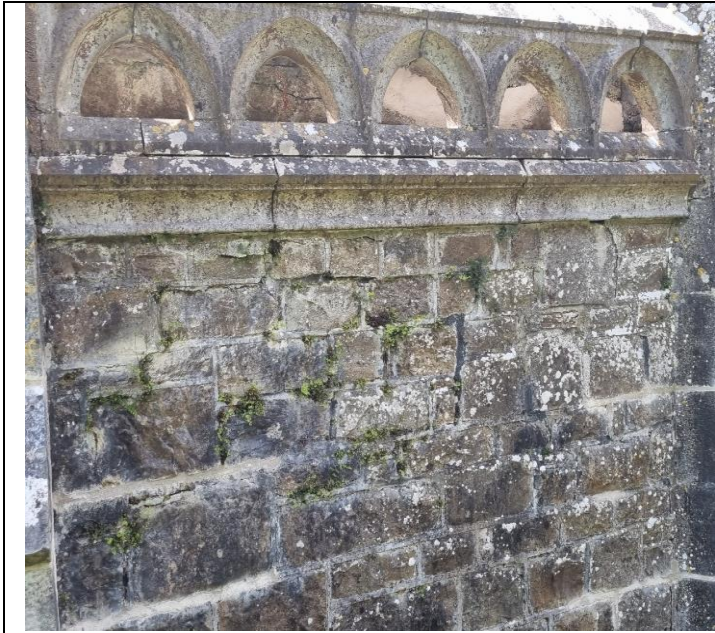
9. Ditto

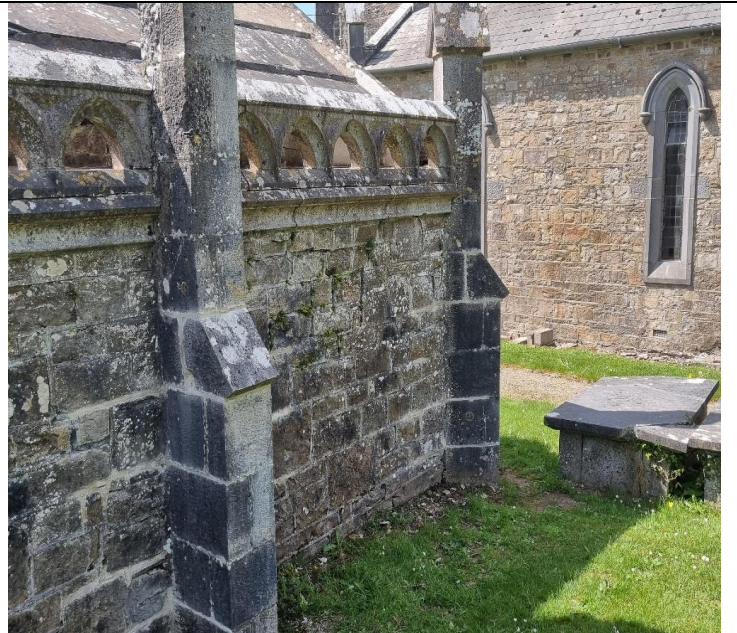
10. Repointed joints with crack tie reinforcement will be coloured to match existing

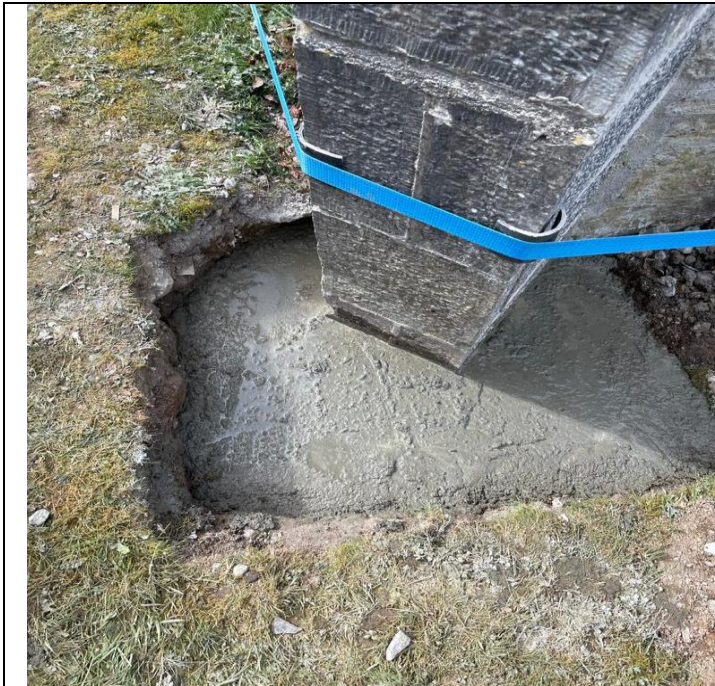
11. Underpinning works during the project stabilising the base of each buttress

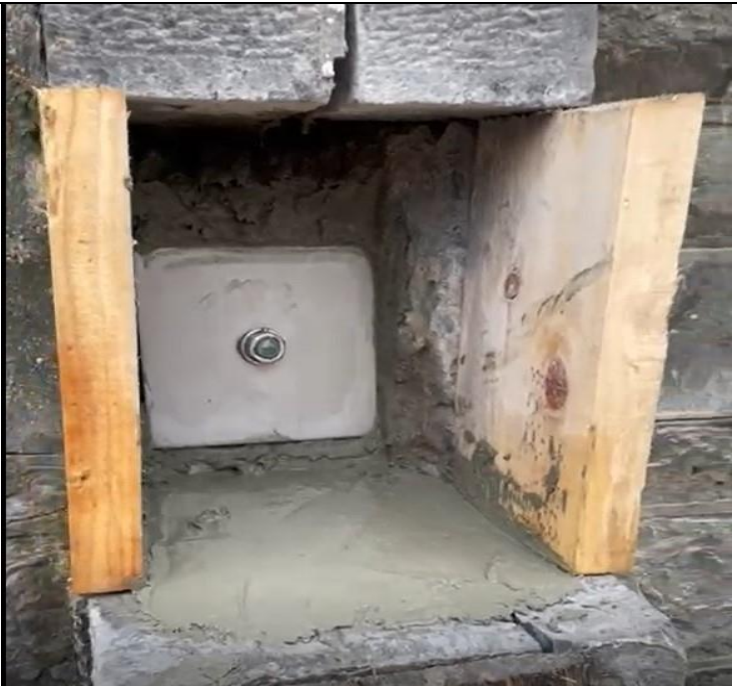
12. Stainless steel tie rod and plates during installation. These stabilise and tie the tall and narrow decorative buttresses to the main structure.

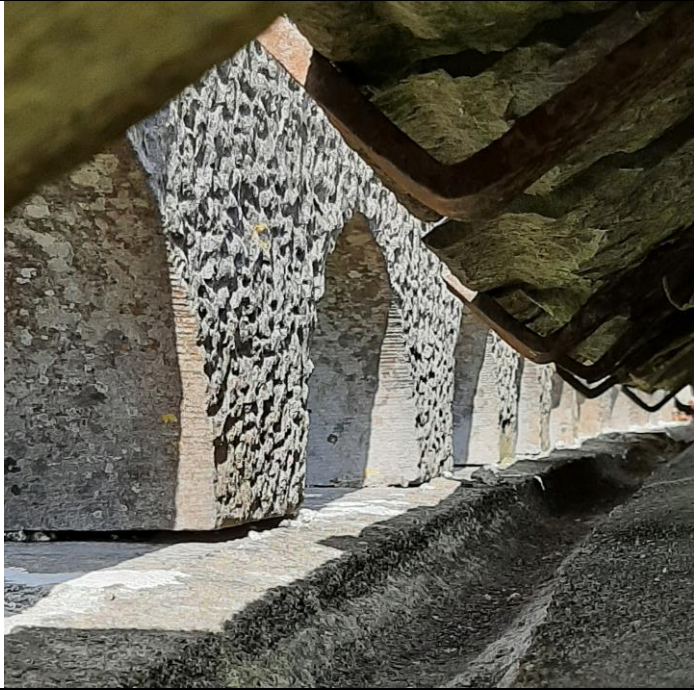
13. The valleys have been cleared and cleaned of debris, the joints pointed in an NHL 5 and the finished surfaces protected in a Remmers water repellent

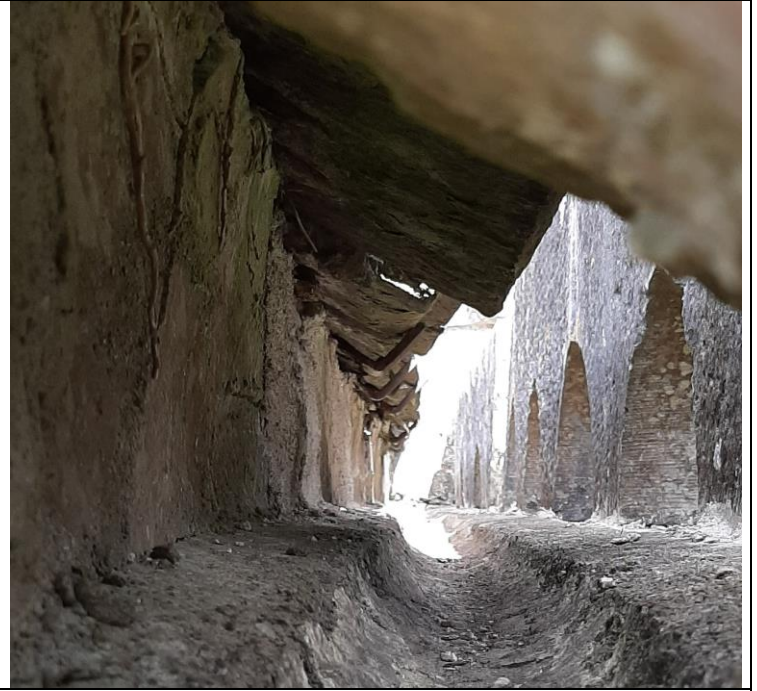
14. Ditto. While the flag roof over sails the valleys in areas the camber of the surface on either side of the valley, now cleared, should allow overshooting water to run back down into the valley and away
