Creative Ireland Projects 2021 – Vernacular Architecture – Final Report

CI Vernacular 21/03 Thatched House, Derrybeg, Co. Offaly

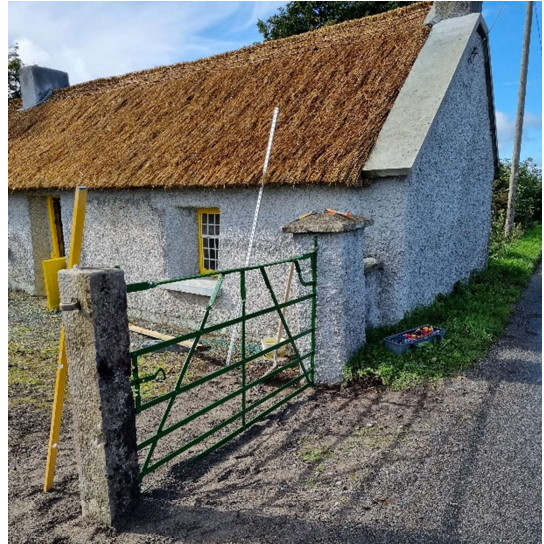
Current 2021

Repairs/reinstatement of windows (note mix of existing steel windows and timber sash) and repair to existing wrought iron entrance gate.

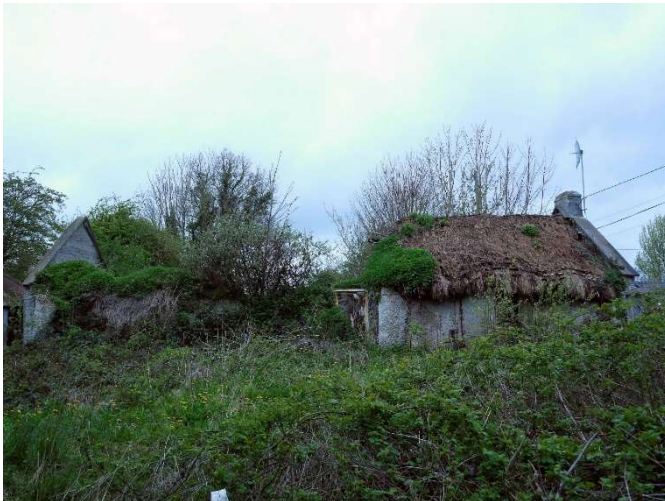
2018 – Thatch Survey

Note when this property was purchased by the current owner it was in a derelict state with the roof and much of the walls collapsed (see 2018 photo). He has rebuilt the walls and roof, rethatched the roof and repaired front steel pivot windows.

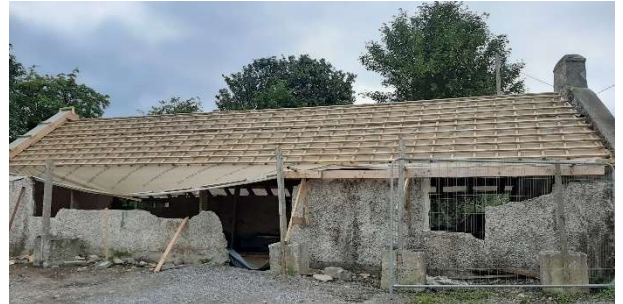
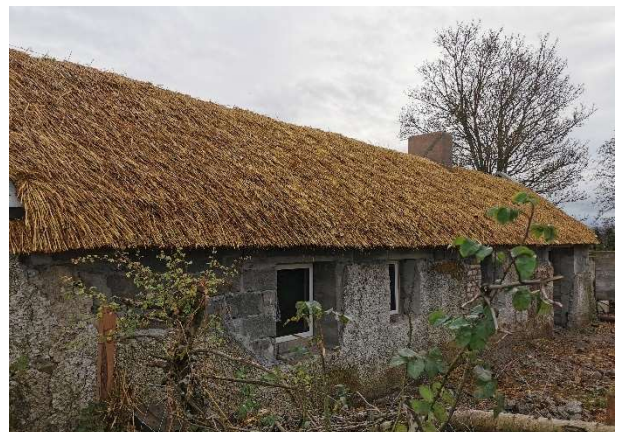
2020 July - roof structure in place

2020 September - rear elevation with new thatch

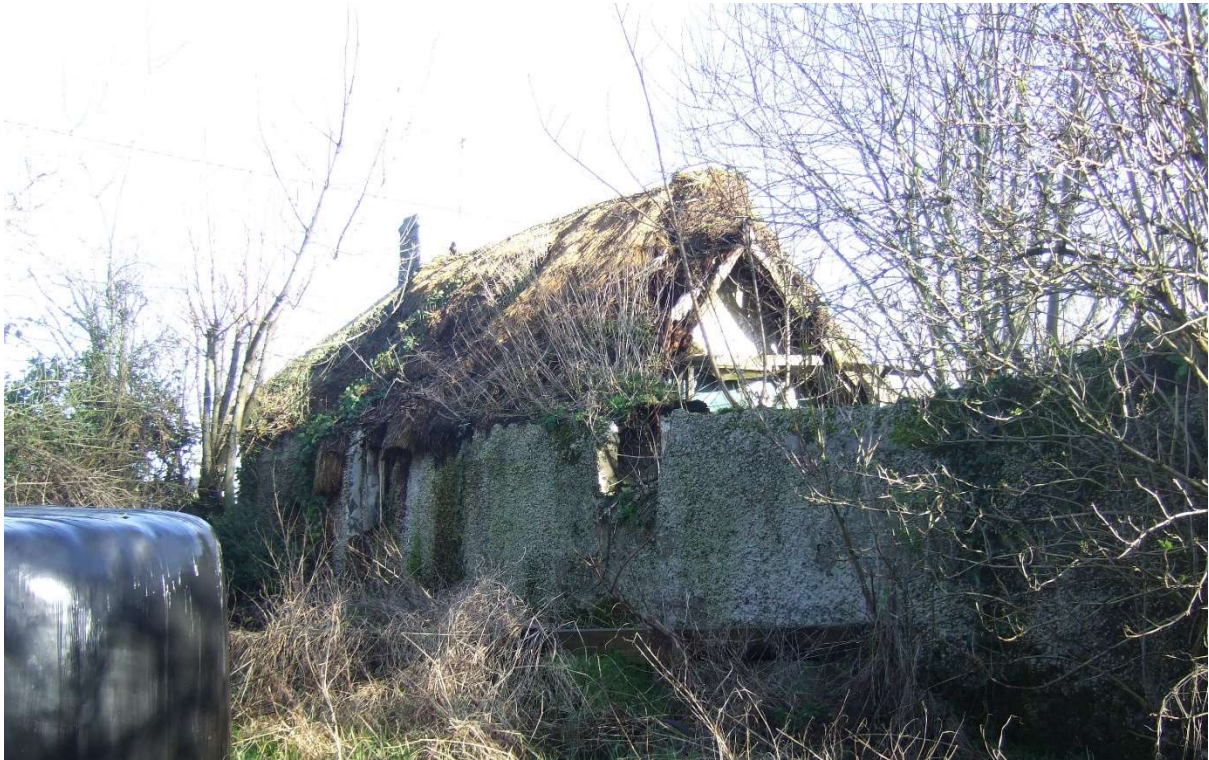
Rear elevation 2016

The applicant sought to provide windows to the rear of the property which matched the front repaired, steel windows. These were in bedrooms and to ensure fire escape provision, they provided a timber casement window designed to mimic the steel windows.

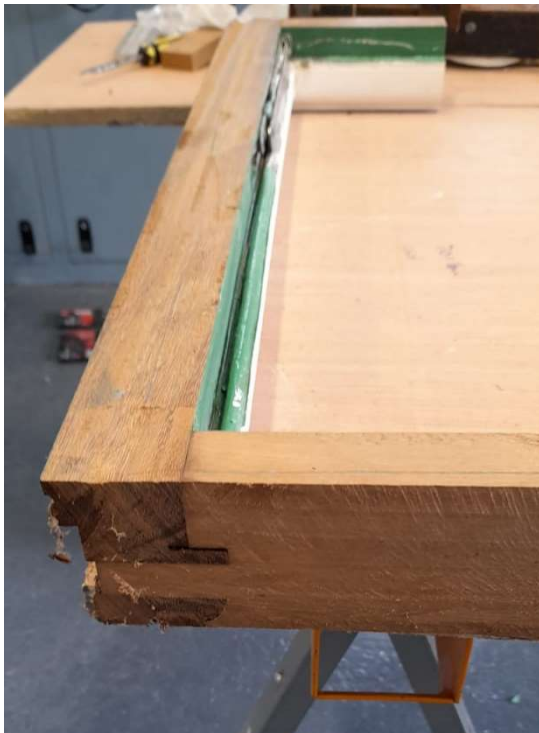
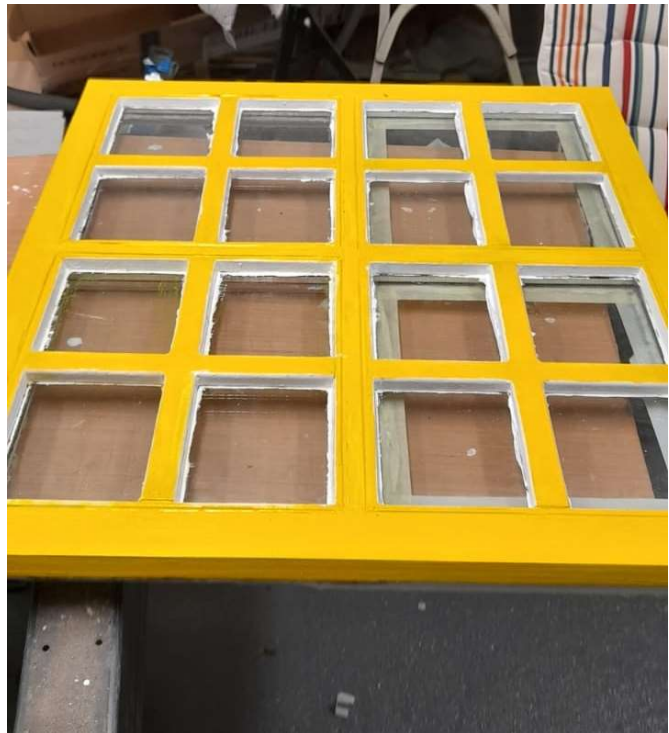
Special windows under construction

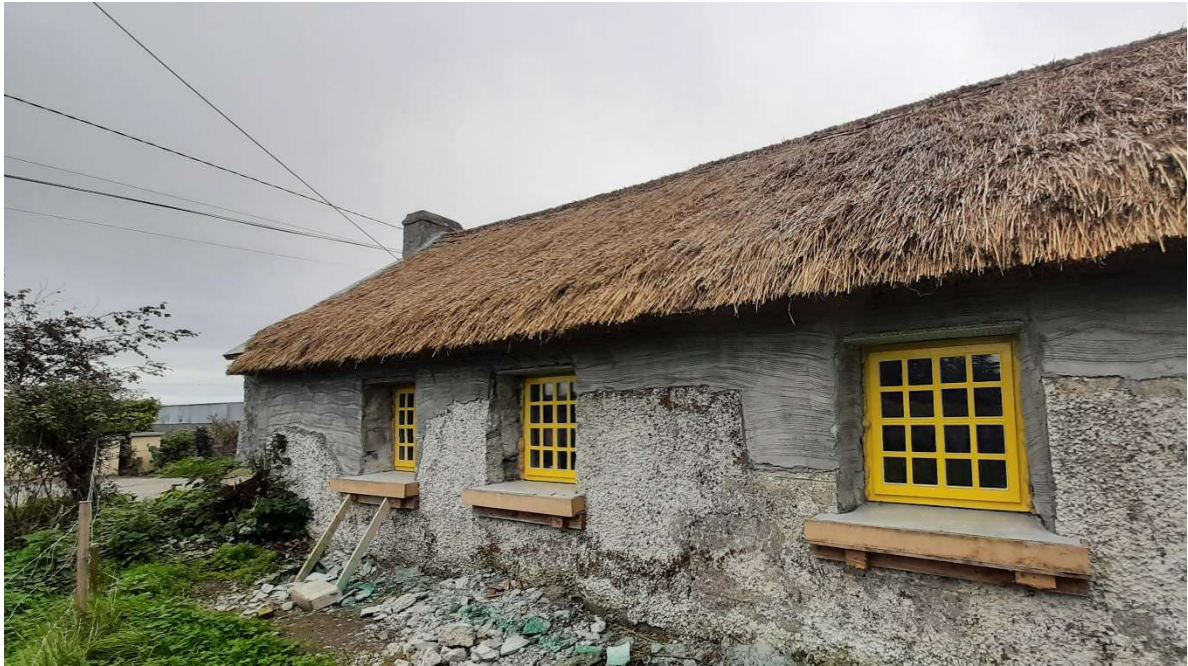
Three new timber windows in rear elevation

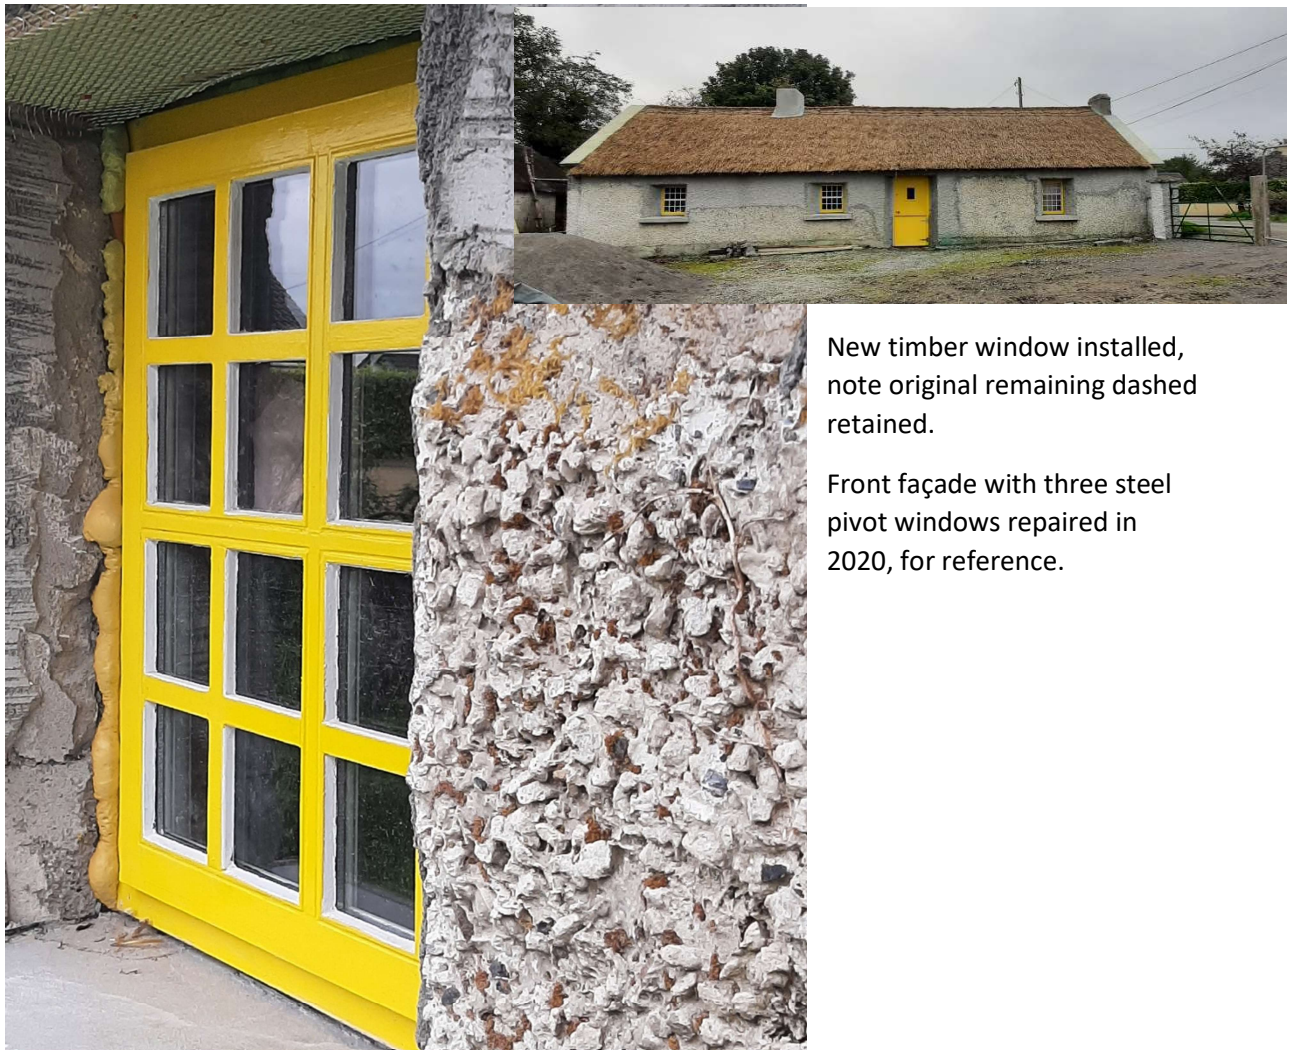
New timber window installed, note original remaining dashed retained.

Front façade with three steel pivot windows repaired in 2020, for reference.

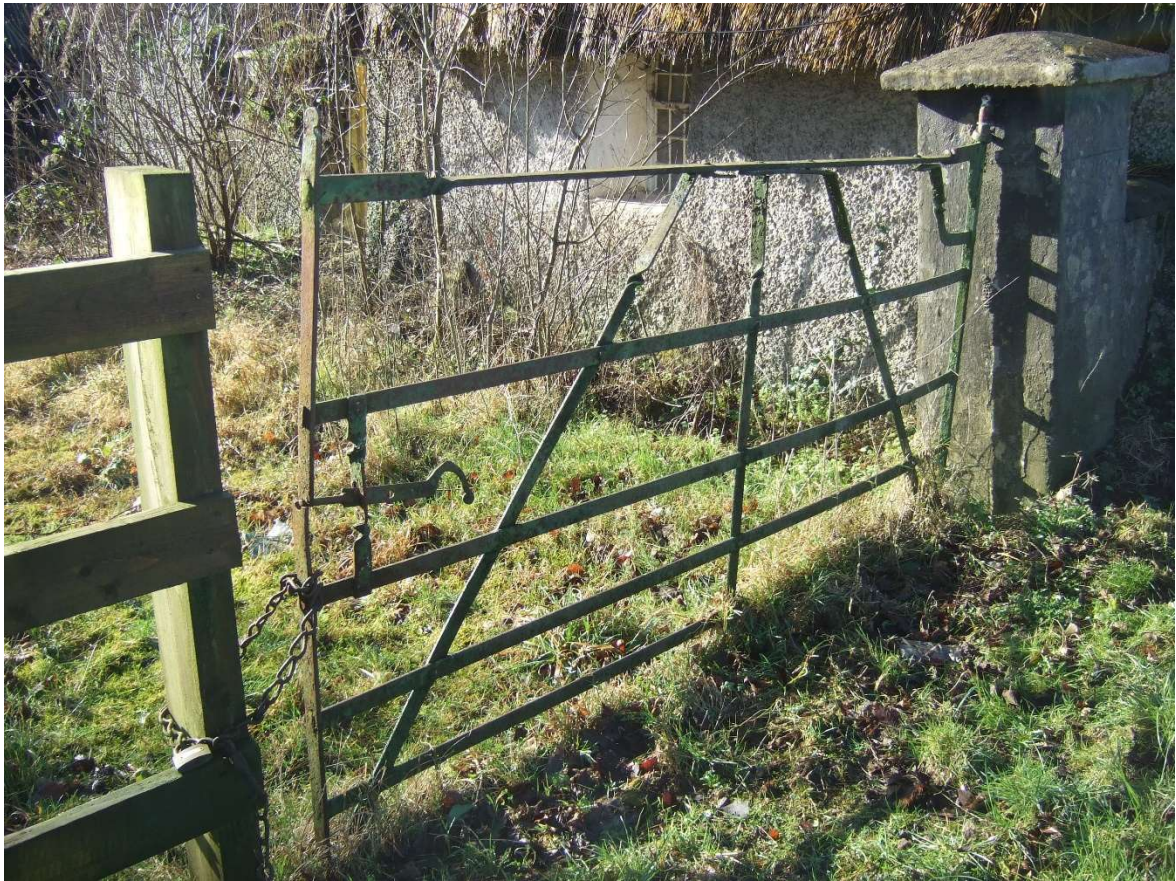
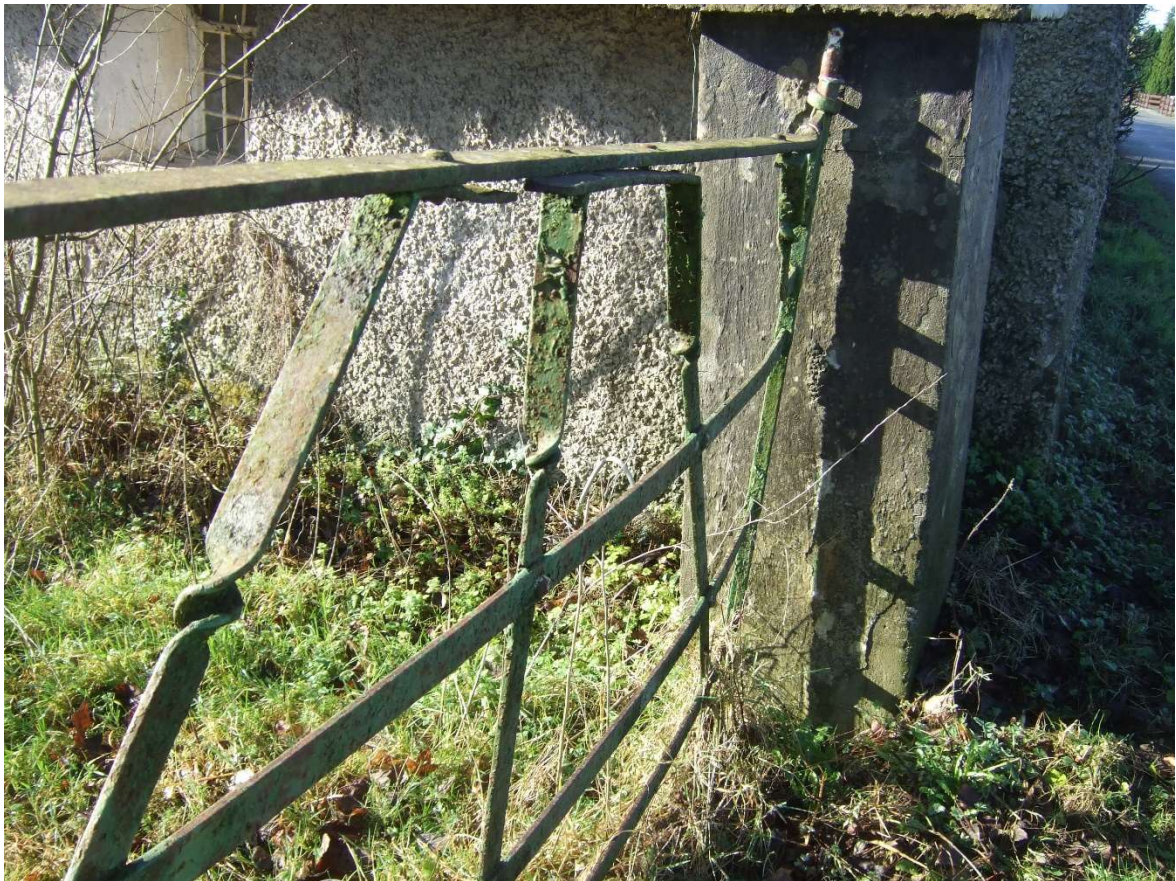
2016_0216 Wrought Iron gate on site – sections bent or broken

Latch and handle with upper and lower twist detailing

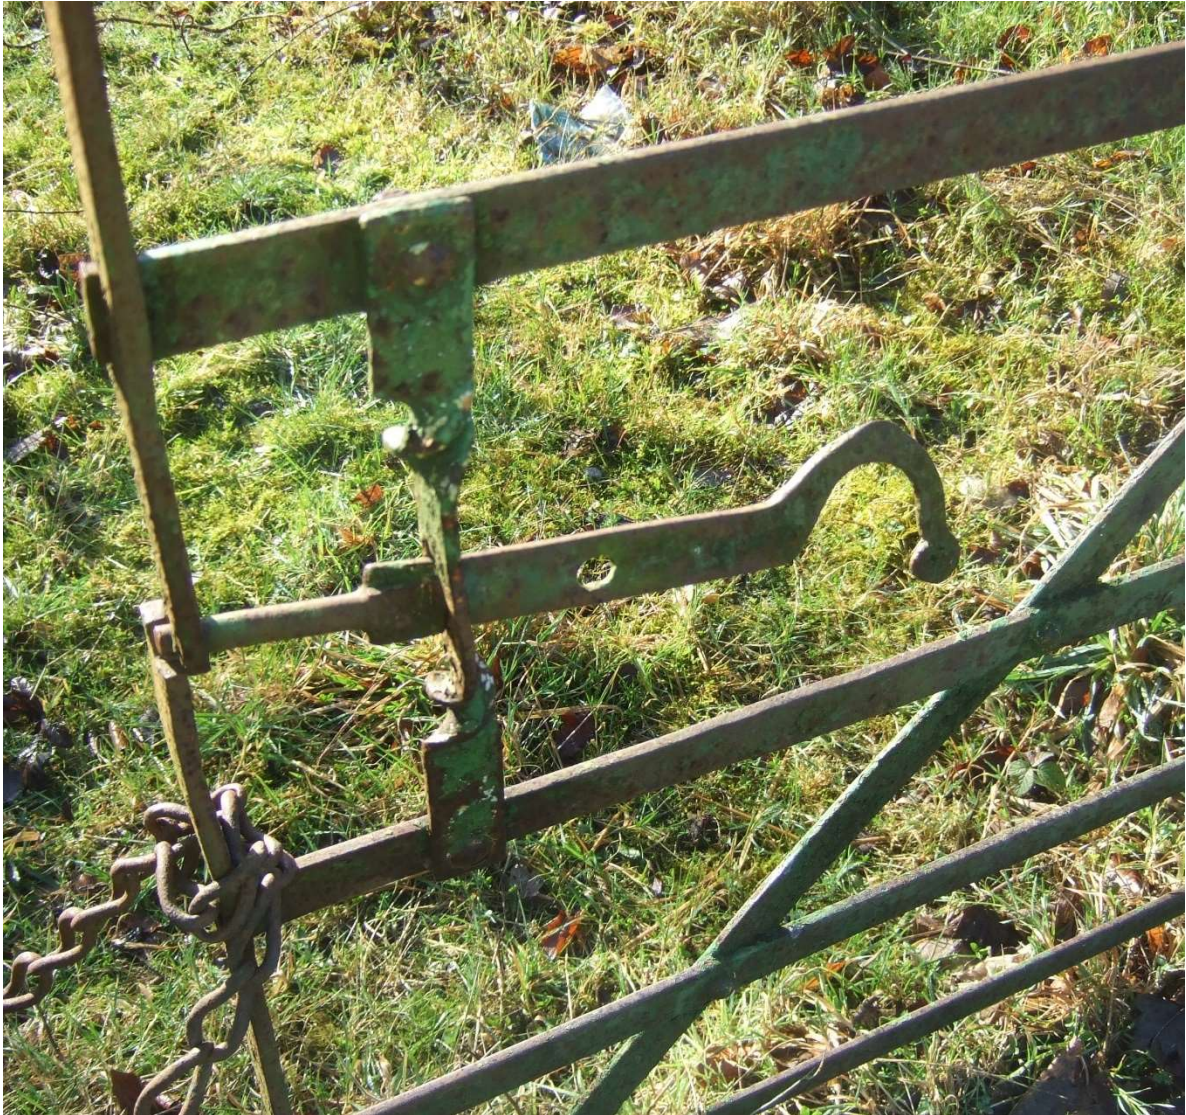
Prior to repair

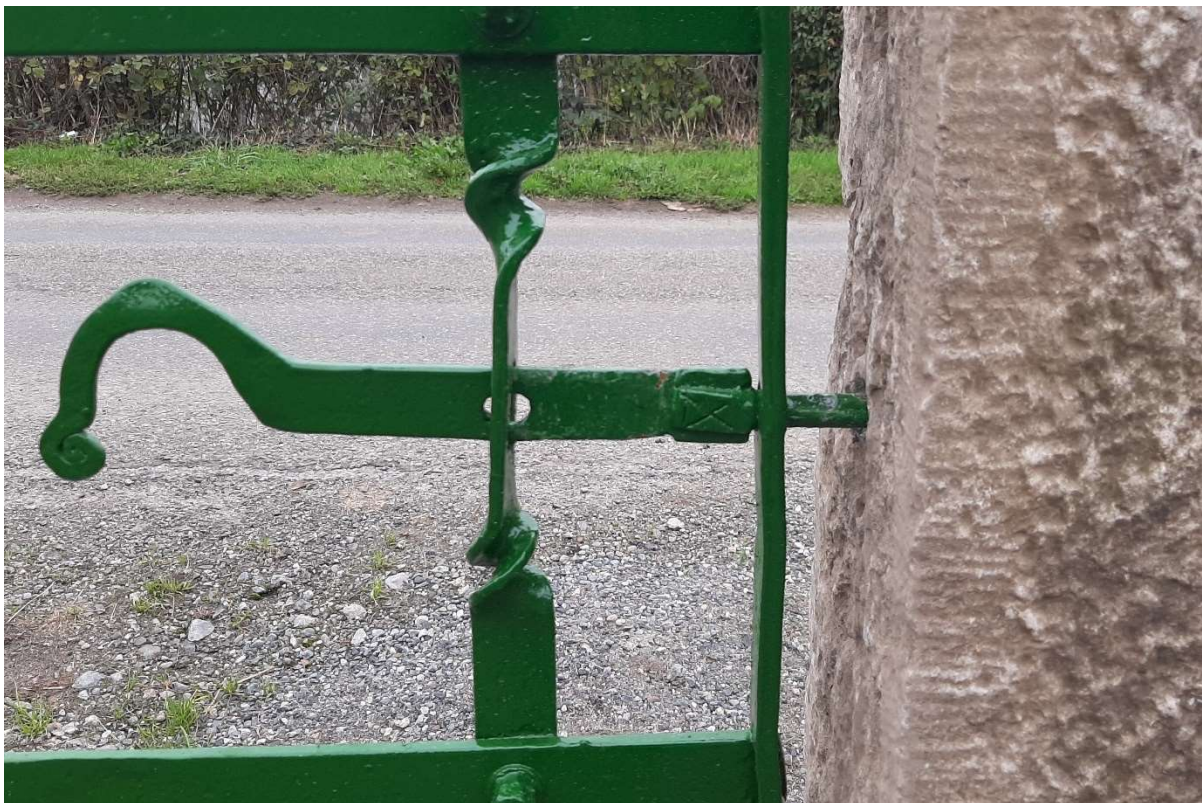
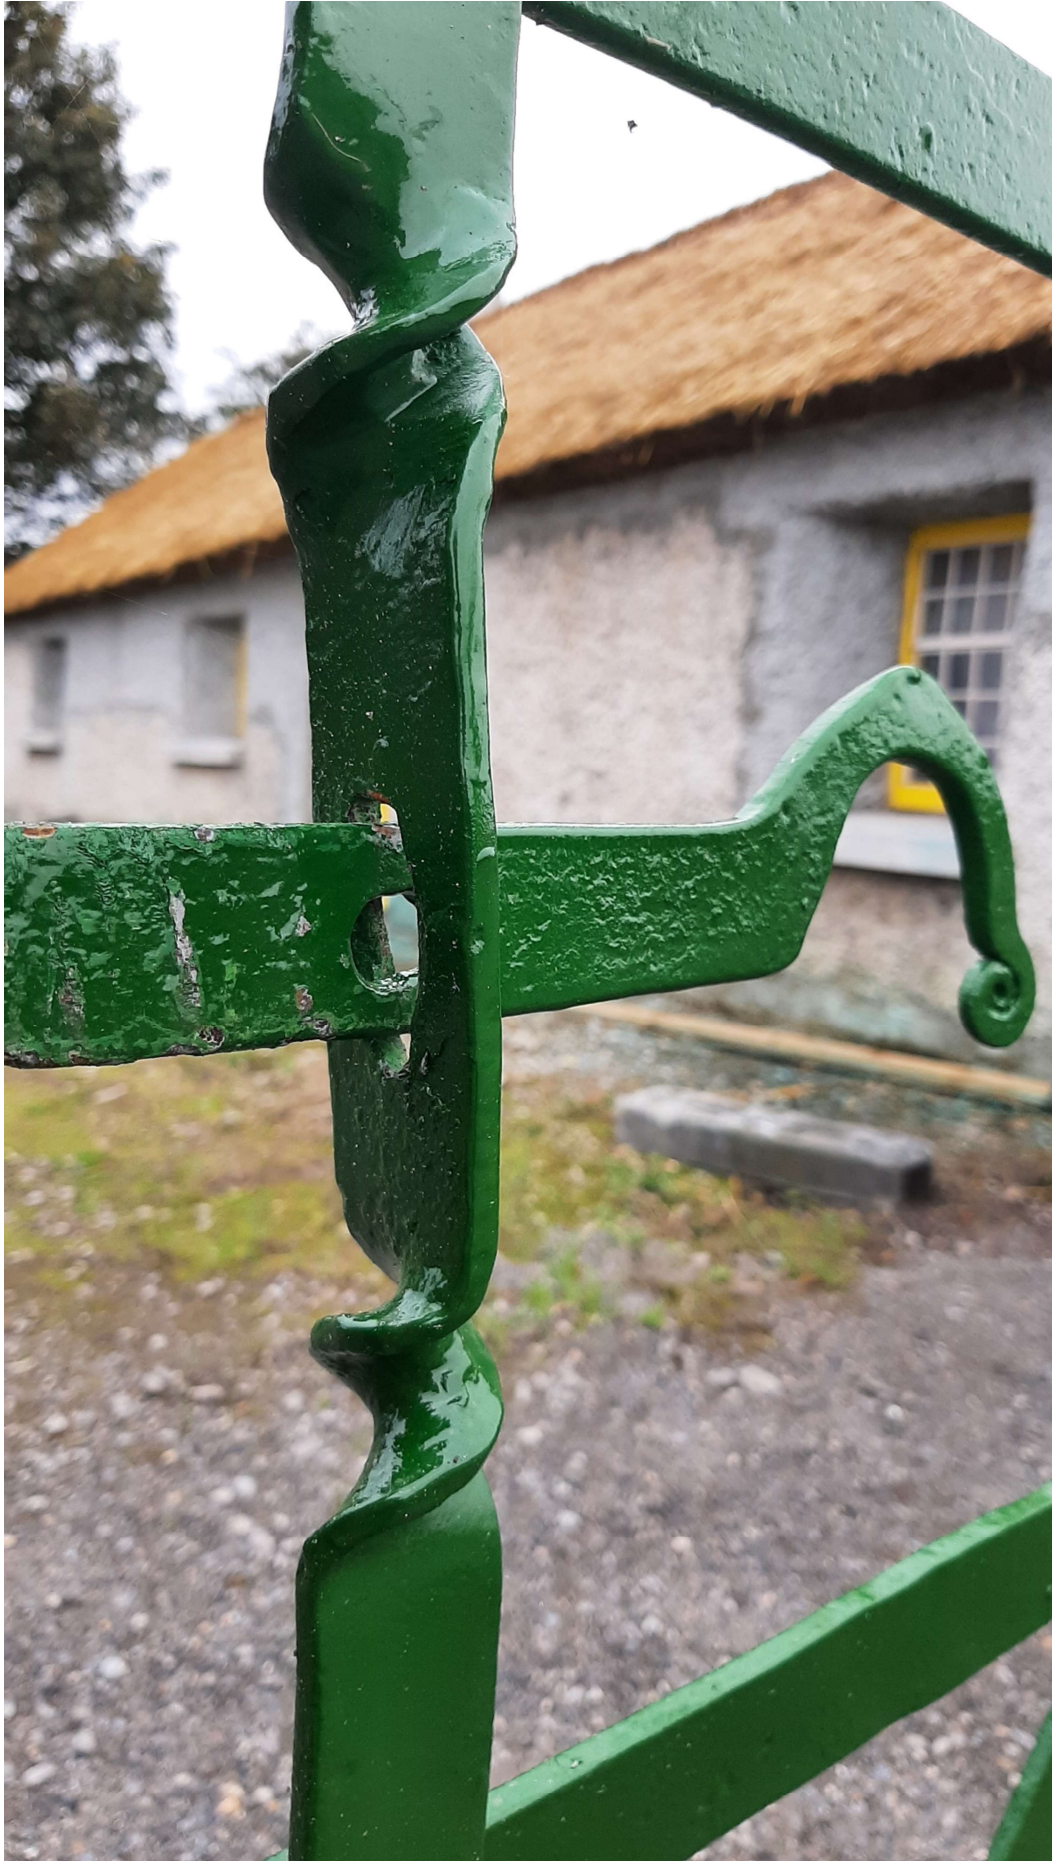
Latch detail with curved handle and scroll finial. Note blacksmith mark (X) at latch bar.

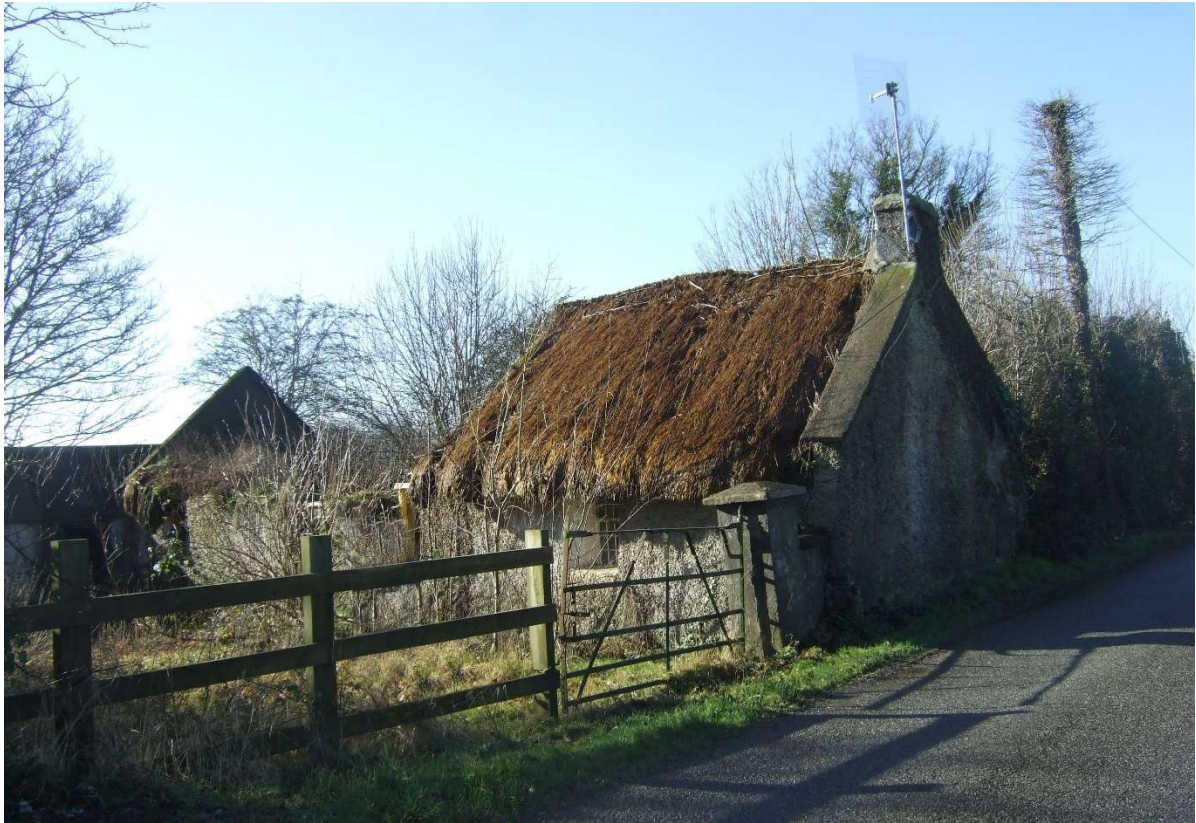
Before: gate, twisted and damaged only one pier – house, roof partially collapsed 2016, further collapsed when current owner purchased the property
