Creative Ireland Projects 2021 – Vernacular Architecture

CI Vernacular 21/02 Killyon Forge, Killyon, Birr, Co. Offaly

Roof and wall repairs

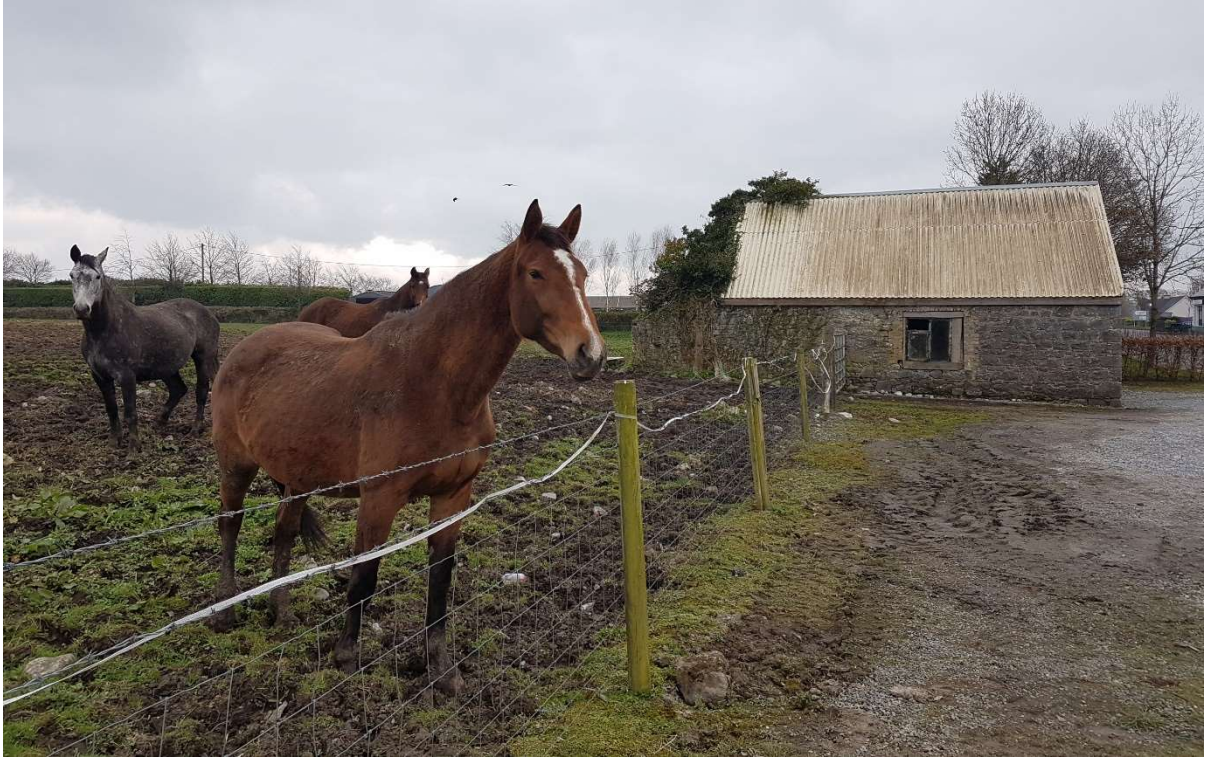
Side elevation

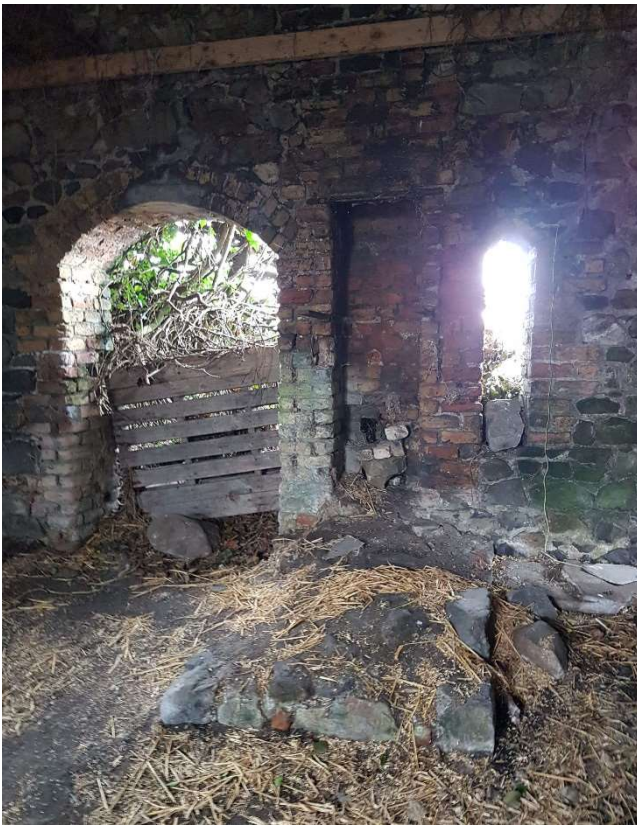
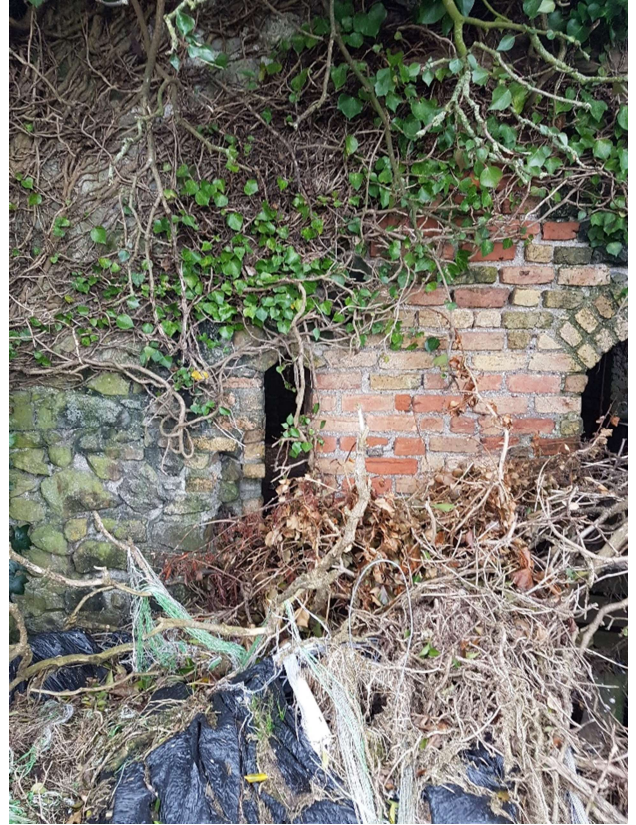
Rear door and brick arched opening, internal showing furnace location and external view

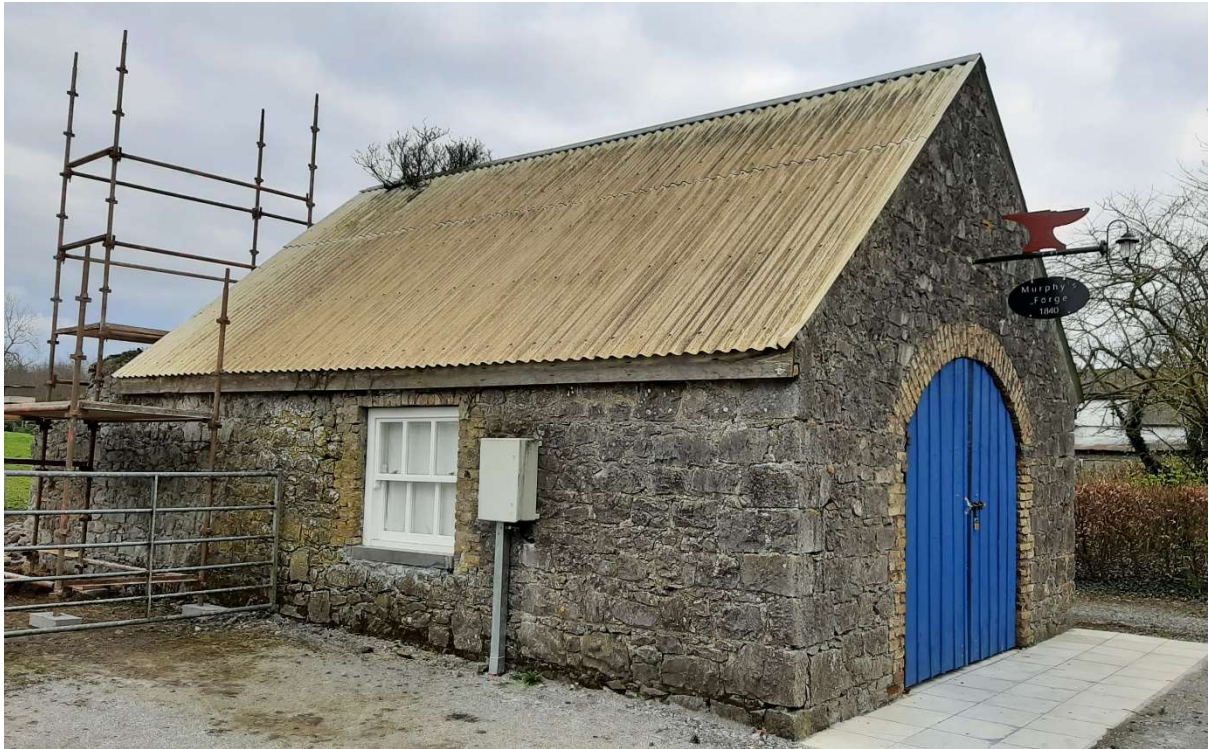
New doors and window in place (2021_0420) scaffolding in place for gable repairs

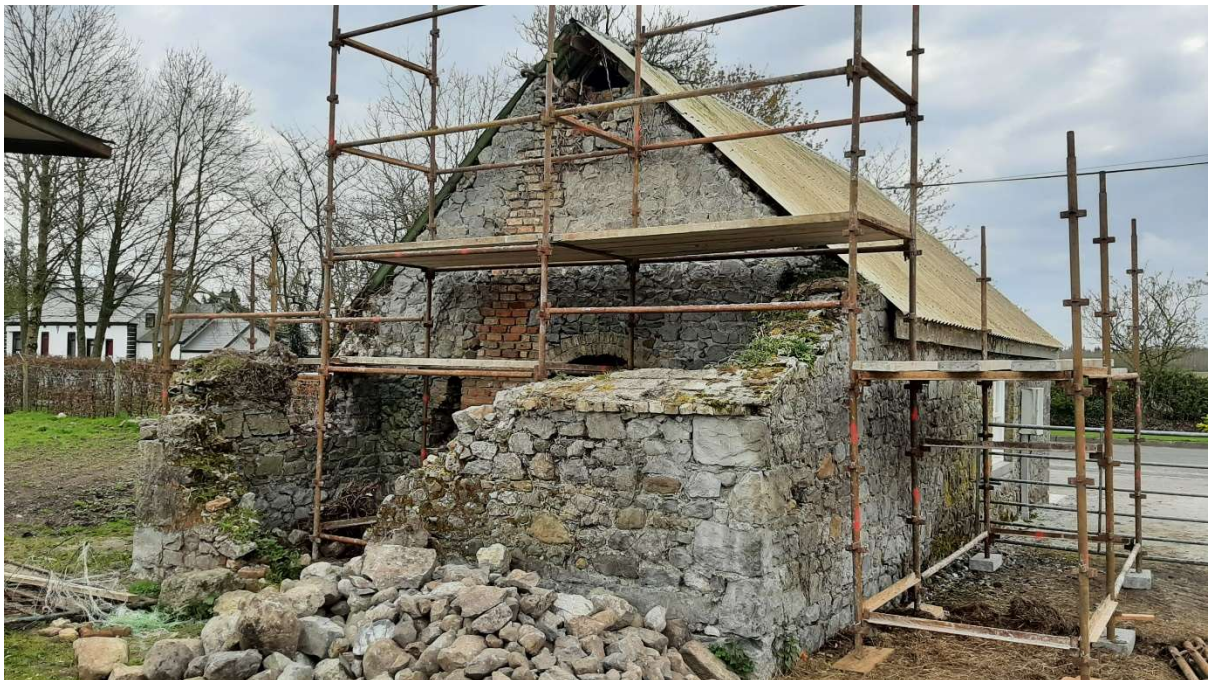
Rear elevation with ivy removed. Lean-to and surrounding loose stone collected for repairs

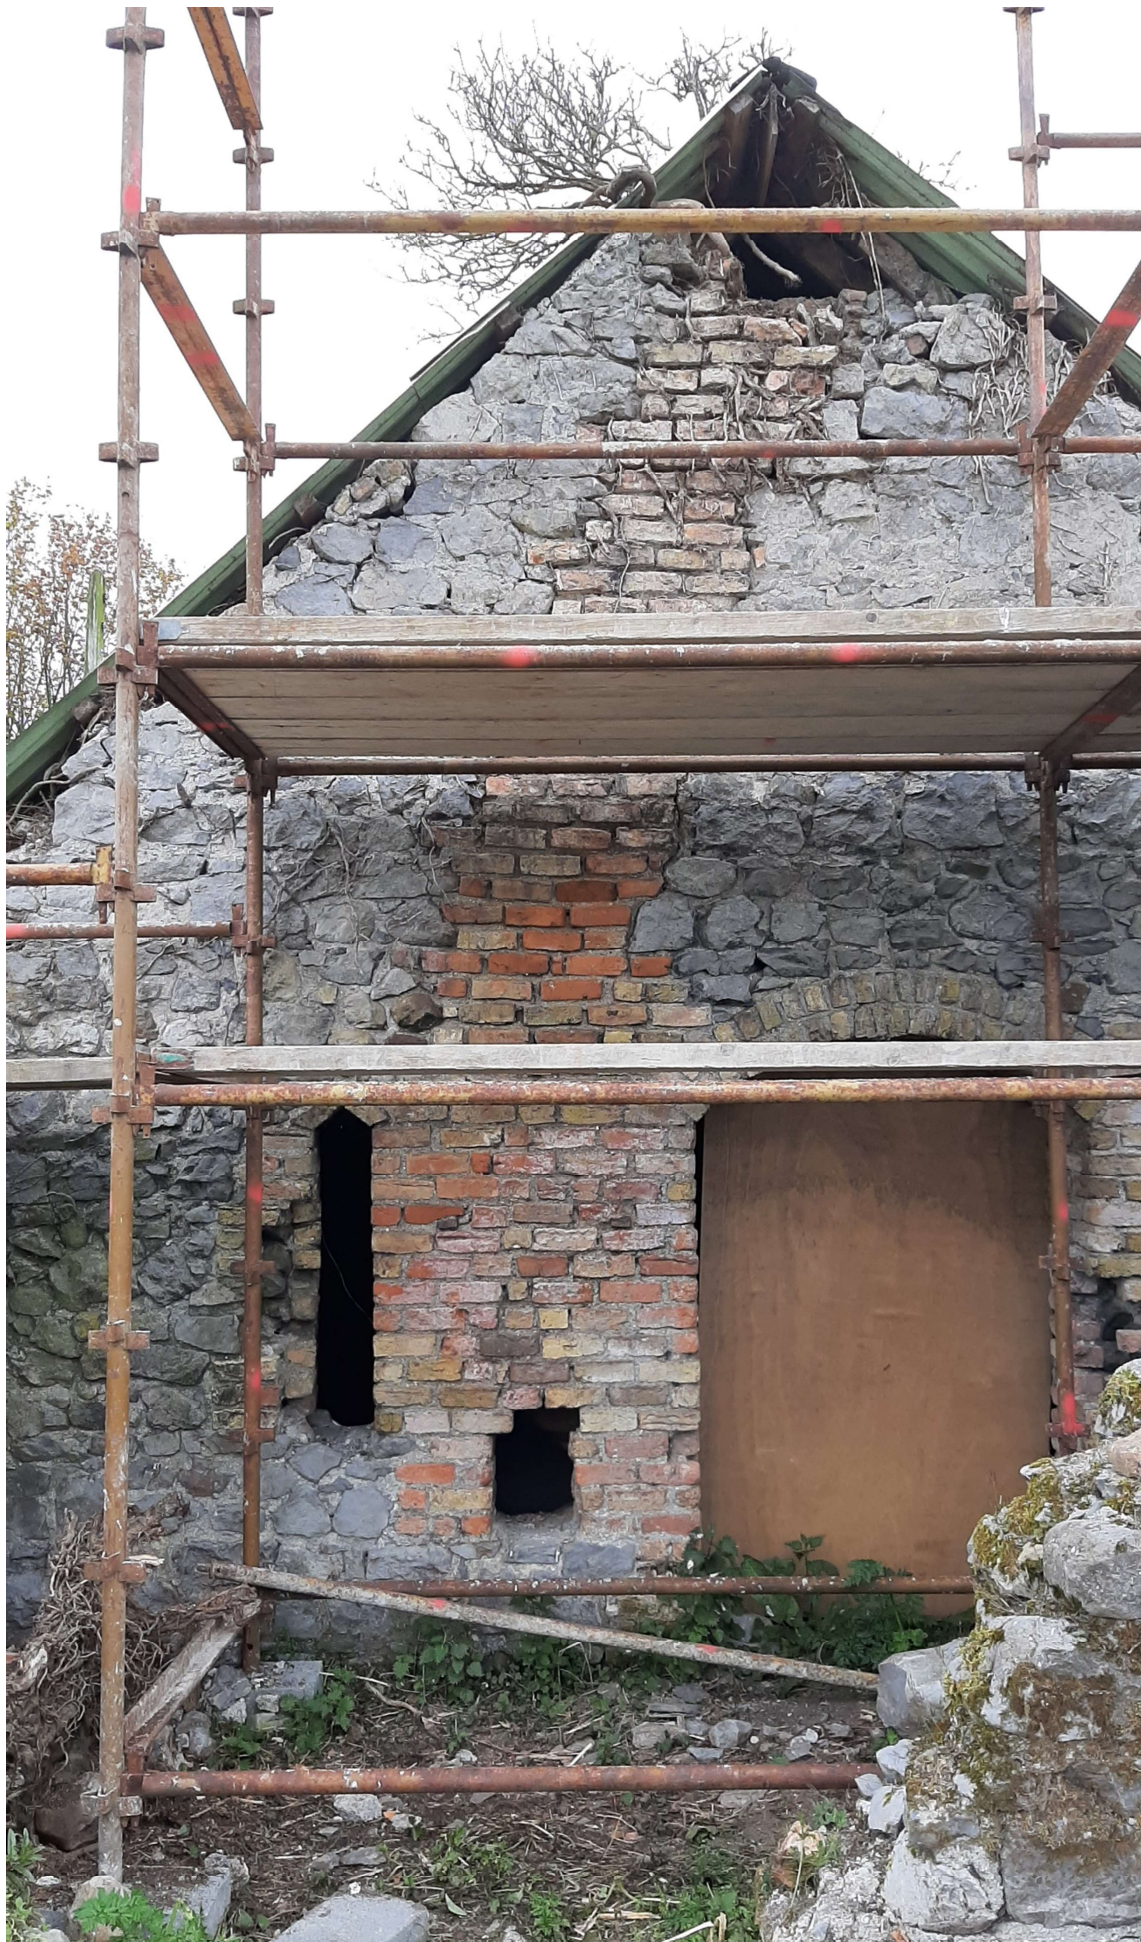
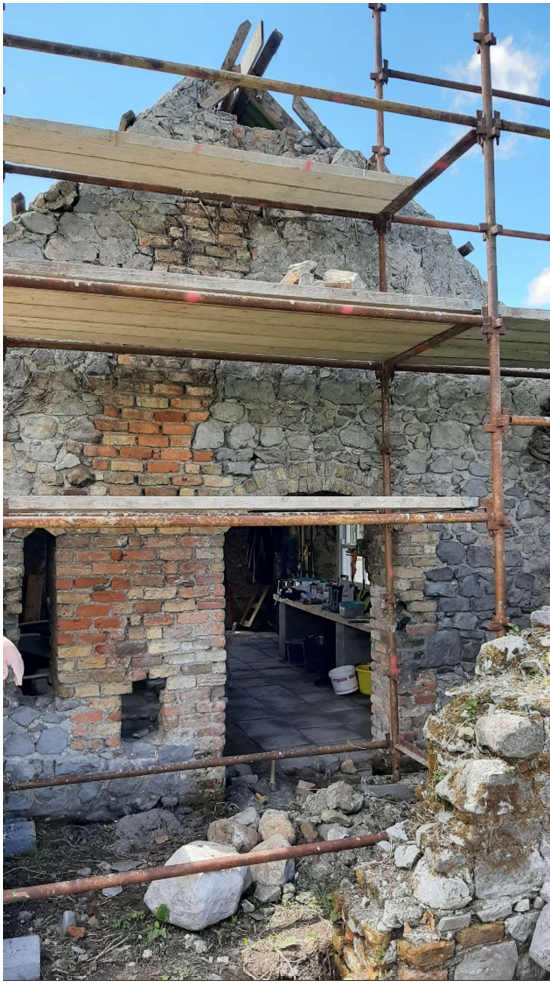
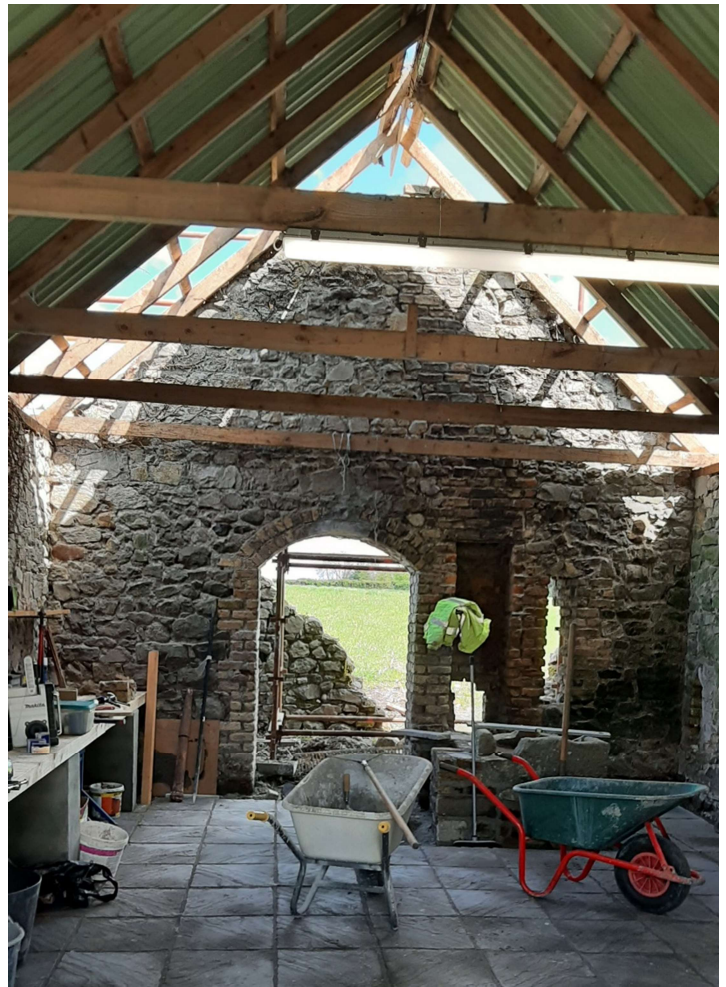
Gable repairs, brick and stone underway, retaining all openings and brick or pointed arched detailing, corrugated metal roof removed

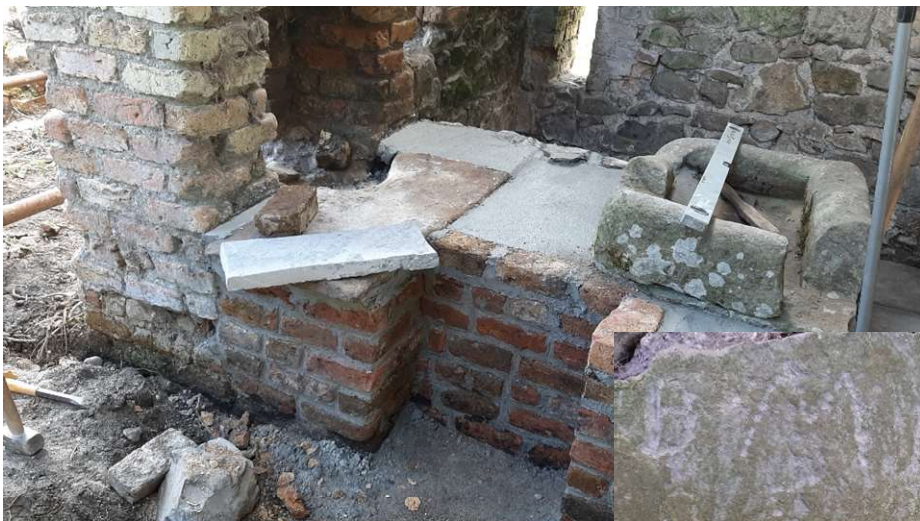
Furnace reinstatement with sink stone

Internal wall stone with carving; 'BMK 1890'

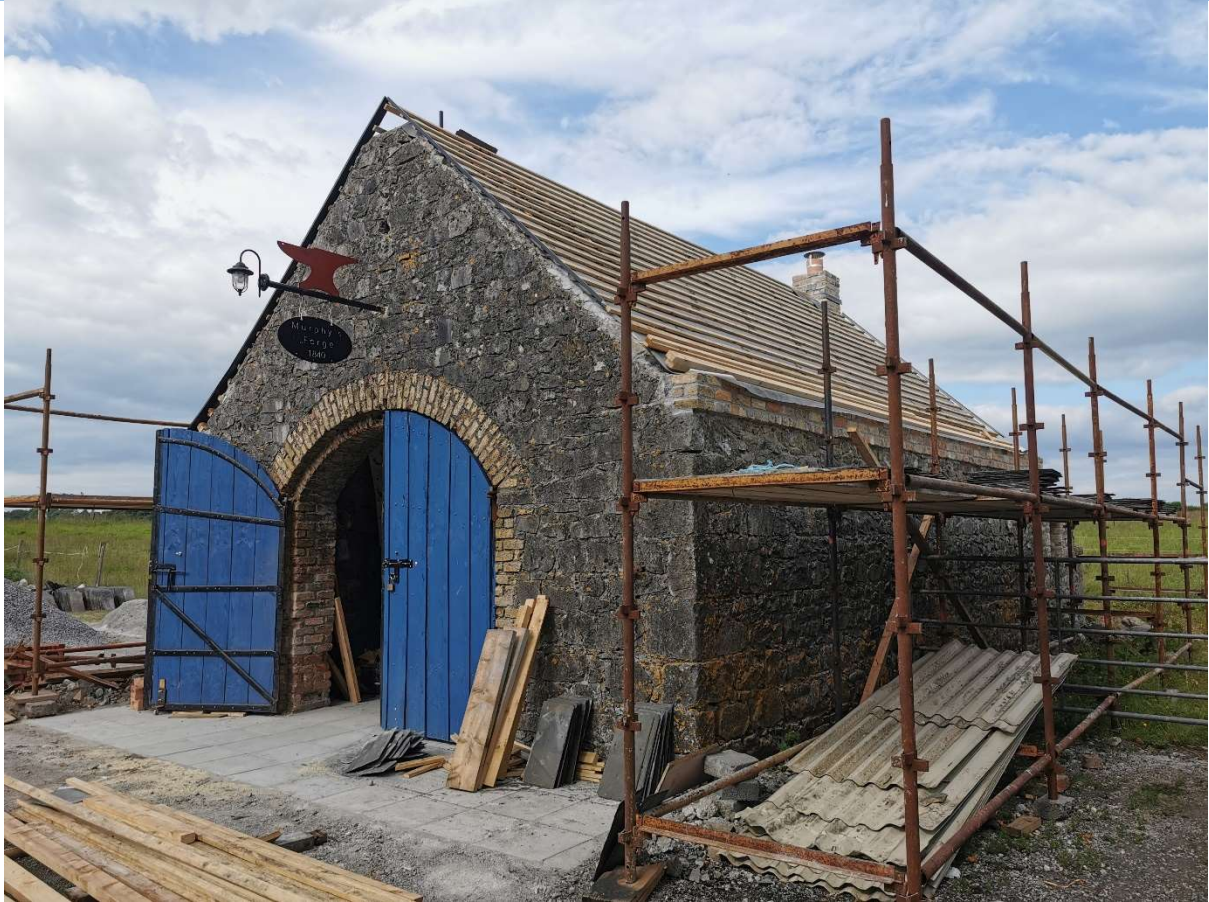
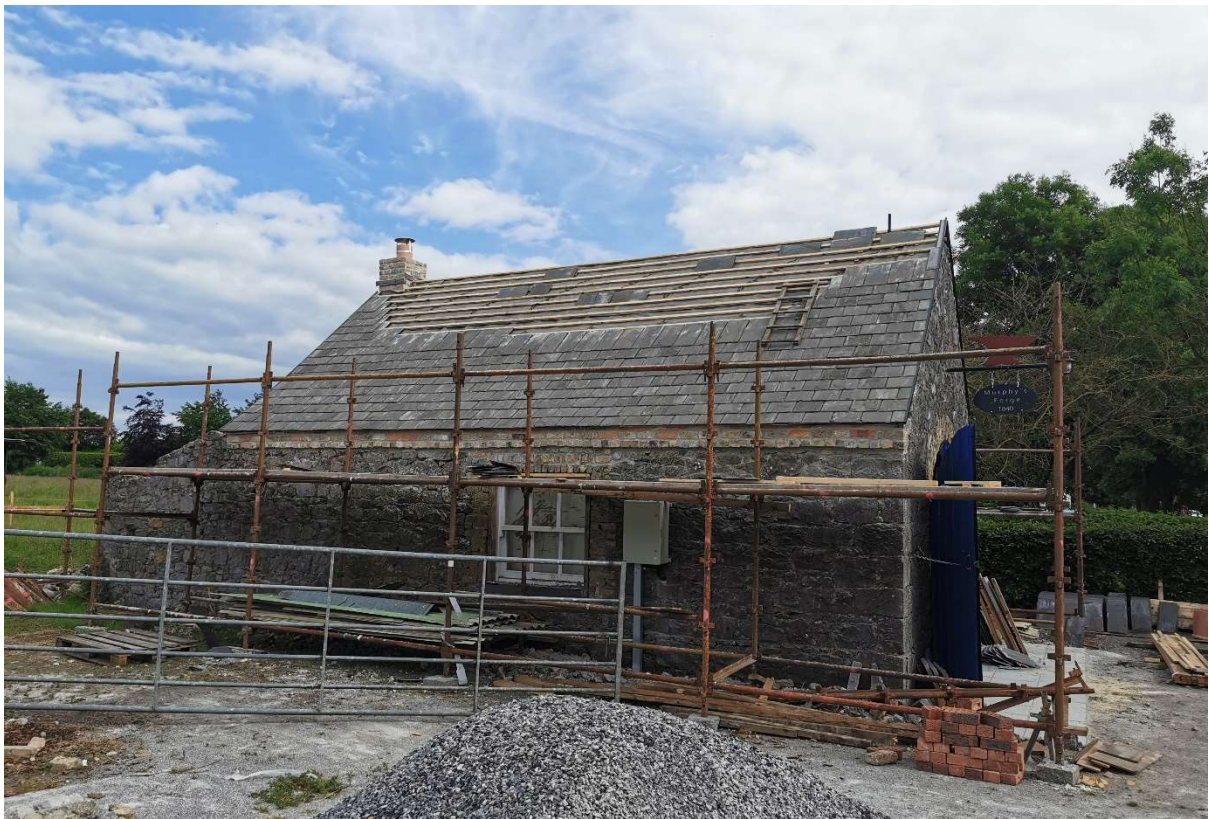
Slating underway, brick chimney repaired

2021_0618 – Slating roof, repairs to chimney and brick corbel to eaves

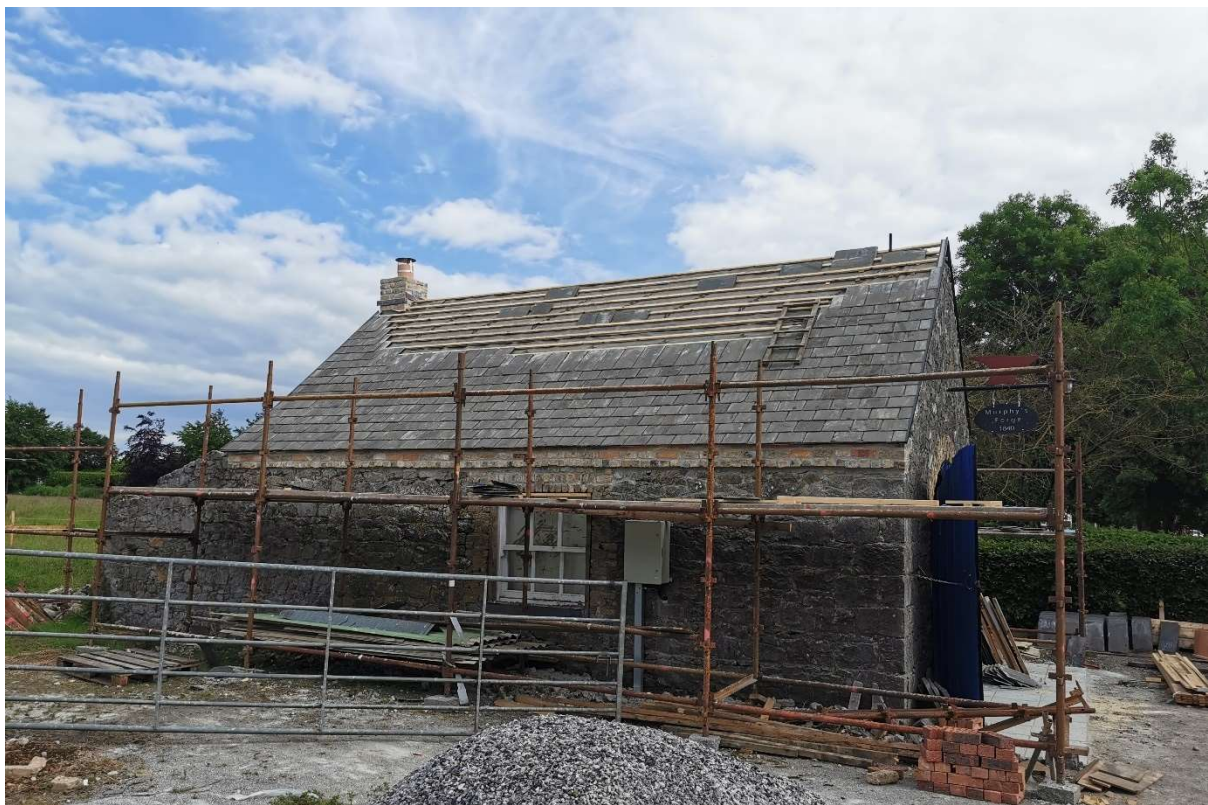
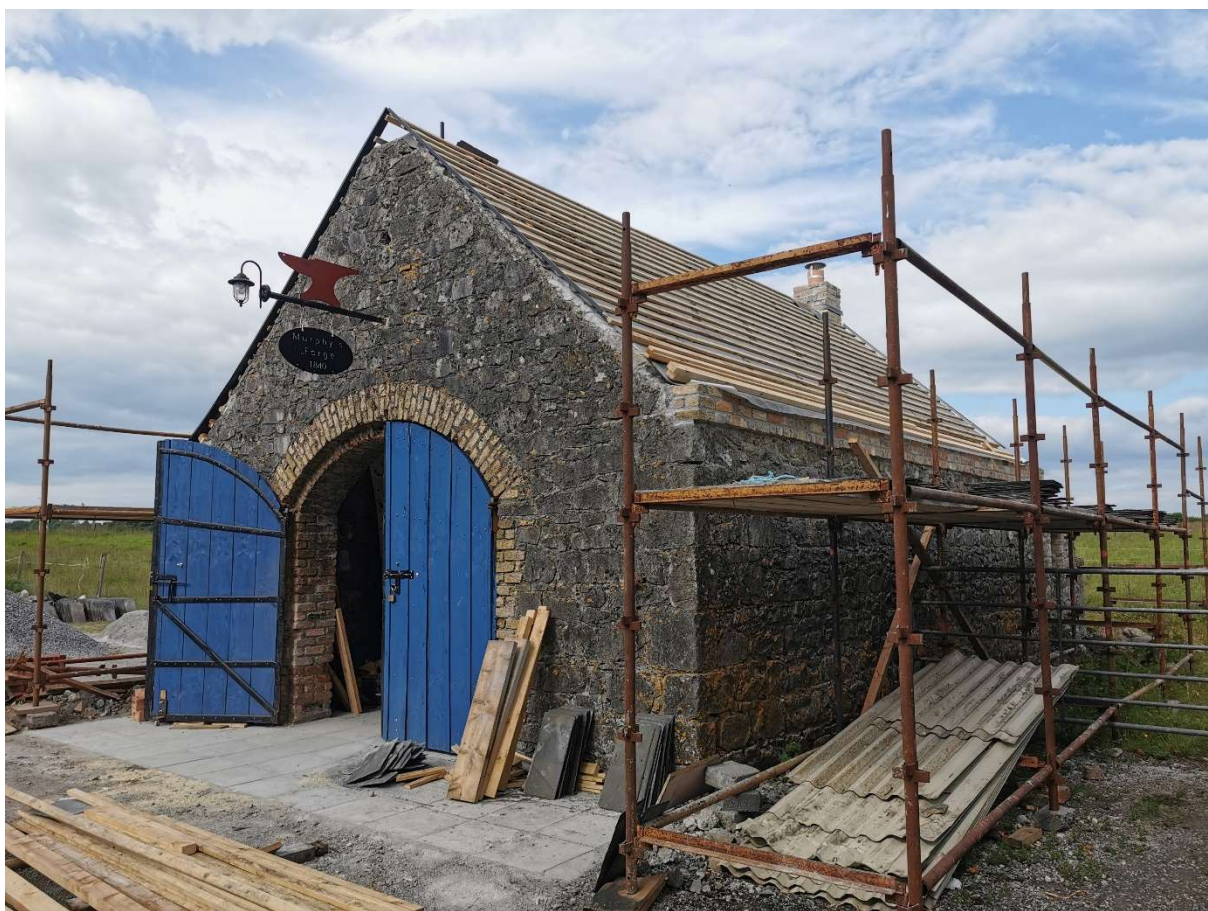
2021_0708 Slating continues, repairs to gable. Flues for chimney and terracotta ridge tiles

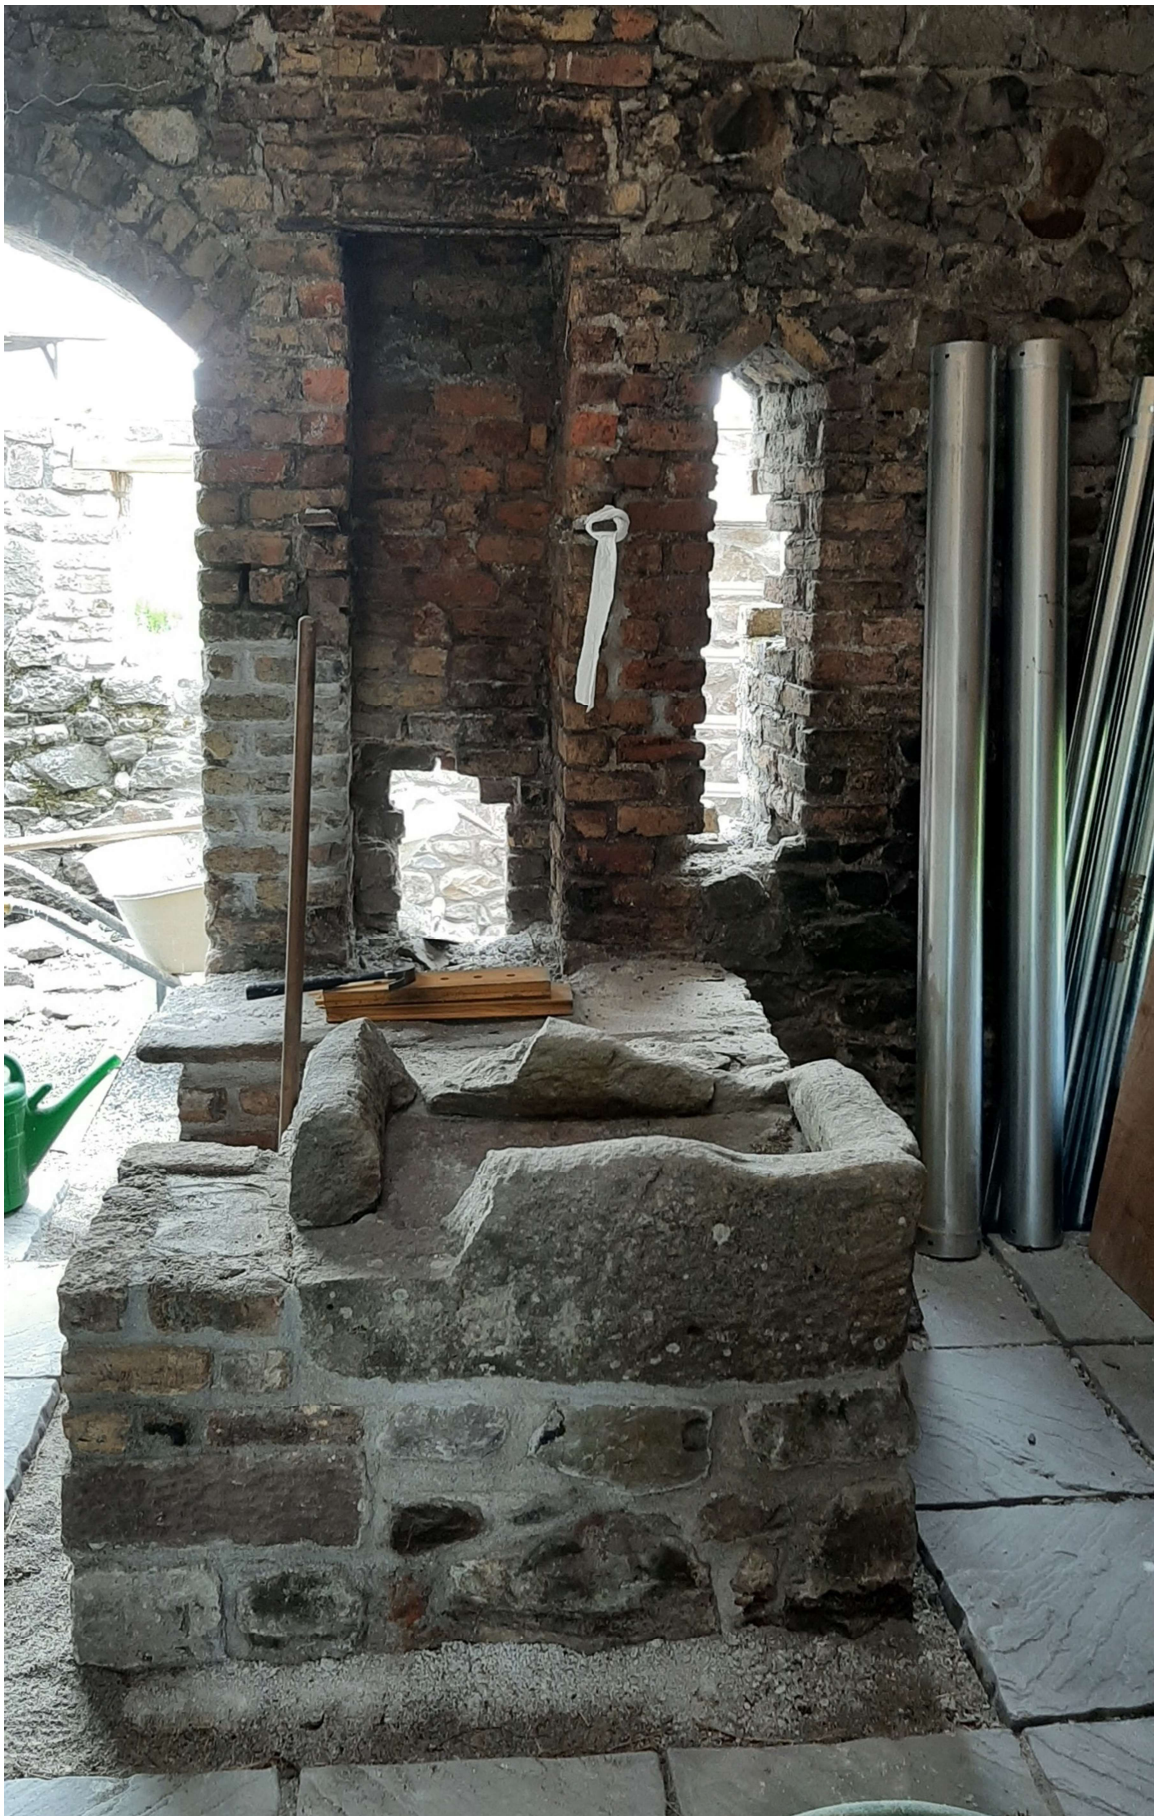
Repairs to brick arched openings, vents, windows and lean-to at rear

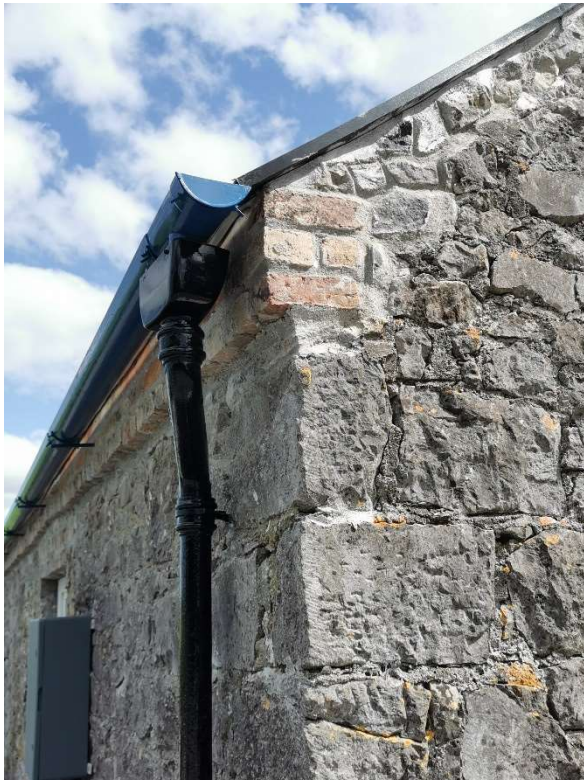
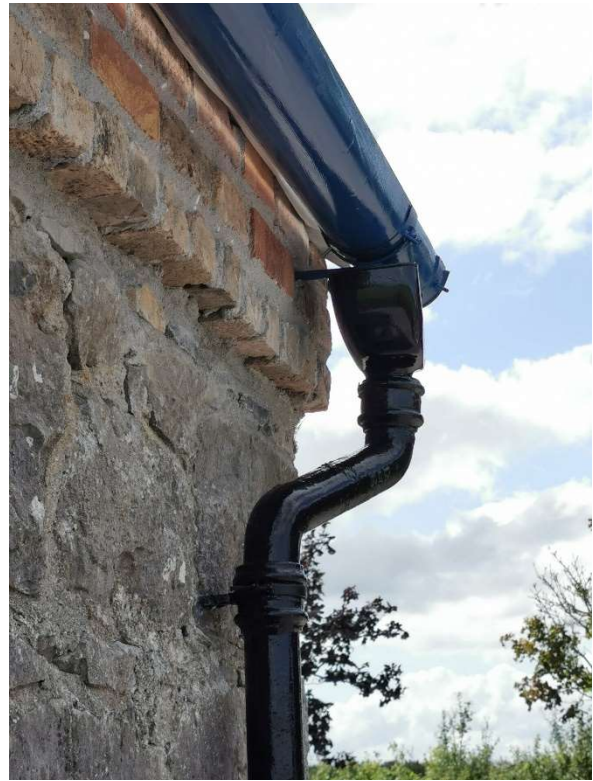
Gutters, downpipe and brick corbel detail

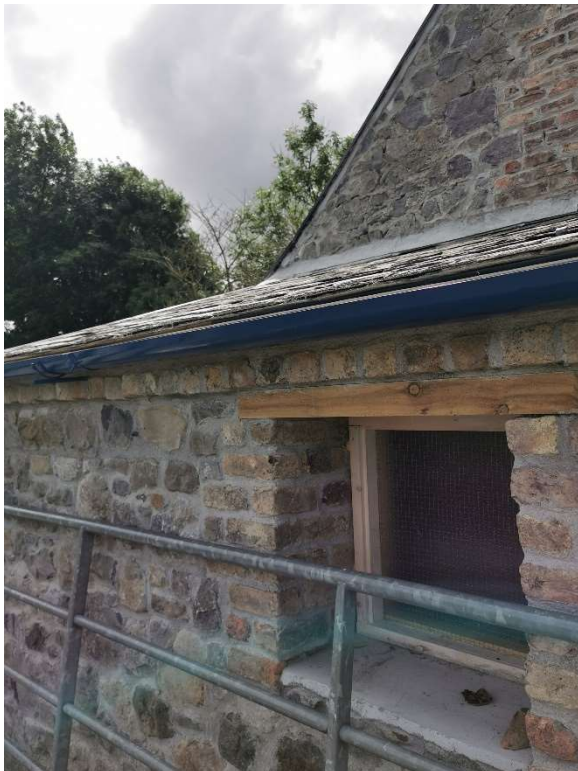
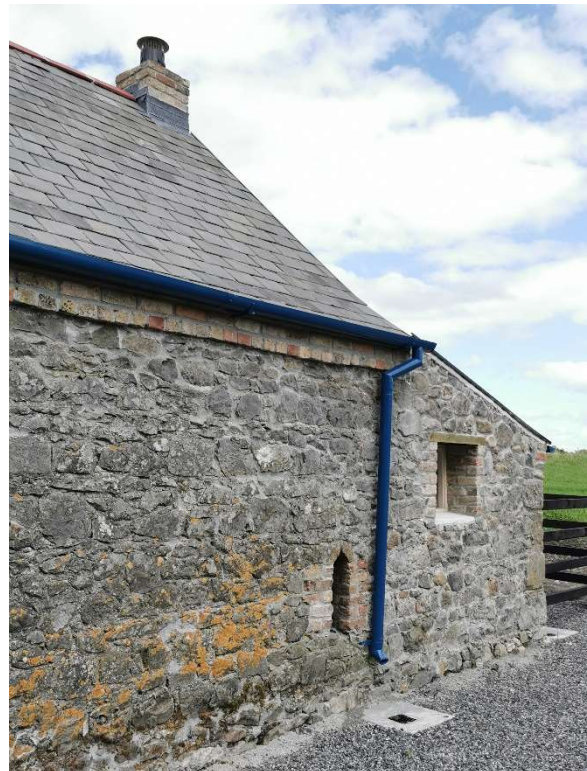
Rear lean-to also completed with slate roof

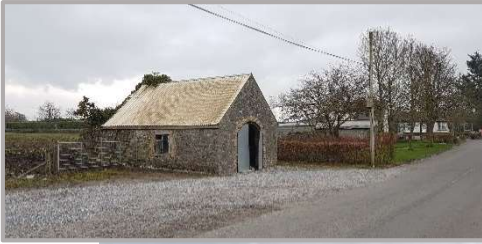
Figure 1 Prior to works

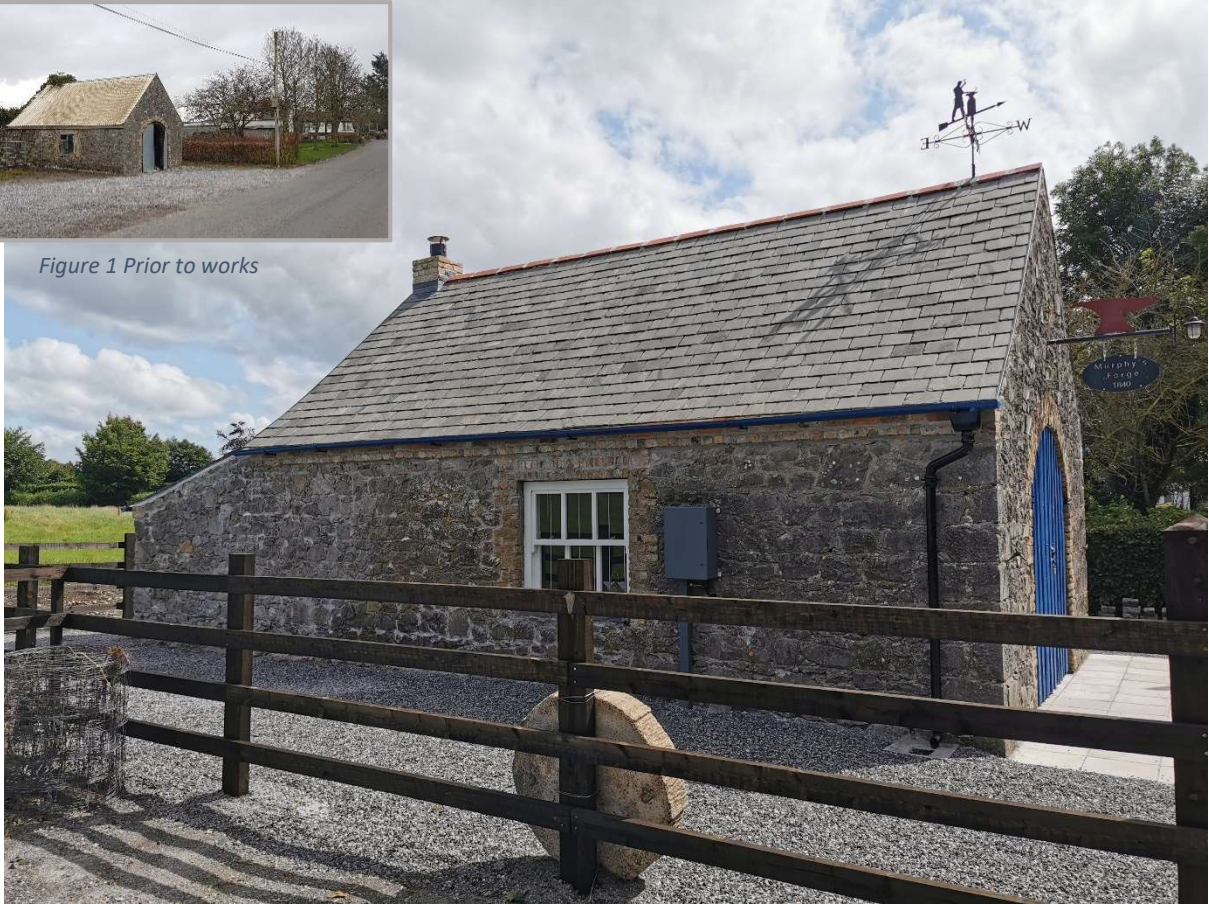
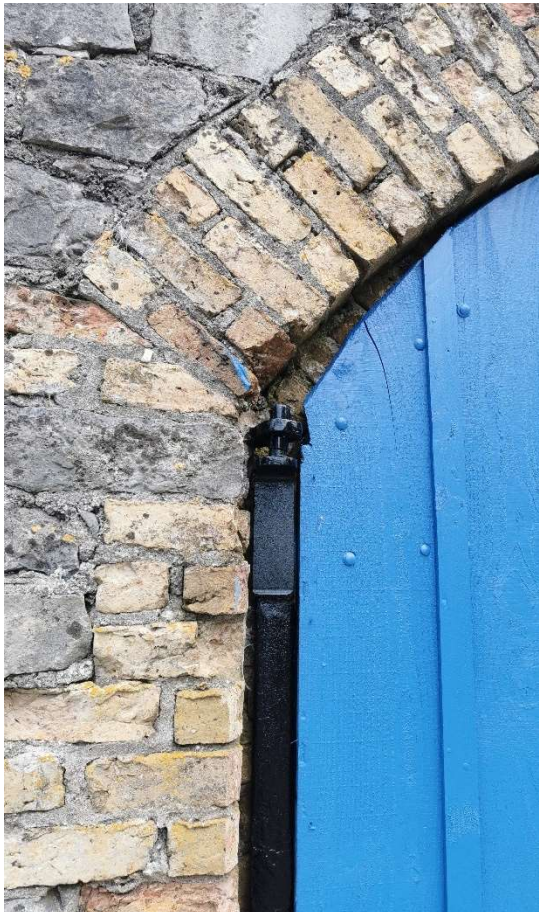
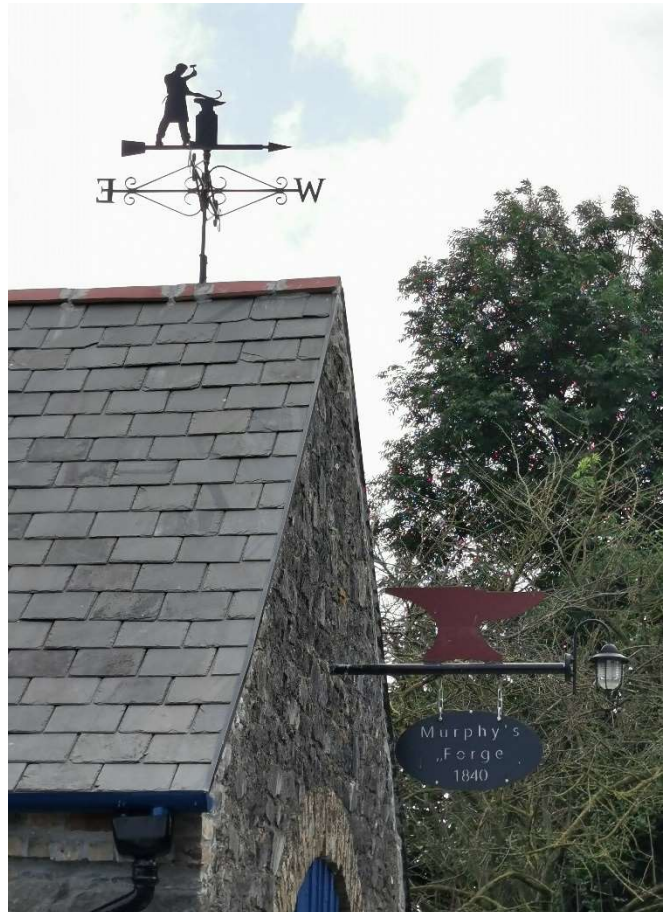
Project complete with minimum repairs, only as required, natural slate roof, terracotta ridge tiles

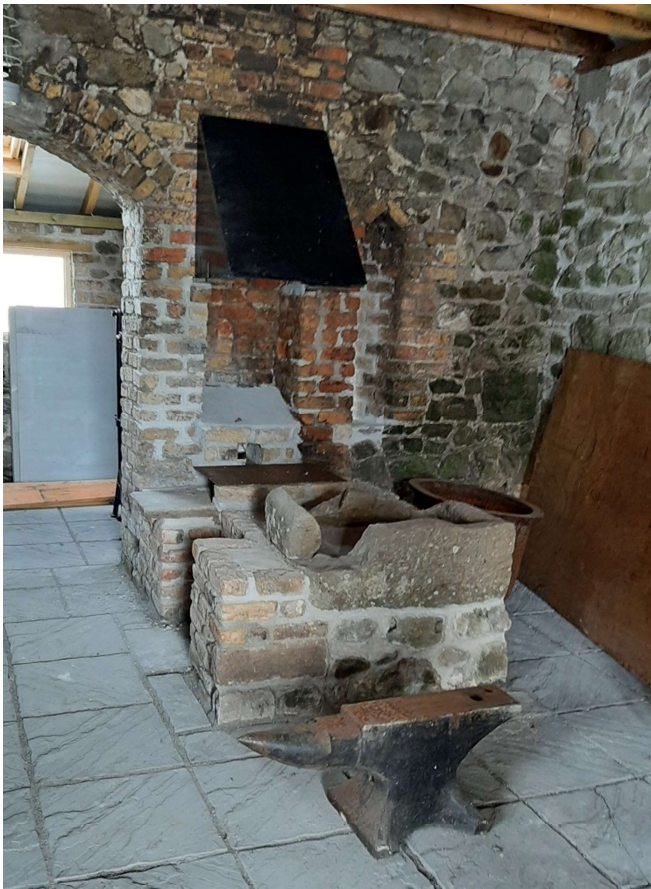
Internal fittings in place

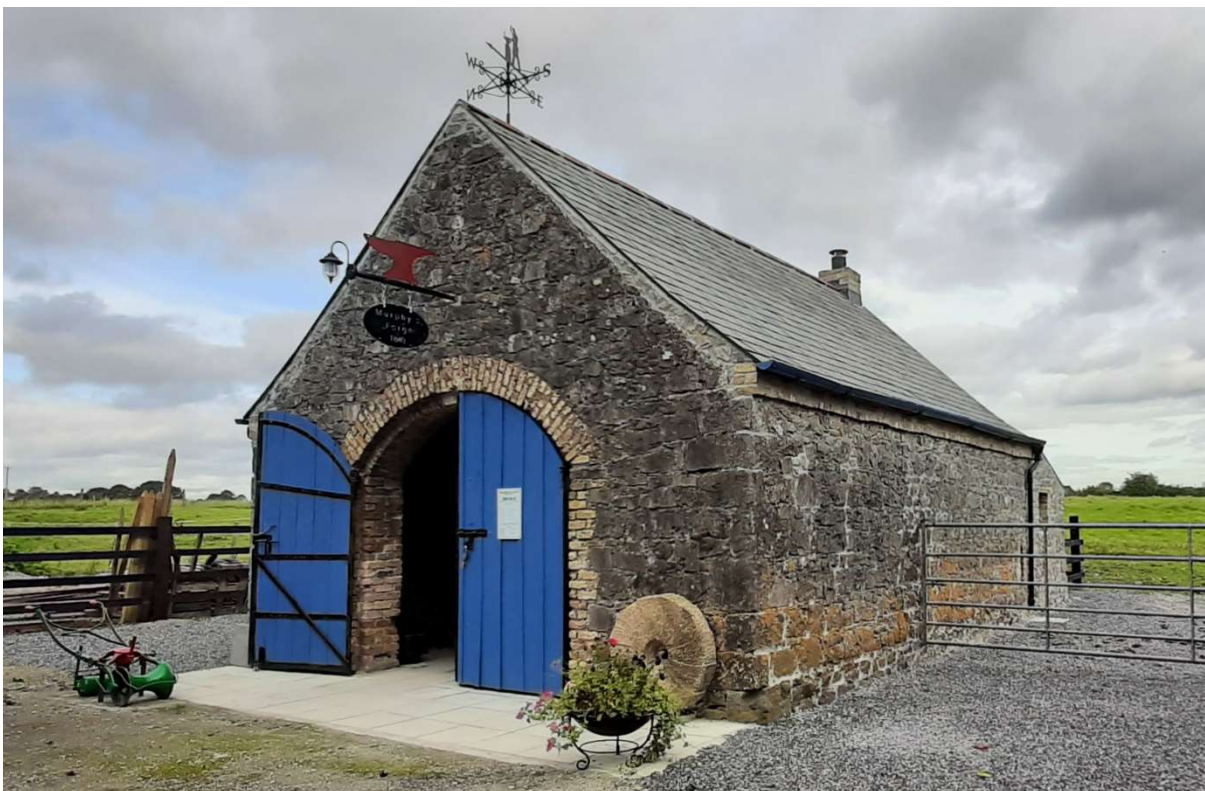
2021_1013

Completed exterior with notice in place

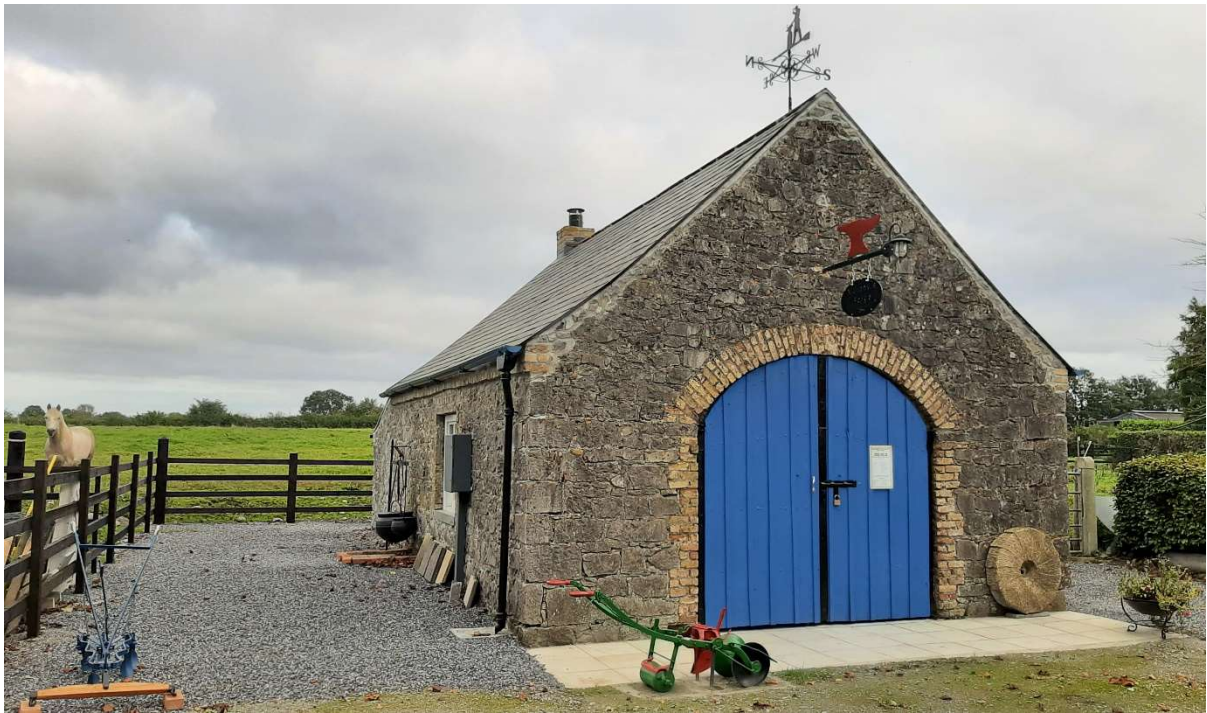
Vernacular fittings added to the site
