REPORT

**BALLYCUMBER FOLLY,
BALLYCUMBER,
CO. OFFALY**

**Connie Hanniffy
Ballycumber House
Ballycumber
Co. Offaly**

October 2018

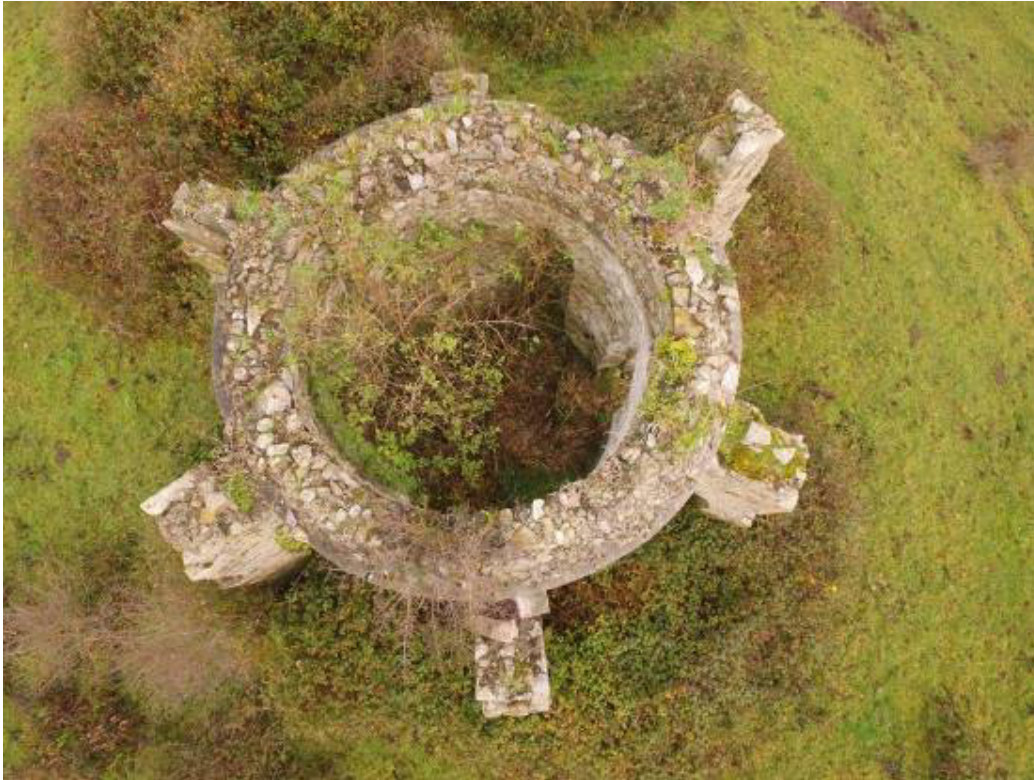
It is suggested that the roof reconstruction should be carried out to protect the vulnerable stonework rubble masonry at the top of the folly as the photo beneath reveals.

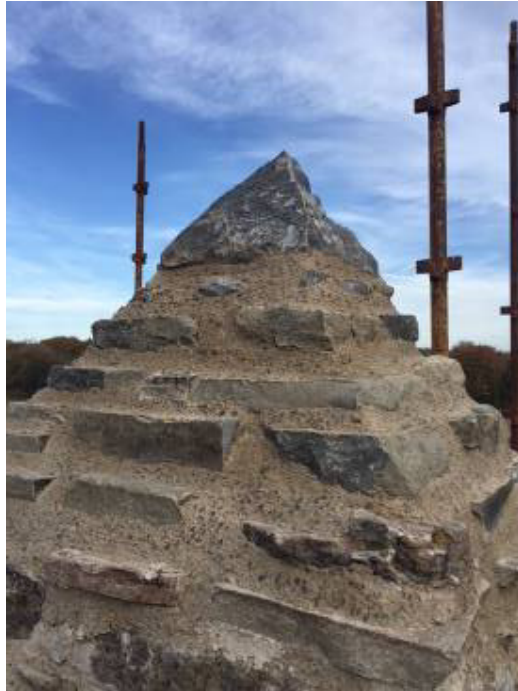
Suggested termination of top of pinnacles

These should be rebuilt in stonework in NHL 3.5 1 :2.5 lime mortar in accordance with the specification. In order to blend in with the general character of the ruin we have suggested adding a pigment to the mortar. Similar reconstructions were carried out recently under our supervision in Gloster House where the tip of the obelisks was constructed with a solid stone in order to preserve from the weather. We suggest a similar approach to the top of the pinnacles on the buttresses as the photo below shows:-

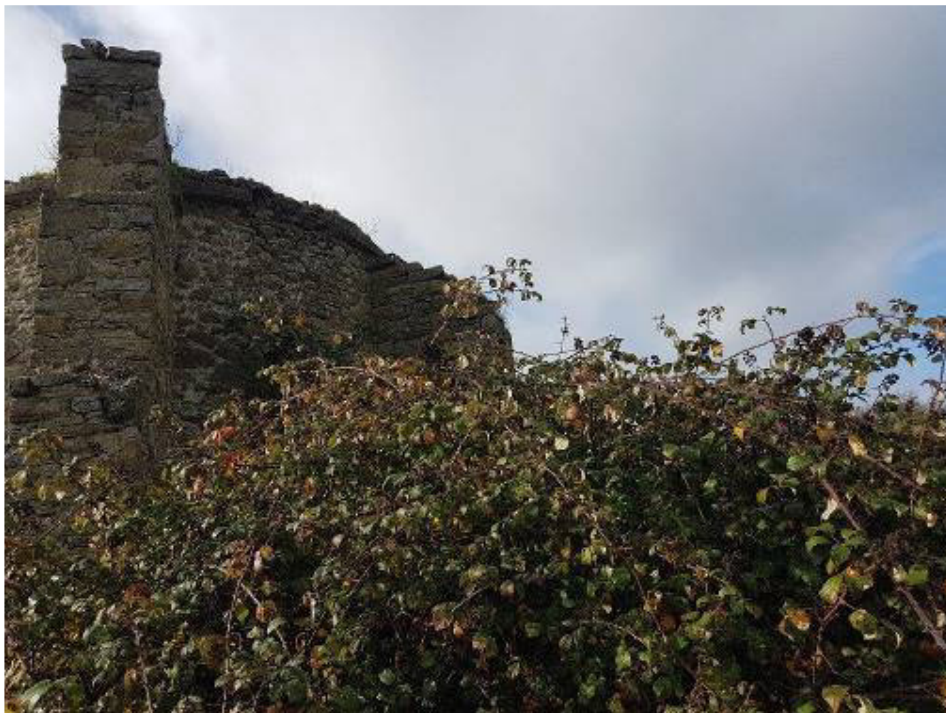
2. Exterior stonework in reasonable condition. Area around to be cleared

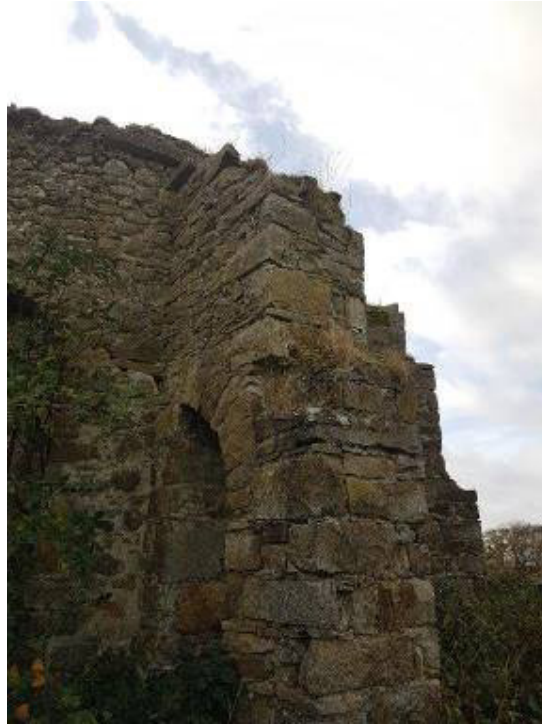
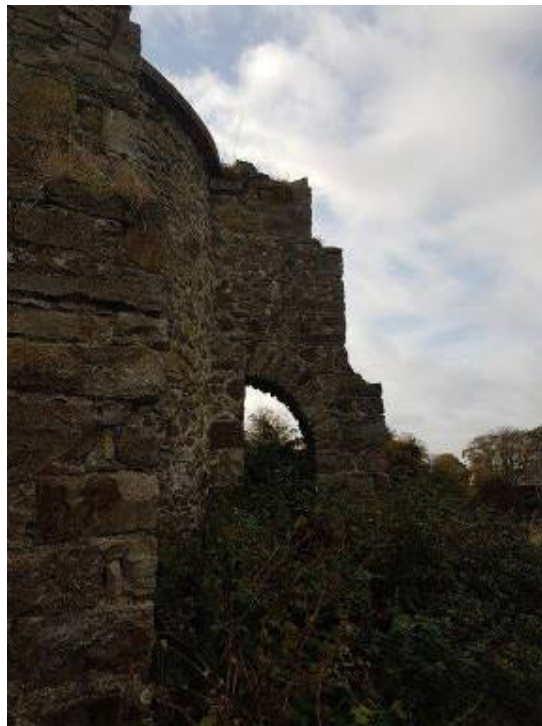
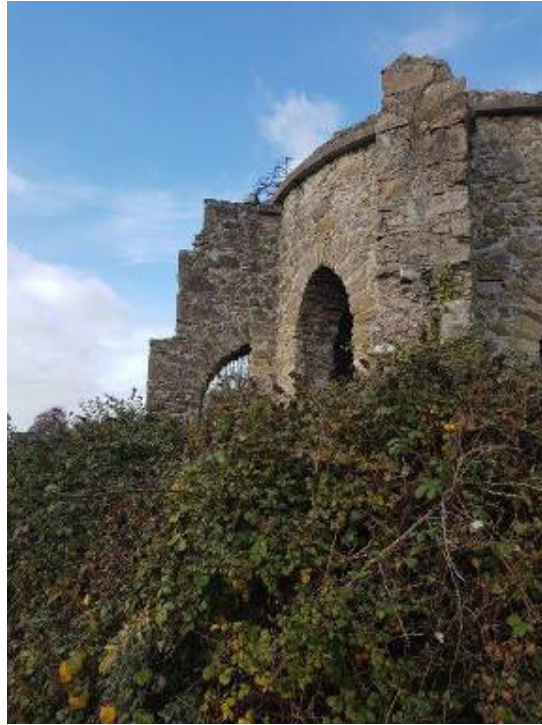
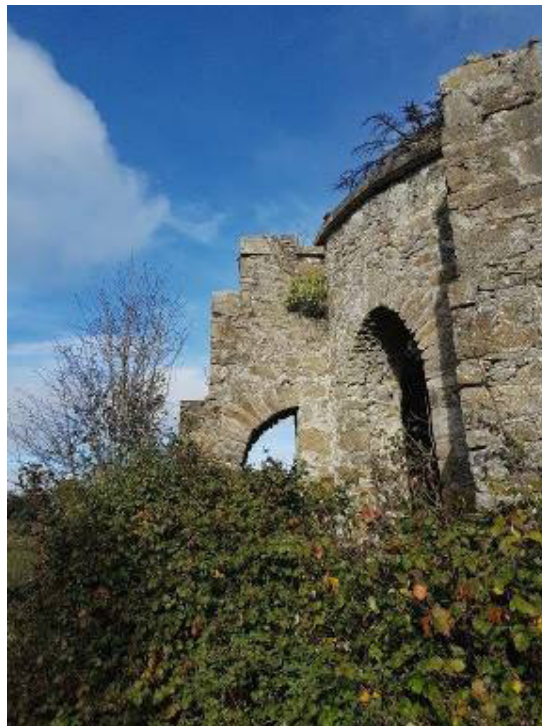
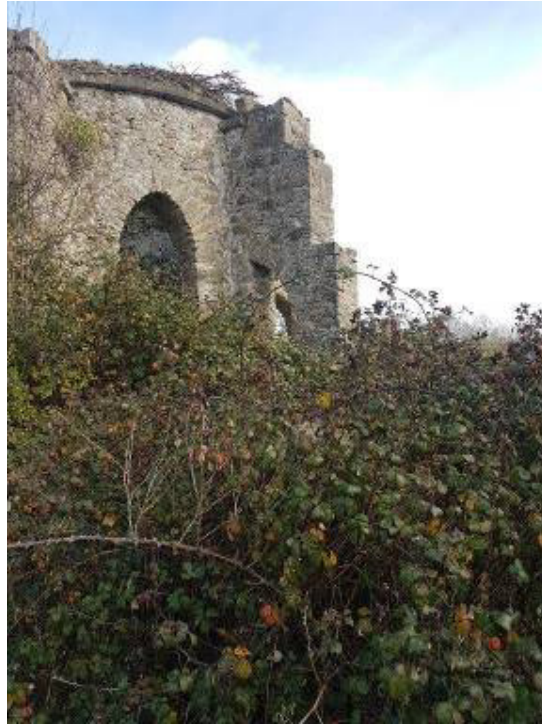
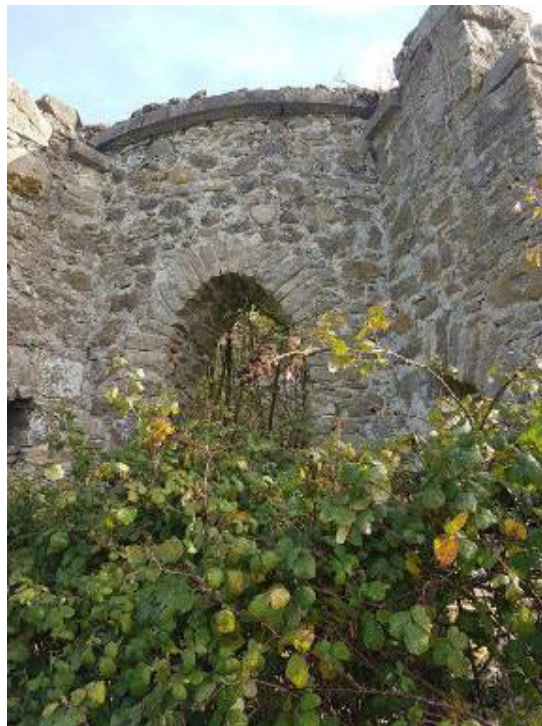
The stonework is found to be in good condition for a ruined folly but requires repair at eaves level and the top surfaces of the buttresses require rebuilding

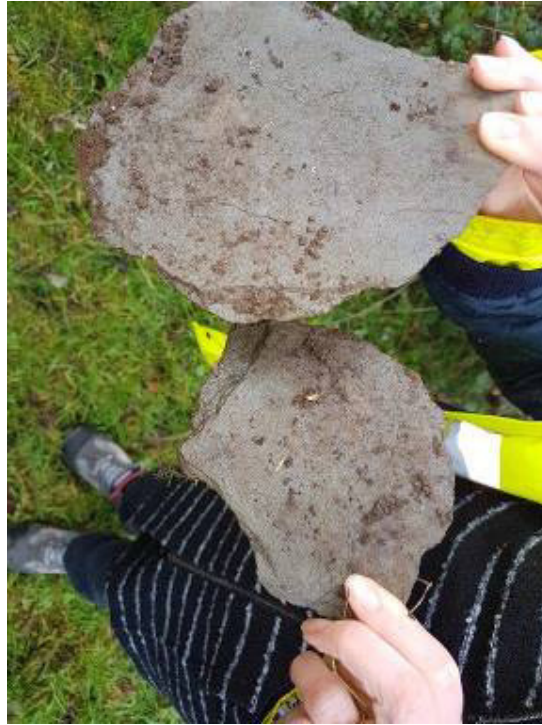
Secondly, evidence was found on site that the rood was slated and while preparing specifications we soon came to the discovery that slating at this small radius with curvature in 2 directions would have left up to 20mm or more gap between slates.

4. Evidence that roof was slated.

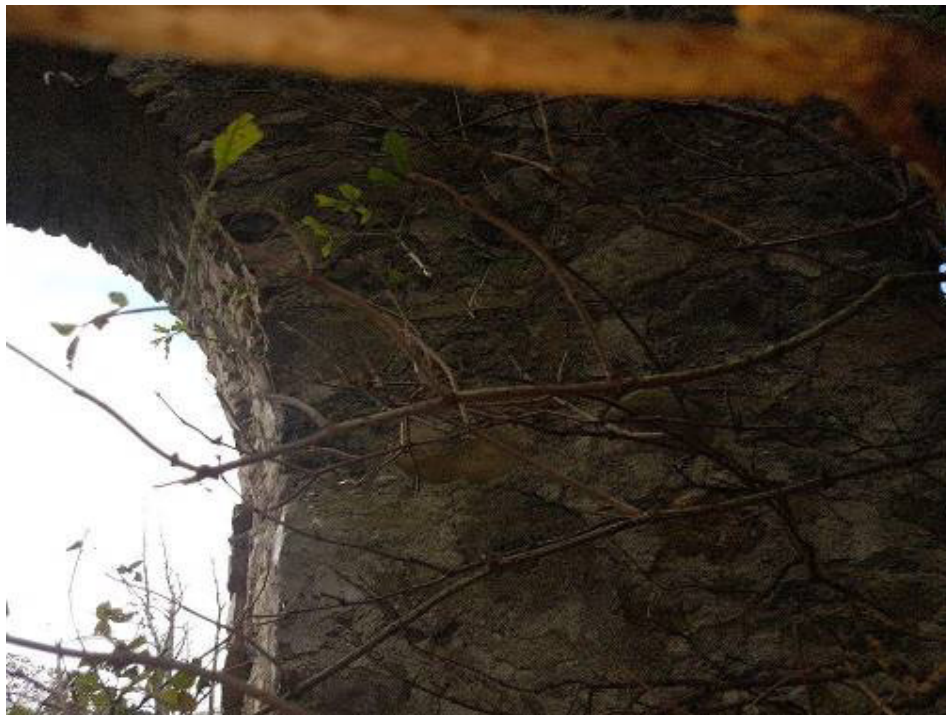
5. Arch voussoirs in reasonable condition.

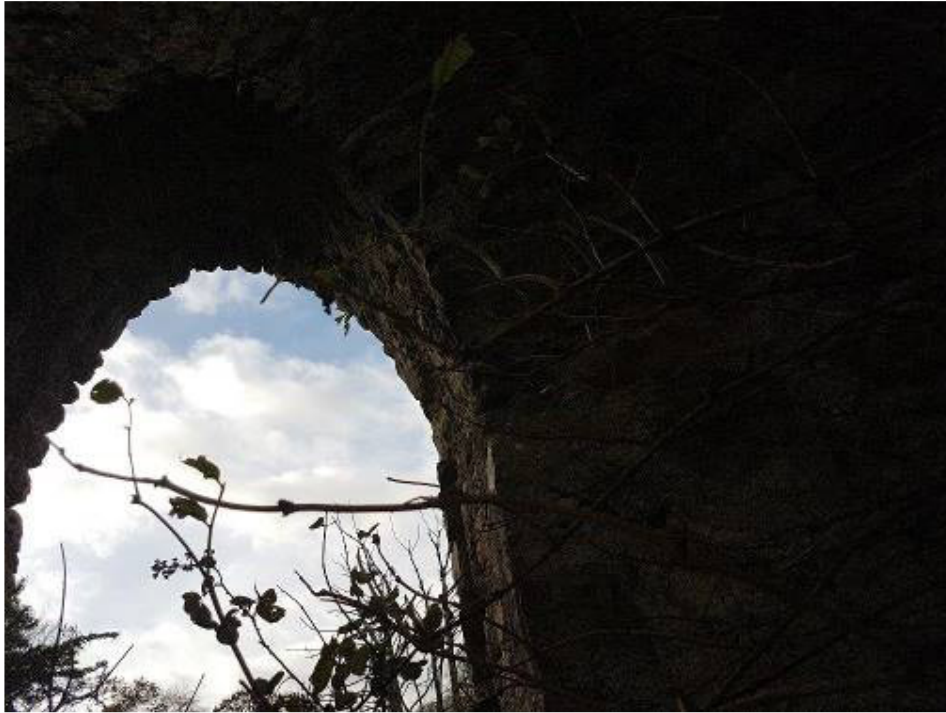
6. Ditto

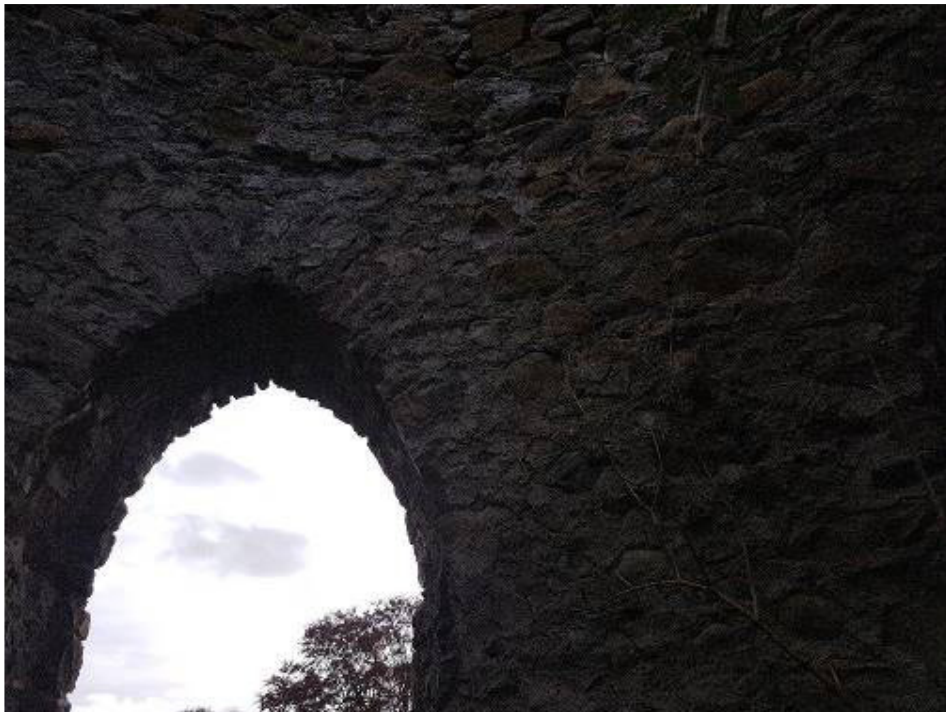
7. Ditto

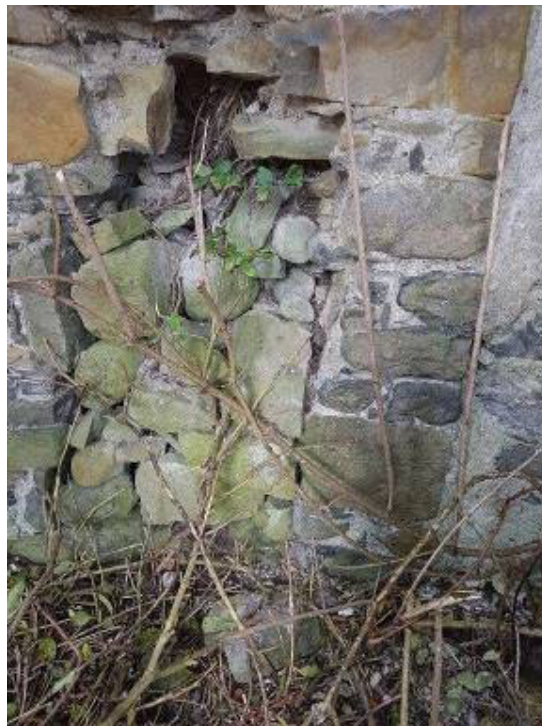
The fireplace has been blocked up and the masonry surround required repairs.

9. Blocked up fireplace to be unblocked.

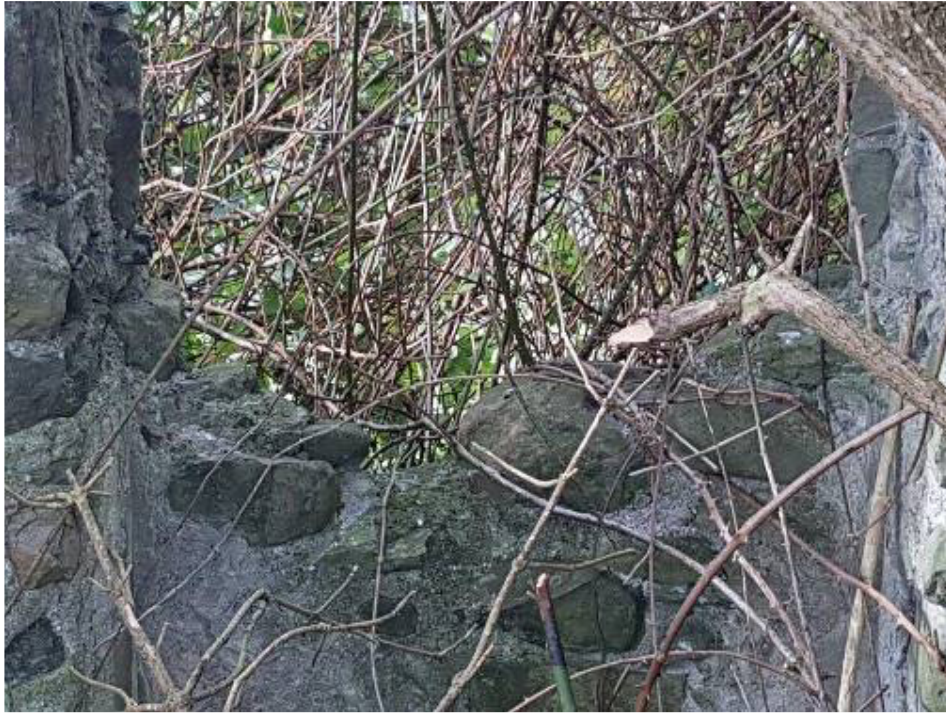
10. Some cills require minor rebuilding.

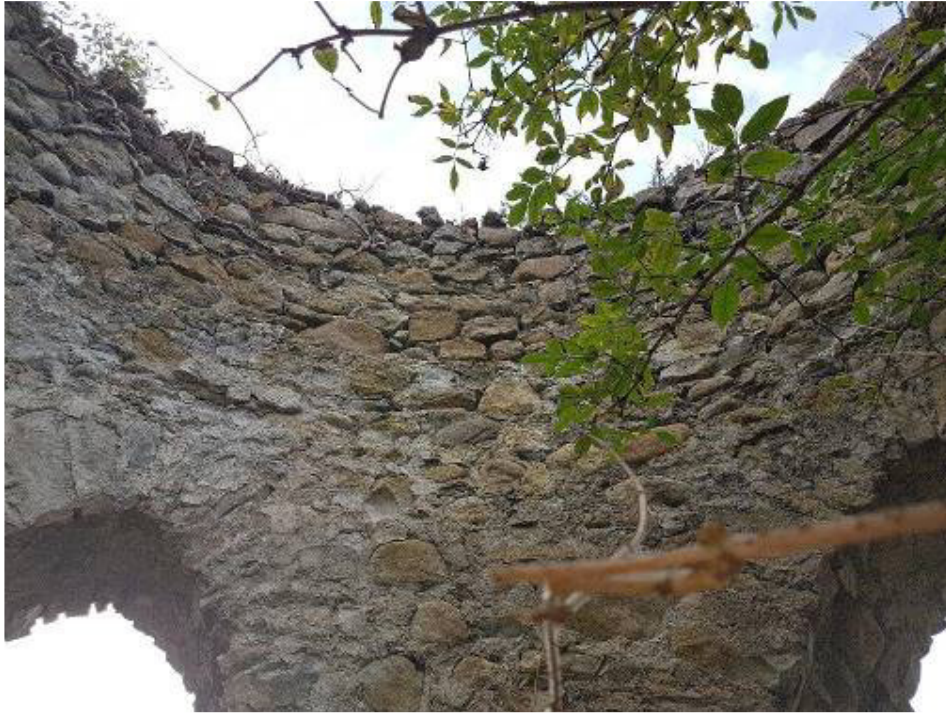
12. Some consolidation to top 1m of stonework is required.

Areas of masonry which have become unstable as a result of mortar dissolution will have to be deep pointed in a 1:2,5 NHL 3.5 Lime Sand mix using '*Ottobeim*' lime and Wexford sand. This should be mixed with a 5-7mm grit and pinning stones to match surrounding masonry. Mortar should be thoroughly pressed into gaps between stones with a timber rammer. It can be left slightly recessed and pigmented with Burnt umber to ensure a match to surrounding original pointing.

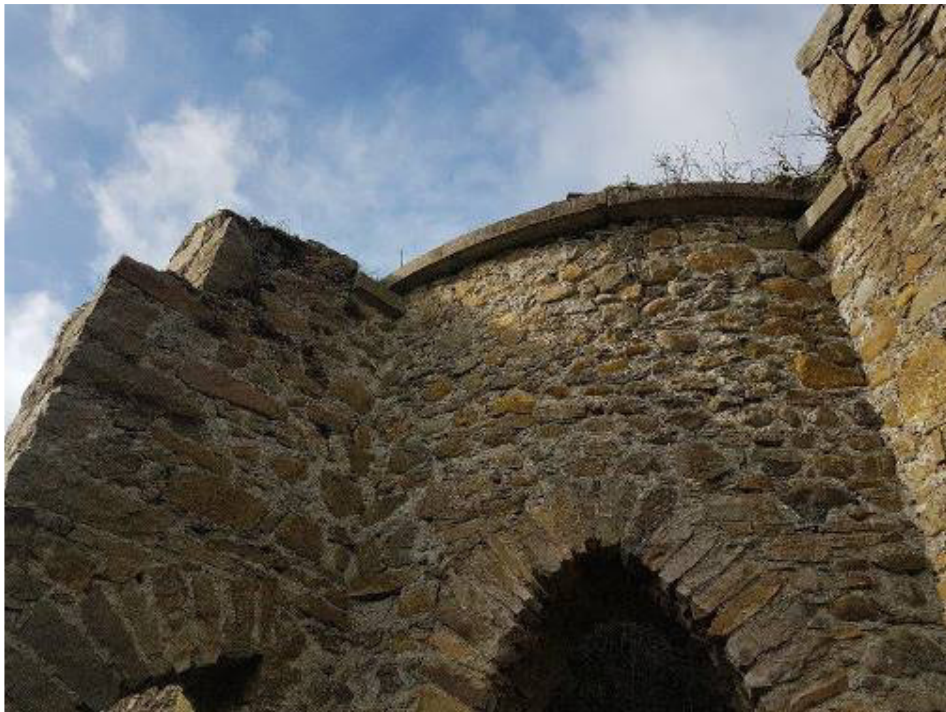
There is evidence that the copings to the buttresses are substantially missing and these will need to be restored as shown on the drawings.

13. Sloping stonework appears to be missing from flying buttresses and requires restoration.

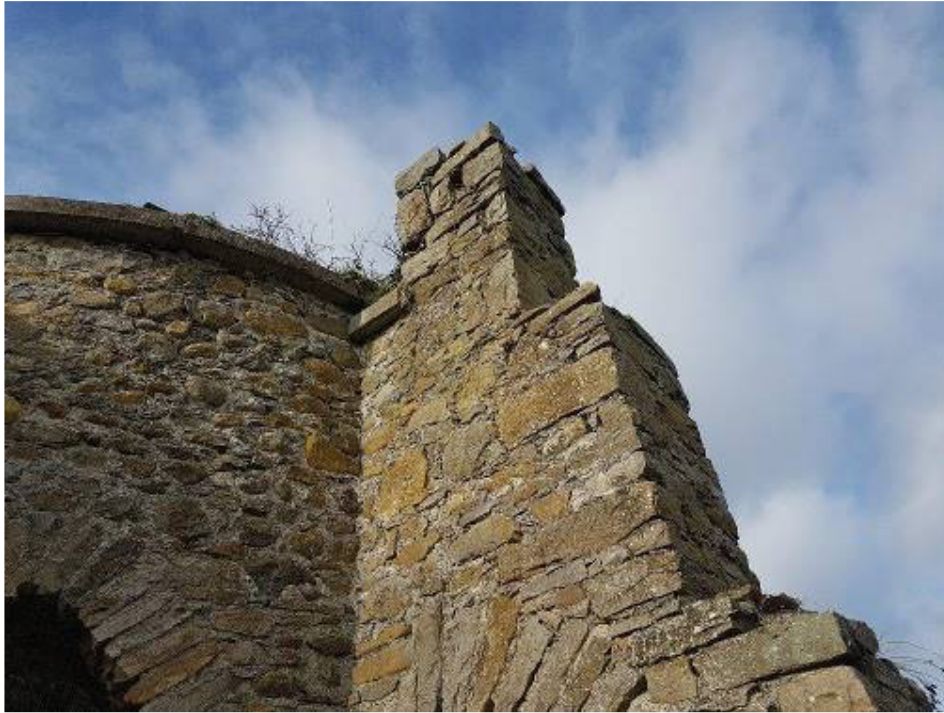
14. One buttress shows stonework above eaves and indicates that all buttresses would be at least as high.

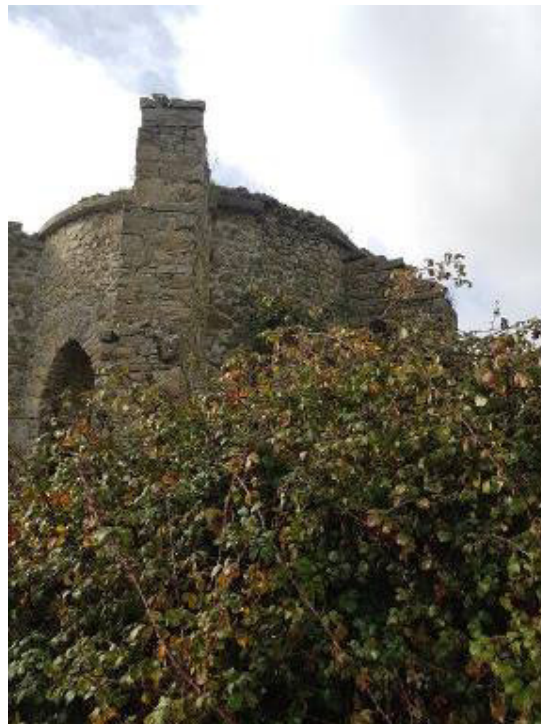
14.1 View of highest buttress. Giving evidence that all buttresses were once well above eaves level

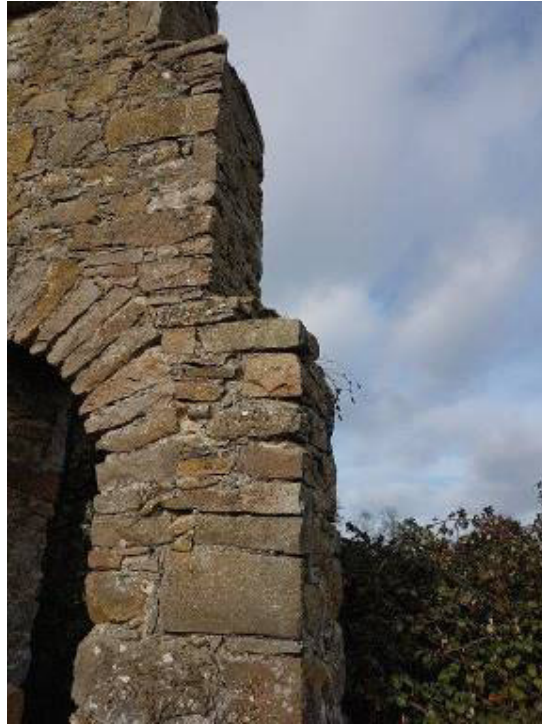
15. Evidence of previous sloping stonework is found in one location

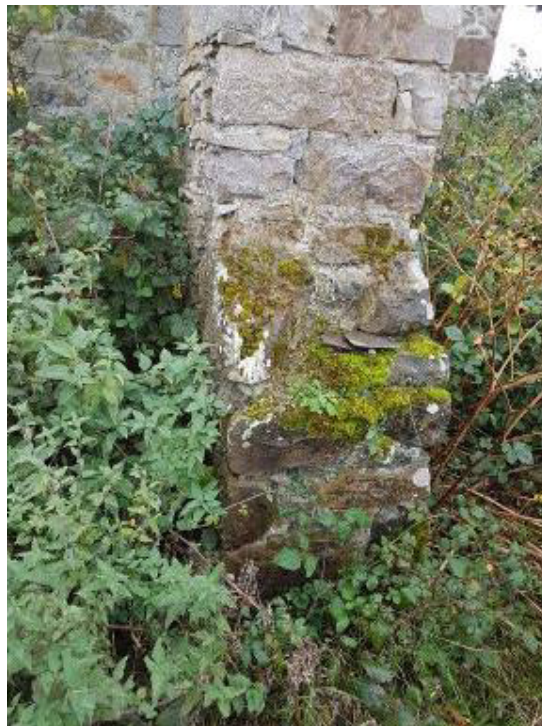
15.1 Sloping masonry to bottom of buttress.

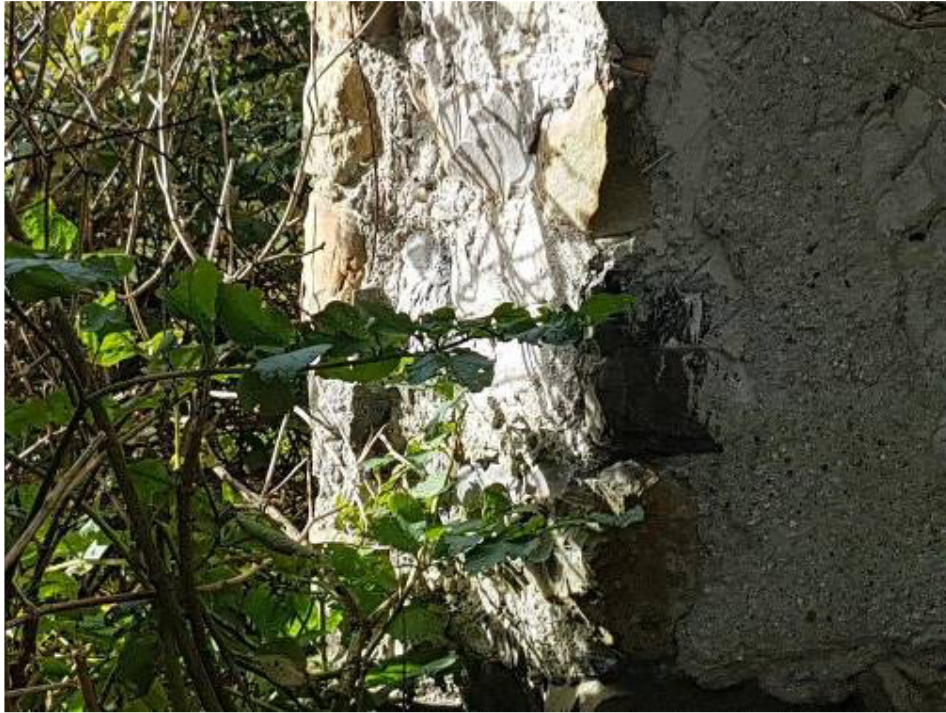
16. Typical window reveal implies working sash windows in the past.

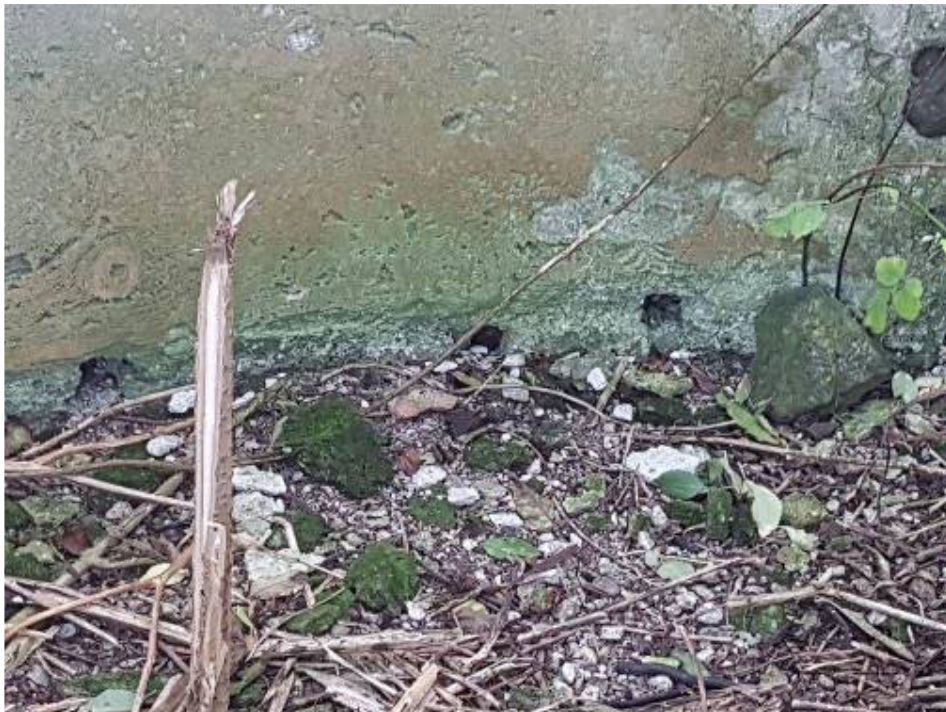
17. Spalled masonry from the top of the walls
