Conservation of Dowry chest: Treatment report:

Client	Karen Gray/Offaly CoCo
Date:	23rd July 2022
Reference:	OC60122

Early twentieth century painted dowry chest from Co. Offaly.

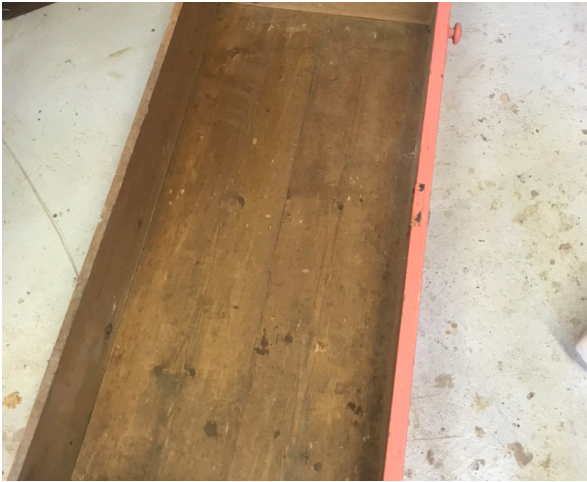
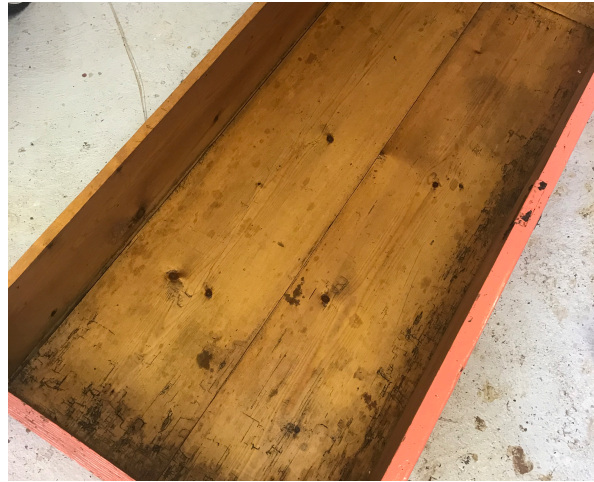
All surfaces cleaned with vulpex solution

Cleaned all surfaces using vulpex solution.

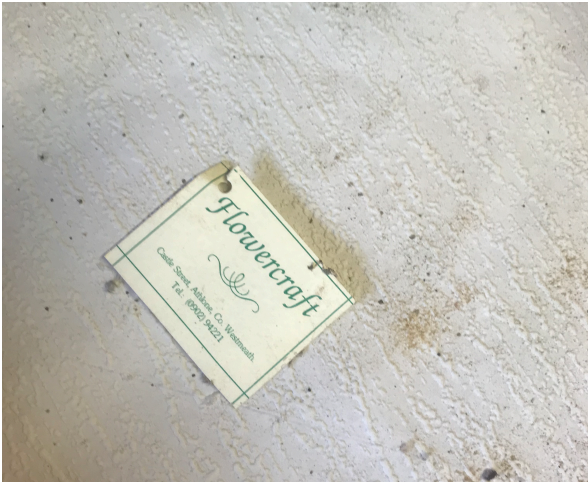
Business card found in drawers:
“Flower craft”

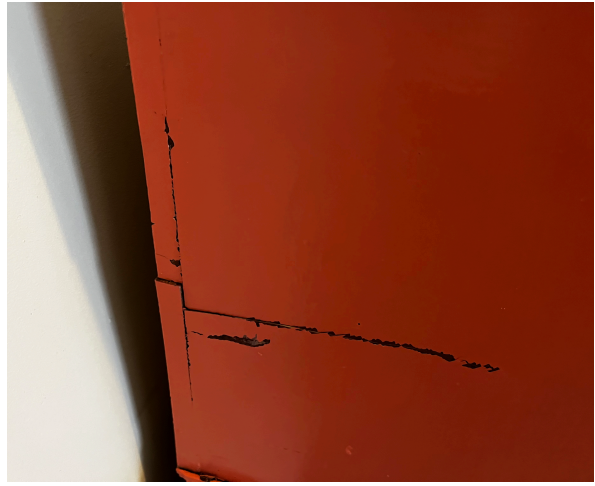
Some blistering in paint surface at points of misalignment on both gables was noted and loose paint flakes came away during cleaning.

Paint flakes and blistering

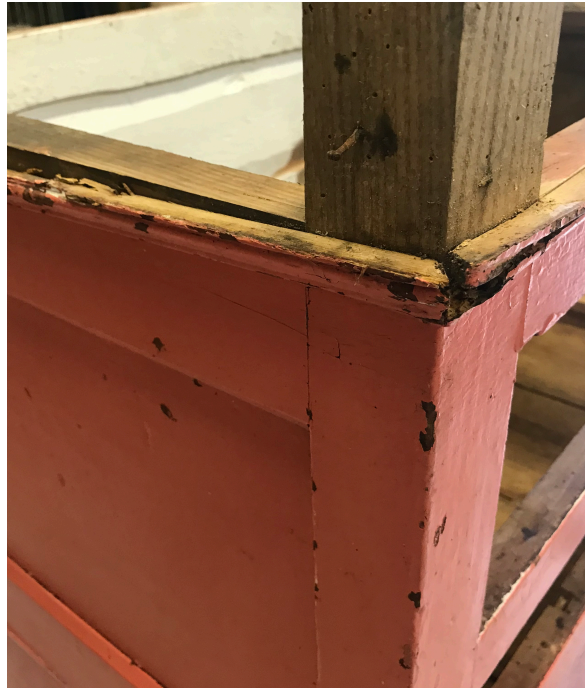
Damaged area to LH side miter

Surfaces were consolidated using paraloid b72.

Micro crystalline wax used as barrier layer before squeezing the damaged area closed and filling areas of loss with epoxy putty.

Loose sections of original quadrant beading were re attached using stainless steel pins.

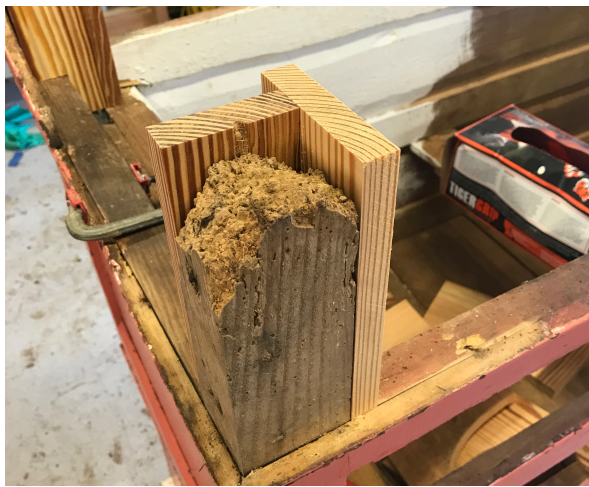
Constructing supports

Beech leg extensions were supported with pitch pine pieces fixed with stainless steel screws to stable areas of the original legs. These supports were fixed to the extension pieces with epoxy resin.

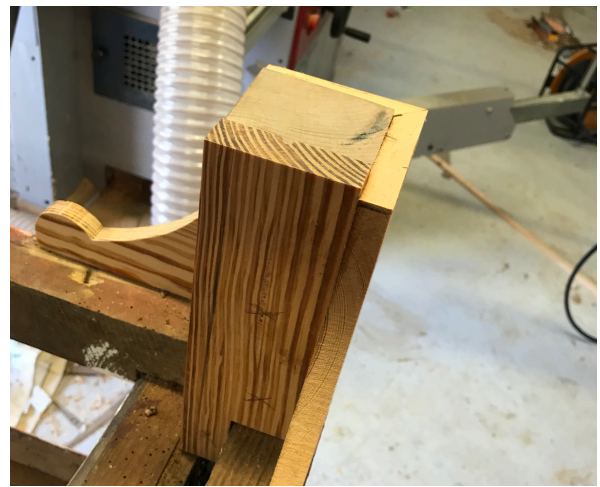
Beech extension fixed inside supports

Extensions were made using beech.

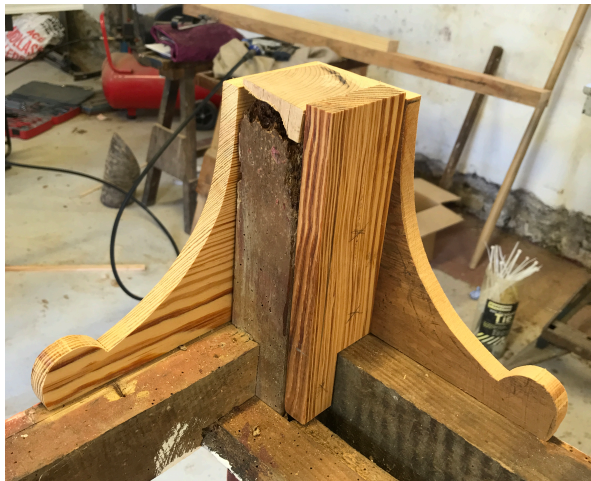
Voids filled with epoxy putty

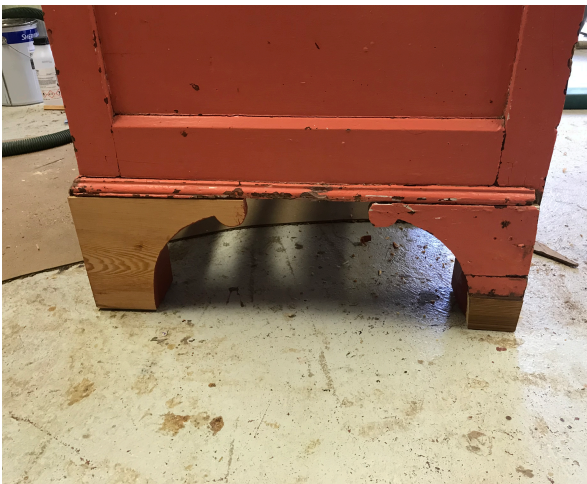
Extended back LH bracket foot

An extension was made to back bracket foot in pitch pine and coloured to match.

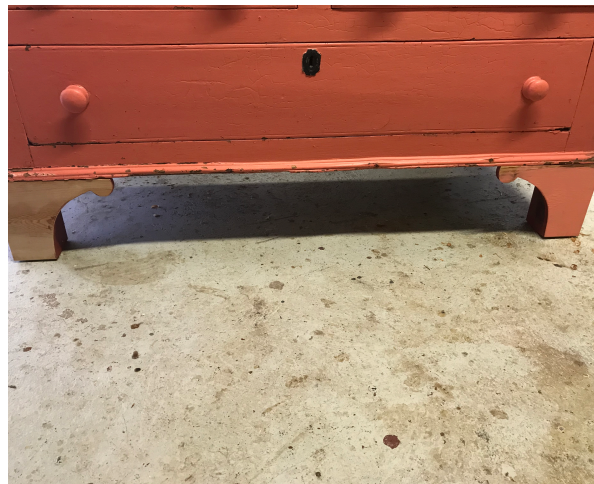
Both front feet replaced

New bracket feet were made using pitch pine to match existing bracket foot.

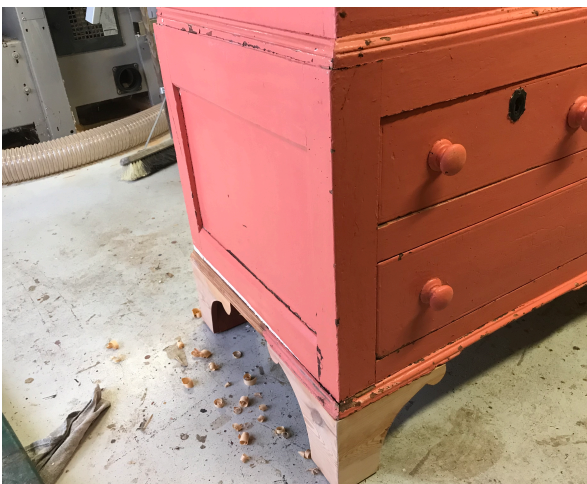
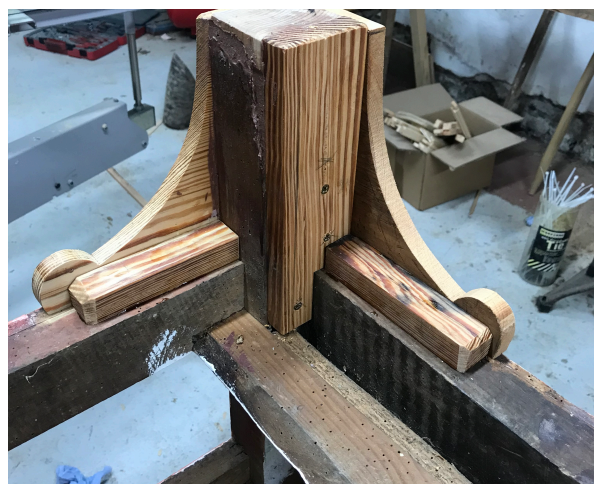
Corner blocks rub jointed to rear of feet.

Glue blocks were fixed to support the bracket feet using animal glue and rub jointed.
