Project Report

Date: 31/08/21
Client: Henry Lamb
Location: Woodfield, Clara, Co. Offaly
Project: Restoration of wrought iron pedestrian gate
Prepared by: Aquilla Cooper

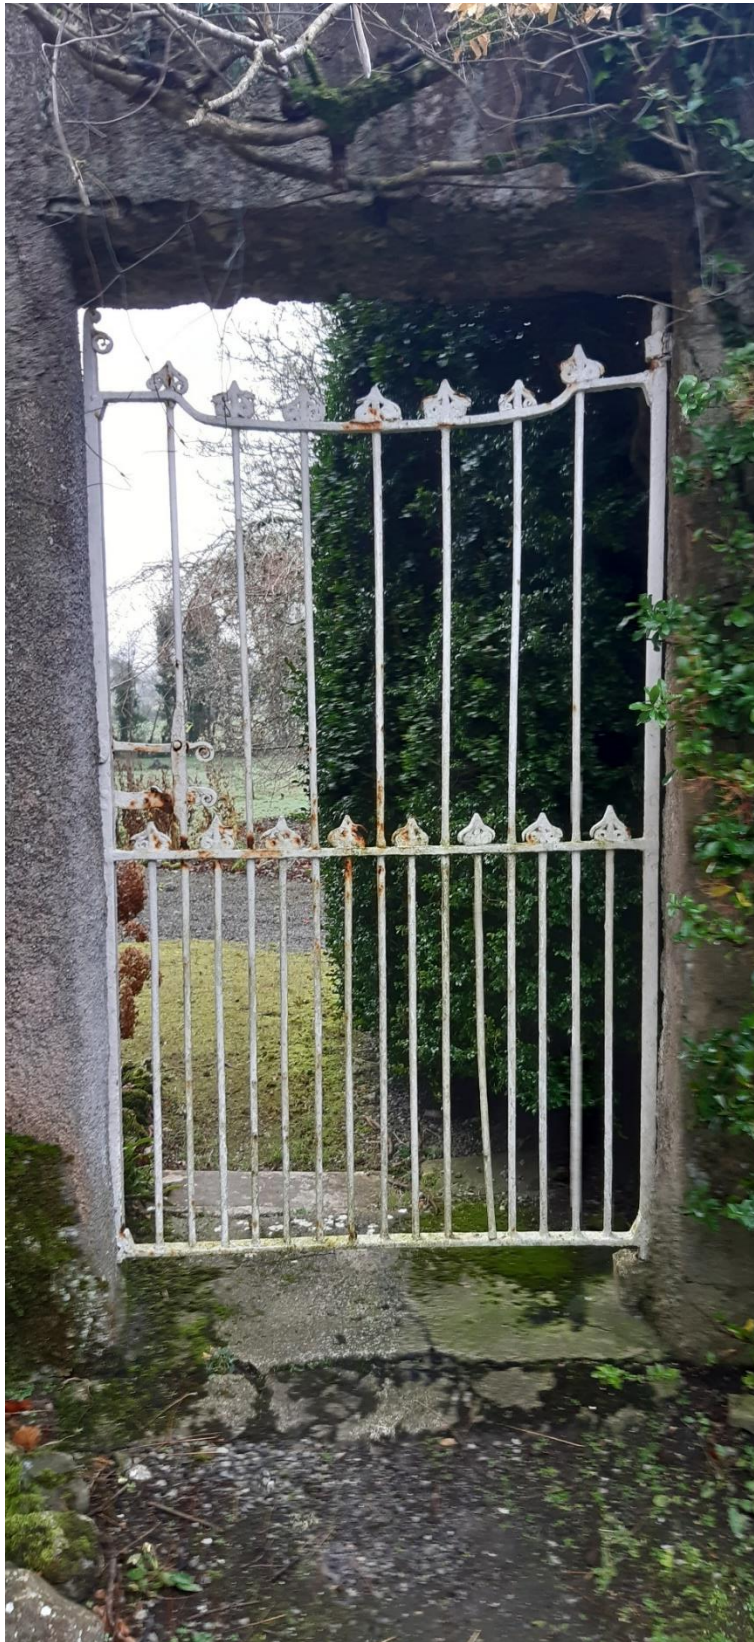
The gate has however, been re-hung much more recently; probably due to excessive wear in the original hinges. In this recent re-hanging the top hinge had been crudely made using a large threaded nut, electric welded to a flat bar.

The gate prior to removal.

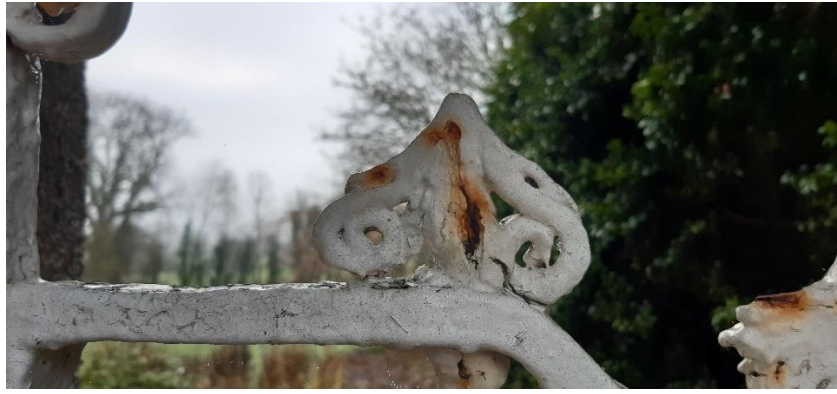
The corrosion can be clearly seen coming through the paint.

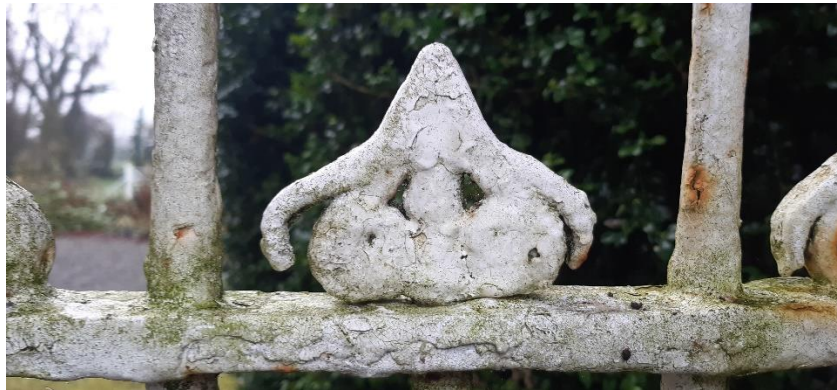
All the fine detail of the finials has been lost, hidden beneath the layers of corrosion and paint.

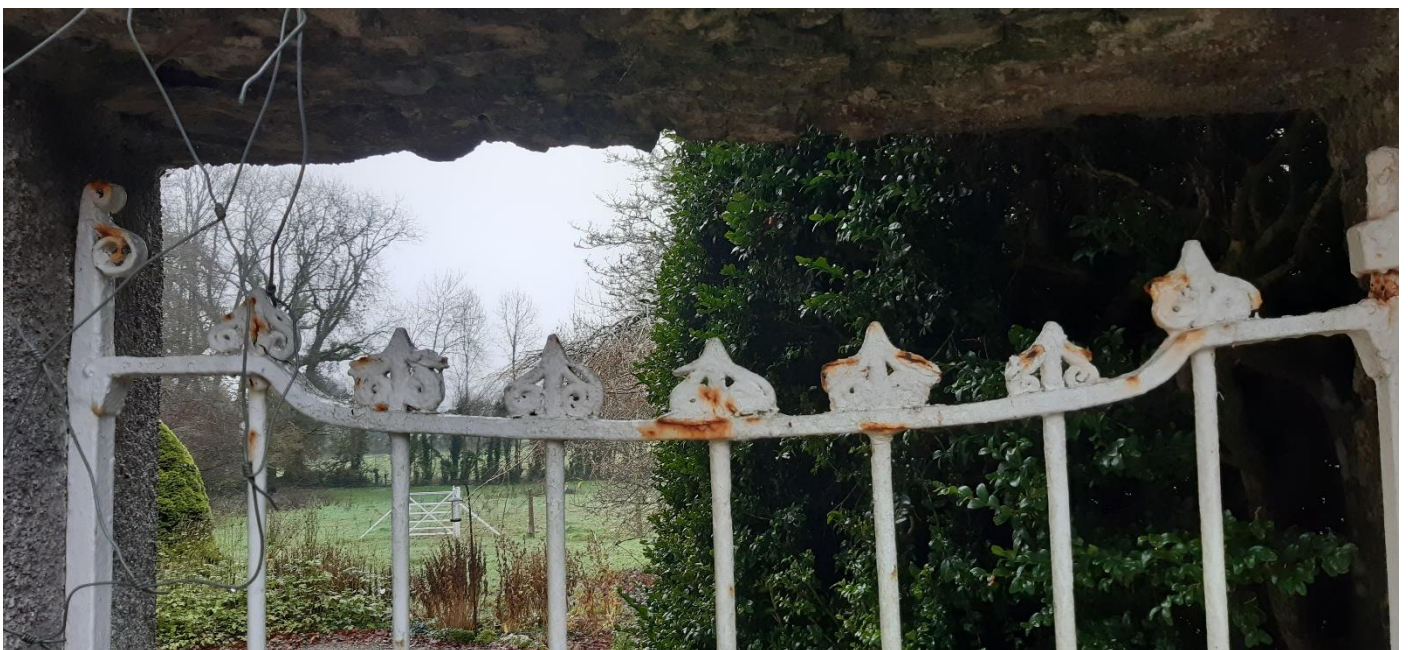
Poor condition of the top row of finials.

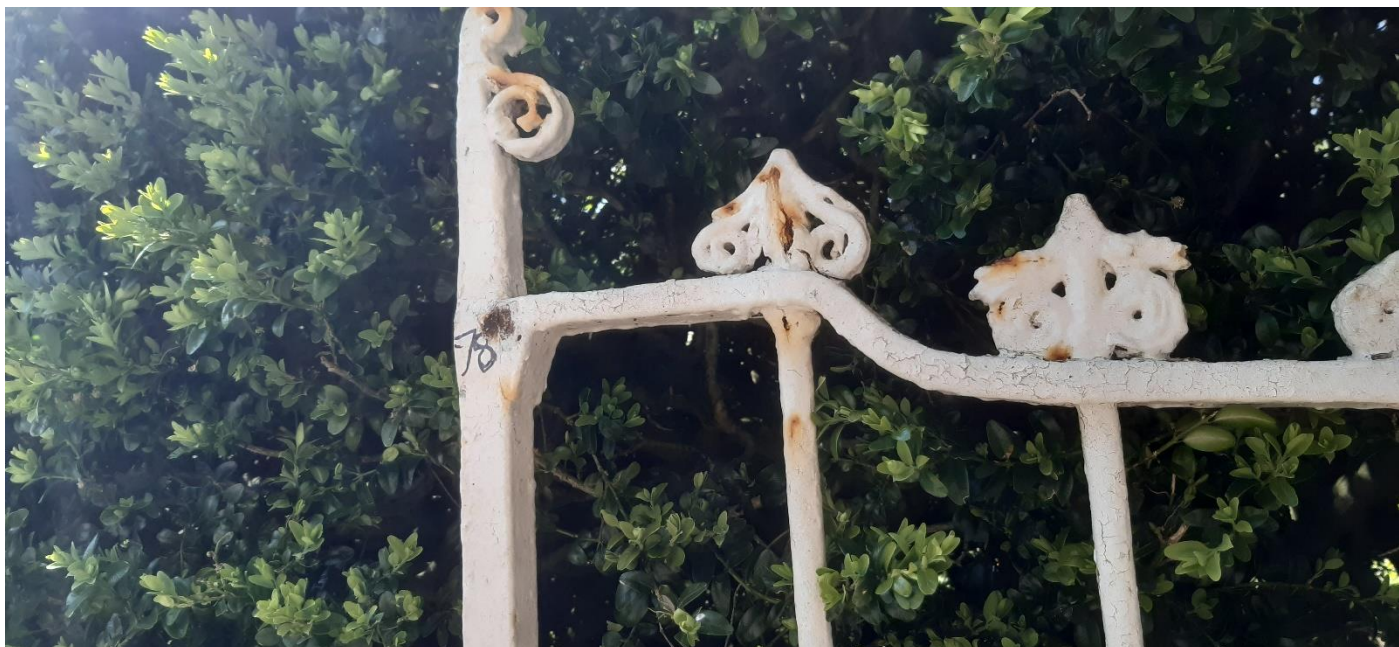
Close up showing the effect of “rust jacking”

The iron rust which forms is 7 times the volume of the original material, so as it forms between the various elements and components they are pushed apart or “jacked”, distorting the shapes of the finials.

This jacking action is strong enough to break joints apart. Luckily this had not happened in the case of this gate.

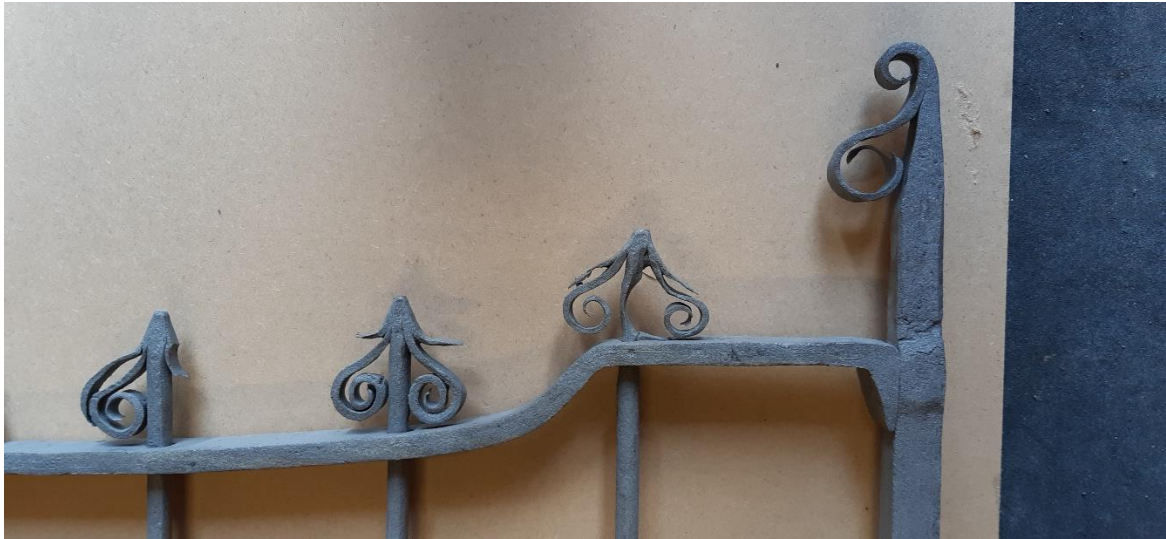
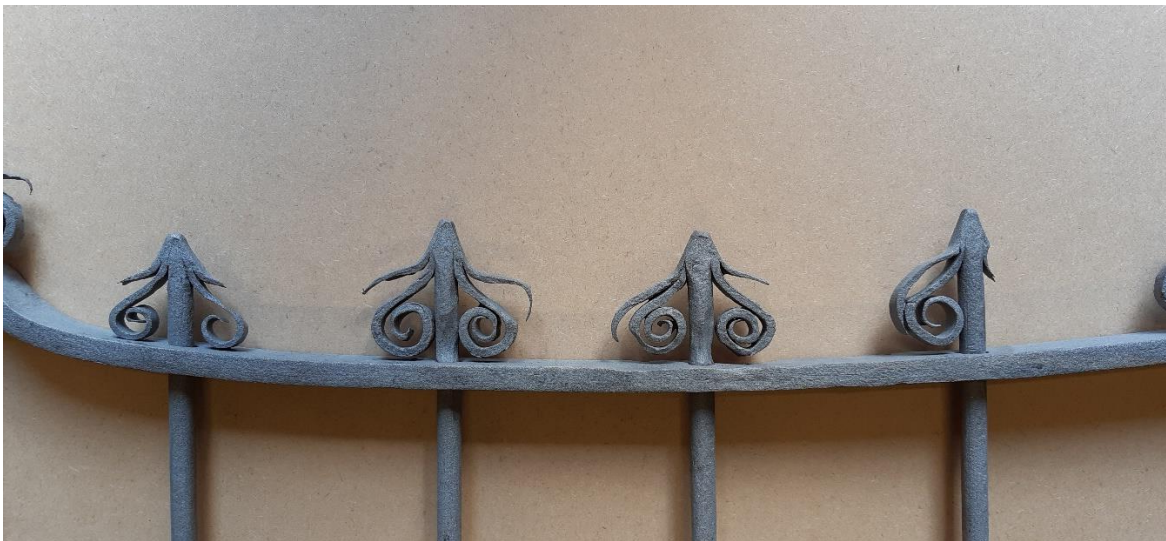
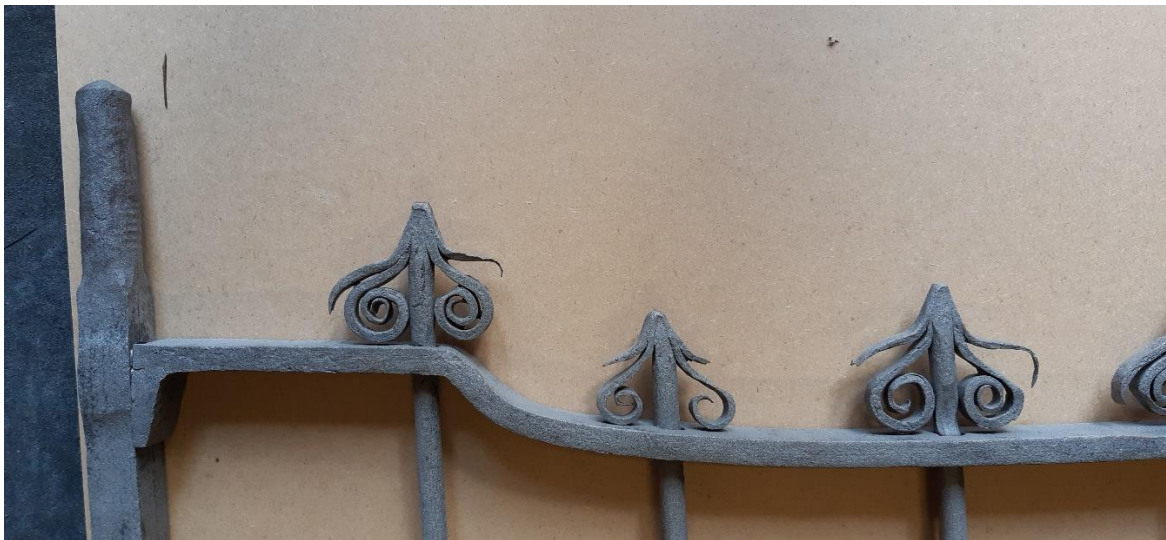
Close up pictures of the top row.

The extent of the corrosion and jacking can really be seen now. Some elements are gone altogether, while others are too badly corroded to save.

- Replace 14 ribbons on finials
- Replace 4 scrolls on finials
- Replace 1 scroll on closing post
- Build up severely thinned ribbons and scrolls by brazing
- Replace worn latch rivet
- Forge new tenon on 1 upright
- Build up wear on bottom hinge with weathering steel
- Build up corrosion thinning on several uprights using weathering steel
- Make new bottom hinge cup
- Make new top hinge eye bolt hanger

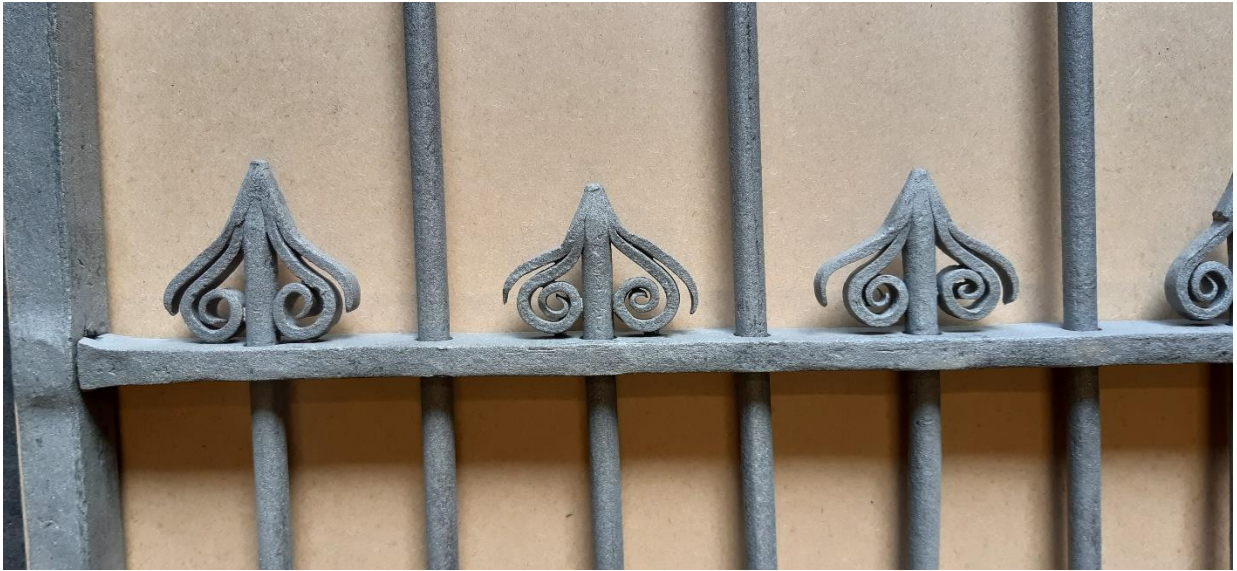
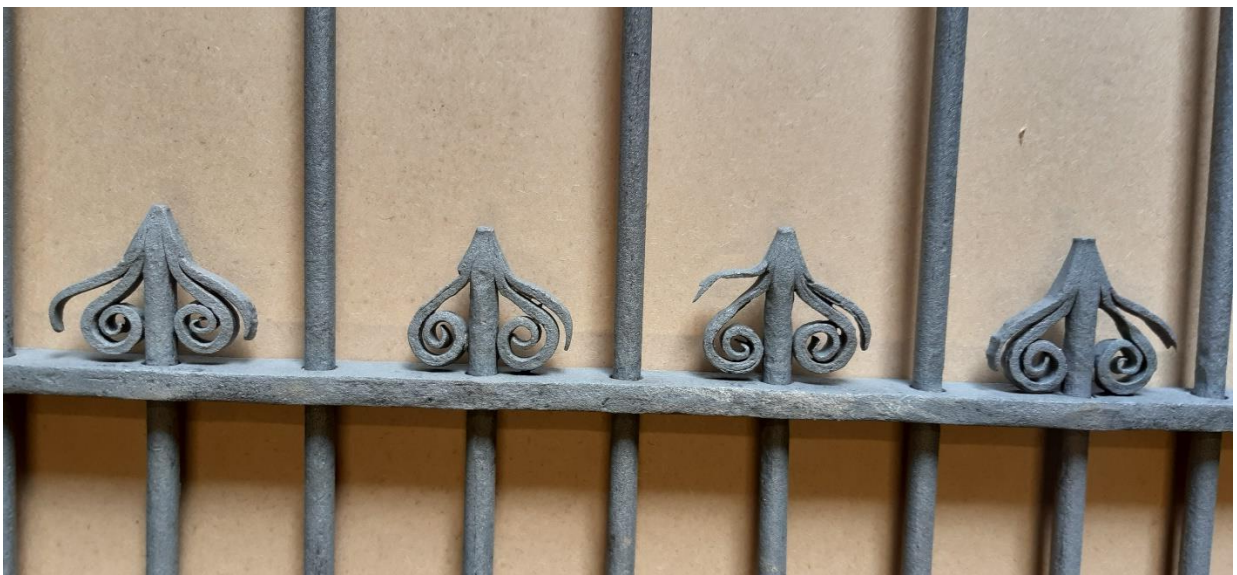
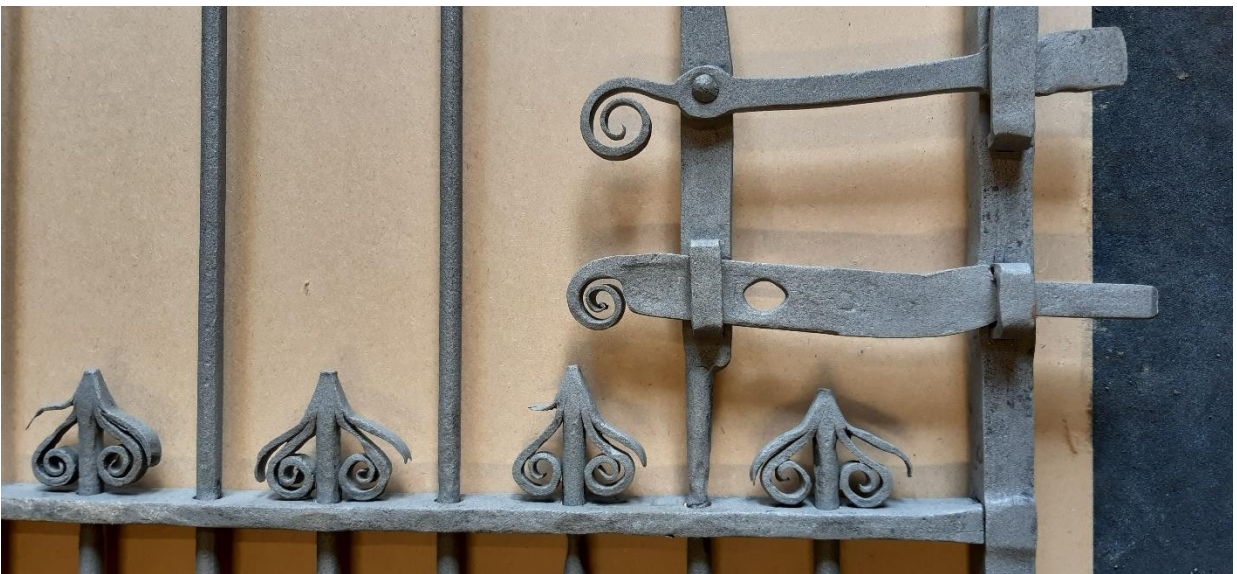
Close up pictures of the middle row.

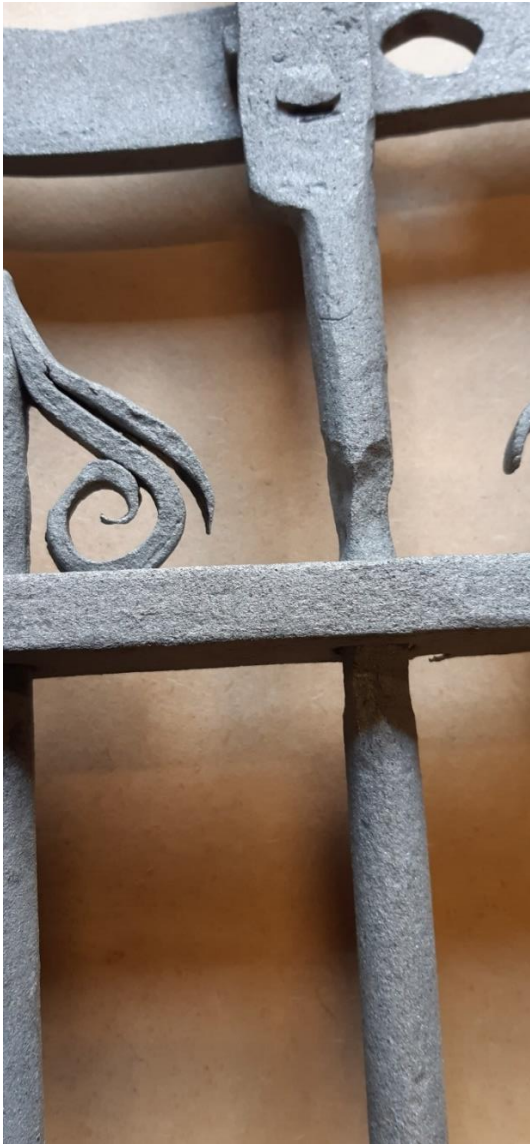
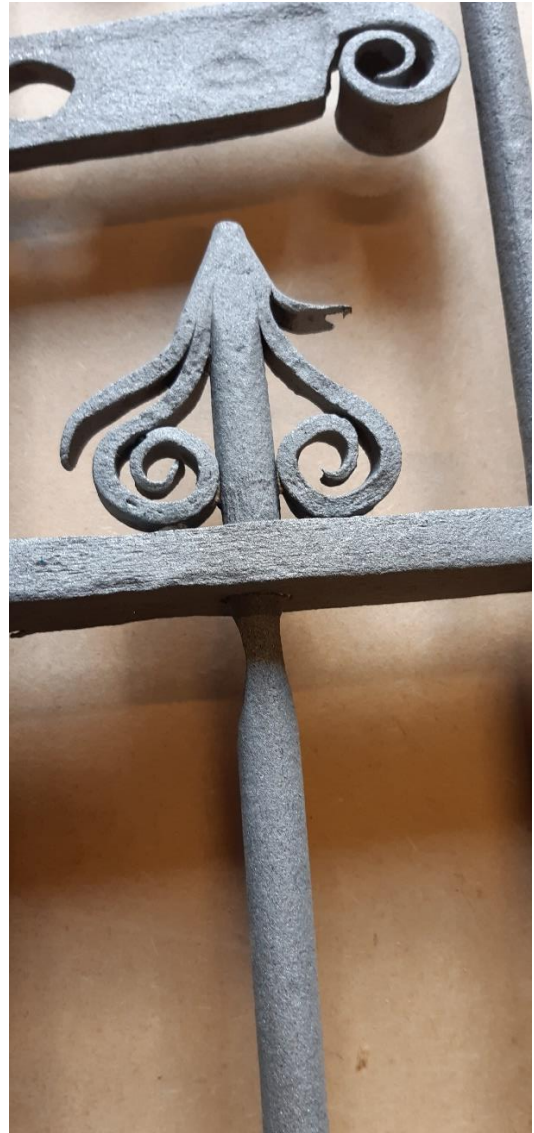
Corrosion thinning on some of the uprights

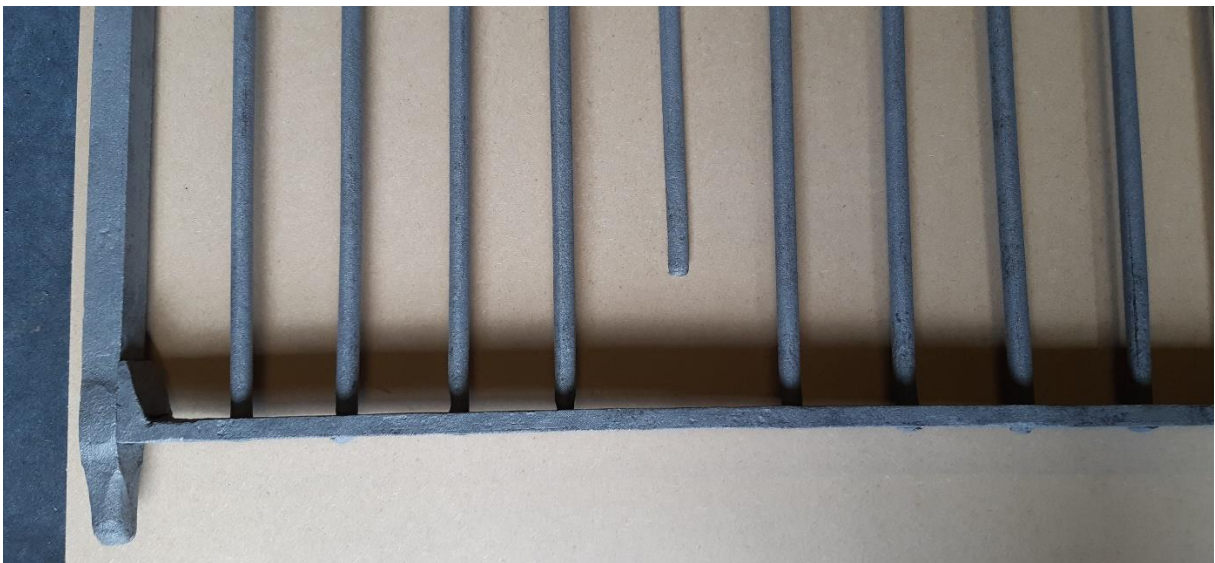
One of the uprights had a broken tenon

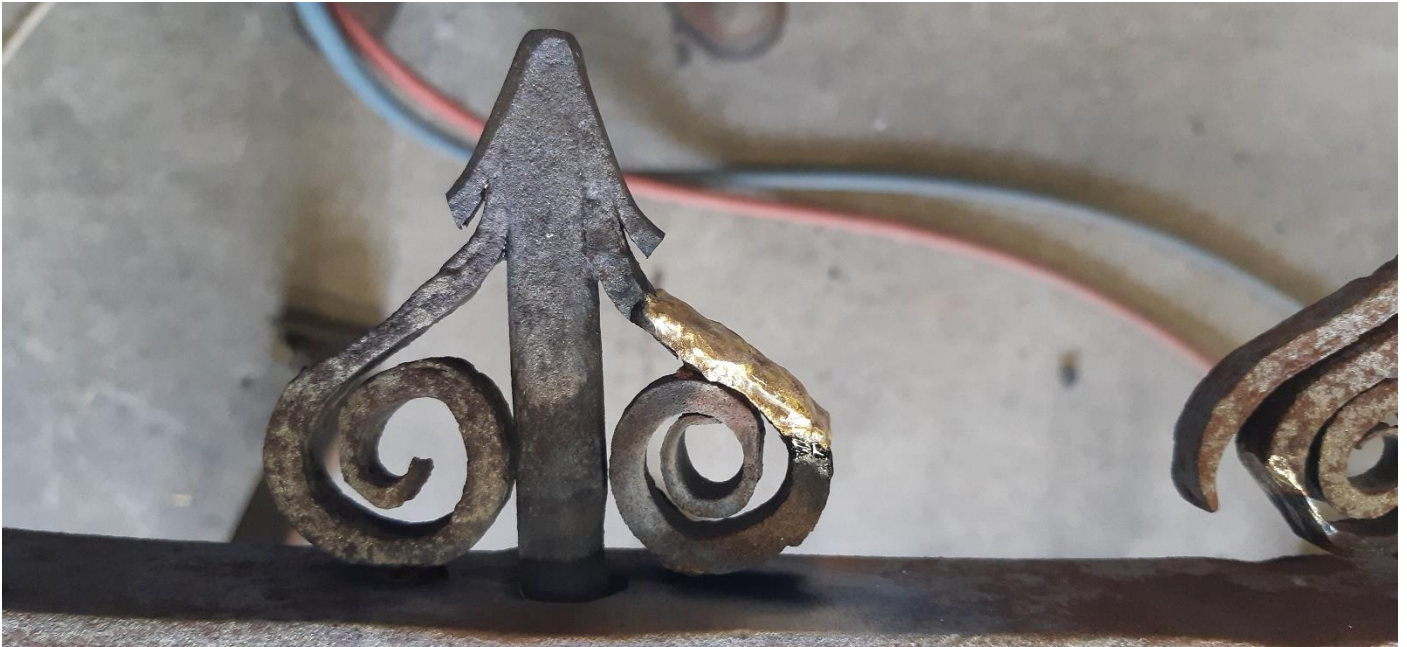
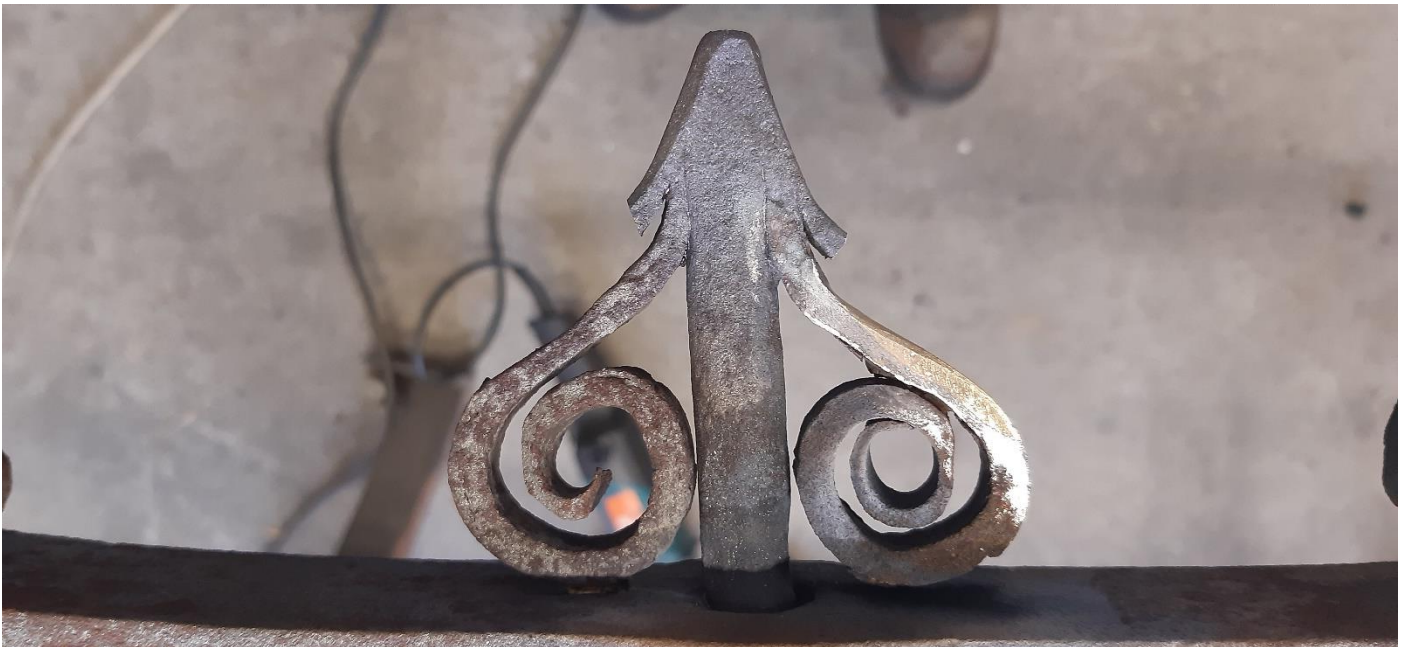
This finial has two of the old ribbons removed in readiness to replace with new ones. One of the scrolls was very thin but it was possible to save it by building up the thinned area by brazing and cleaning back.
