**Condition Assessment,
Recommendations and Method Statement**

**Bloomfield Mausoleum,
Borrisnafarney Church of Ireland,
Ballycormick,
Monegal,
Co.Offaly**

*Southgate Associates
December 2021*

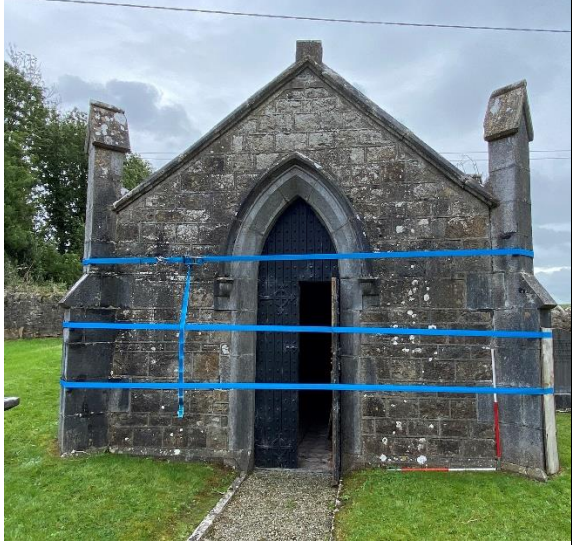
<p>1. North west facing front gable of structure. Note pointed arch door wall and moulded gable coping.</p>	<p>2. North facing side of structure. Note arcaded cornice and well-formed ashlar buttresses.</p>

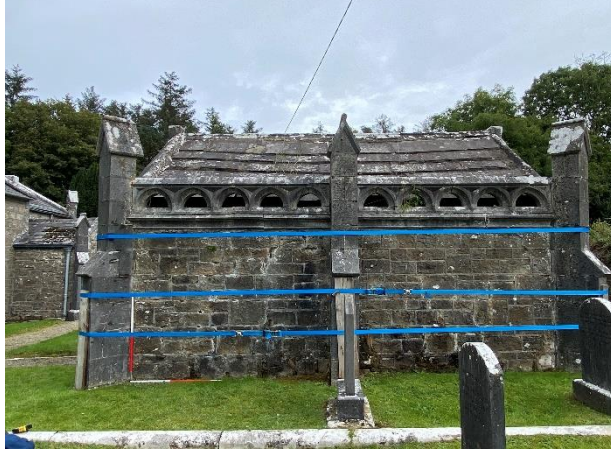
Six buttresses surround the structure. These are cut stone with a kneeler stone approximately half way up the buttress. The buttresses have shifted recently, predominantly on the right hand side of the mausoleum and the rear left corner. The buttresses appear to have shifted downwards and outwards away from the structure likely due to subsidence and the lack of a suitable foundation. The buttresses have been recently held in place by high tension strapping which has also served to pull the leaning buttresses somewhat back into their correct positions. It is possible the buttresses are largely decorative as they appear to have minimal ties into the main structure. The two buttresses at the front of the building have two blocks which tie the buttress to the main front façade wall. The buttresses will benefit from the kneeler stone been removed and stainless steel M20 tie rod and plate been cored into the main masonry walls and subsequently the kneeler stone be replaced back in position. This could be carried out on all the buttresses. Stainless Steel M6 helibars angled to run from the joints of

<p>3. Rear south east facing gable. Note down pipes running from eave level stone valleys.</p>	<p>4. South facing side of structure. Strapping is keeping buttresses in place currently and has aided in some cases to pull the subsiding stones back into correct alignment.</p>

- x 1 Stainless Steel tie plate and M20 rod to be cored into wall behind kneeler stone and kneeler stone put back in place, this is for the two central buttresses on either side of the structure.

- For corner angled buttresses x2 Stainless Steel tie plate and M20 rod running from the centre of the buttress behind the kneeler stone and into the masonry.

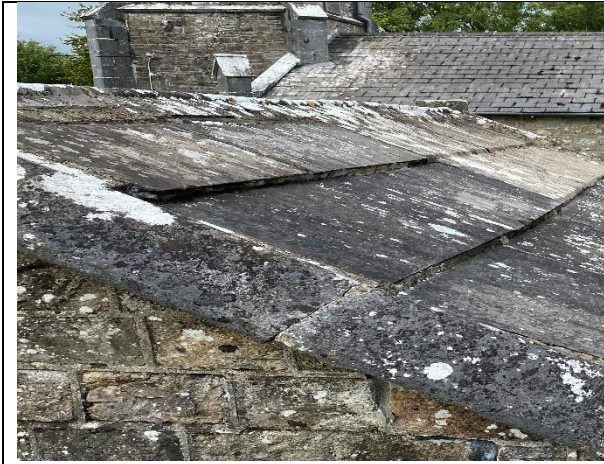
The roof structure is composed of flagstones set on a sand and cement bedding mortar. On the left hand pitch (as viewed from front) it appears several flagstones are missing and have been replaced with moulded sand and cement to mimic the shape of the original flagstones. The ridge of the roof is cut stone also set on a cementitious mortar. The roof is in reasonable condition overall but will require correct resetting on a NHL3.5 Lime bedding mortar during later phases of the conservation of this structure. The roof flagstones on the right hand side pitch of the roof appear to have slipped downwards at some time and have been rebbed poorly using cementitious mortar. These will require removal and resetting at a correct level and course on a NHL 3.5 Lime bedding mortar. The missing flagstones will require replacement on a like for like basis. The roof ends at the front and rear façade in a moulded stone coping which is in good condition but will benefit from repointing in NHL 3.5.

5. The north facing flagged roof, note bedded on apparently cementitious mortar and some flags missing replaced with moulded sand and cement

-Replacement of missing flagstones on left hand pitch of roof on a like for like basis using reclaimed matching stone if possible.

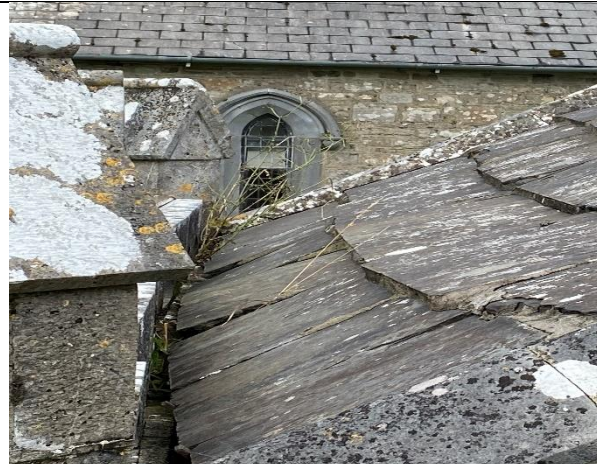
6. South facing flagged roof, appears to have been damaged or slipped at some stage, possibly by tree fall as noted by committee. The slipped flags have at some stage knocked the arcaded cornice out of line. The flags should be reset in correct position on lime mortar as should the arcaded cornice.

-Resetting of full roof onto NHL 3.5 Lime mortar correctly in correct course and in their original positions.

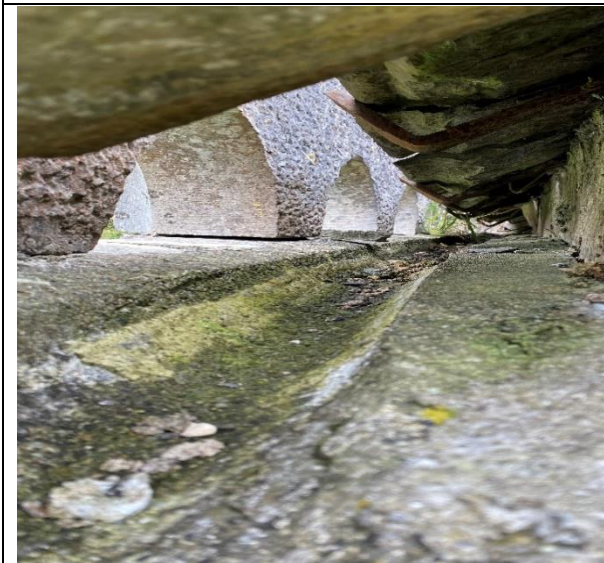
The roof pitches runs down to a stone valley running along either side at eave level. This is in poor condition and requires repointing in an NHL 3.5 or a suitable sealant to ensure a suitable slope to allow water to be carried from the valley. In the interim a PVC gutter liner may be suitable to prevent water running through damaged stone valleys into the masonry walls or arch top internally.

7. Damaged stone and cement rendered valleys at eave level behind the arcaded cornices requiring repair. Note the dry joints of the arcaded cornice requiring repointing.

- Sealing and repairs of stone valley on either side of the building using NHL3.5 or a suitable lead mastic and repair to cast iron downpipes as necessary in Sikaflex 11fc.
- Repair to land drainage running from gullies at rear of structure to ensure no wet ground around base of buttresses.

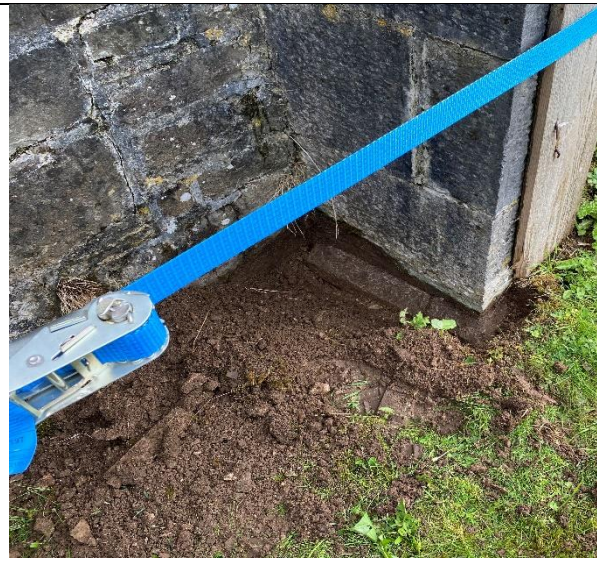
each buttress into the main masonry walls would also serve to form elbow ties at several positions along each buttresses. The base of the buttresses, although not excavated to foundation level, are set on a sloped plinth, as visible at the front of the building, but under ground level on the sides and rear of the building, but it is likely this plinth is not set on a sufficient foundation or pad. These bases should be underpinned on a gradual step by step basis with one section been excavated and underpinned before moving onto the next. As repair works are being carried out on the leaning buttresses these can be gradually jacked or propped back into their correct alignment. The buttresses have been pointed in sand and cement and this should be removed in cases where it has failed or become loose and repointed in NHL 3.5.

8. Buried plinth exposed at base of central buttress on south facing side of structure. Similar plinth noted buried at the base of each plinth around building. This is likely set on no, or an inappropriate foundation causing subsidence.

- Careful underpinning of each buttress with a concrete pad in C20/25 concrete at a 1:3 mix cement: sand. Underpin should be carried out step by step with 48 hours allowed between each section.

- Exact depth and width of underpin to be confirmed by depth location of sound ground
- Gradual propping or jacking of buttresses into correct vertical alignment

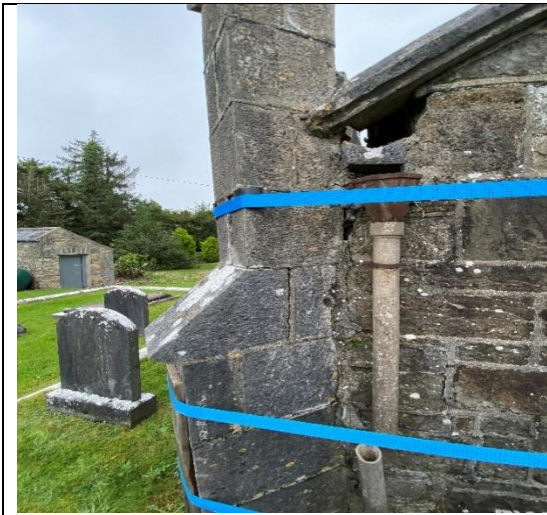
9. Buttress at rear corner south east corner. The buttress is no longer in correct vertical alignment and appears to be sinking with the kneeler stone pushing outwards and the upper half of the buttress leaving backwards. Tie rods and elbow joints should be used on each buttress to tie them back into the structure.

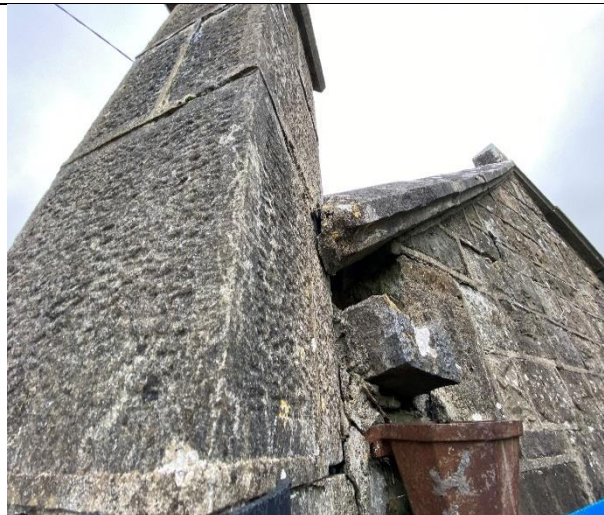
10. South east corner and connection to gable coping. The joint is dry suggesting they no longer connected. Note also the stone valley chute and cast iron hopper head

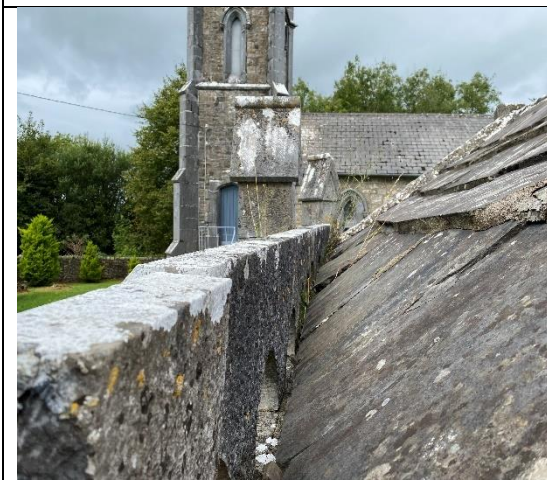
The individual blocks of the arcaded cornice are in good condition however on the right hand side of the structure the blocks have been pushed out of alignment likely by the previously slipped flagstone roof. These require resetting and realigning on a bed of NHL 3.5 Lime mortar. Similarly on the left hand side of the structure the individual blocks themselves are in good condition but washing out and exposure has caused a large amount of the joints to become dry and these should be repointed in an NHL 3.5 lime mortar.

11. Arcaded cornice on south side of building with the clear movement of the stone noticeable. This appears to have been caused by downward movement of the flagged roof. This stonework should be reset correctly in phase 2.

-Resetting of arcaded cornices in correct alignment and repointing in NHL 3.5

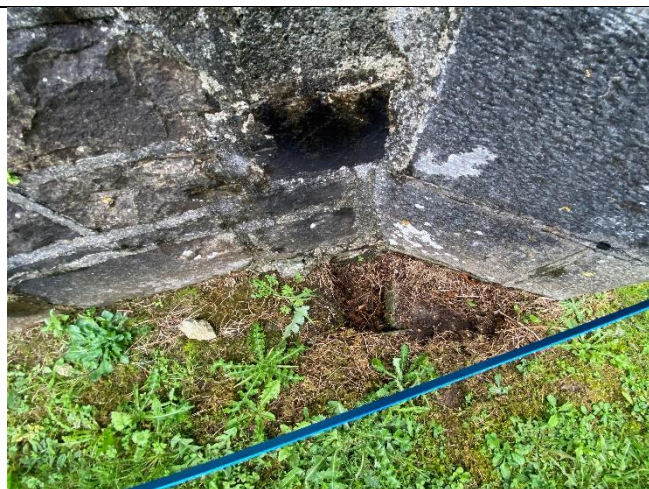
The lands slopes from the rear of the structure downward to the front of the structure. While no large scale drainage is likely to be necessary consideration will have to be given to the splash blocks or ground gullies at the base of the rear of the building where the downpipes run. Appropriate land drainage may require investigation and renewal from these gullies down either side of the structure and away from it. The ground in general appears to be soft silty clay and may be contributing to the subsidence of the buttresses also.

12. Blocked, inappropriate gully to rear of structure which should be corrected in phase 2 to prevent softening of the ground below the structure.

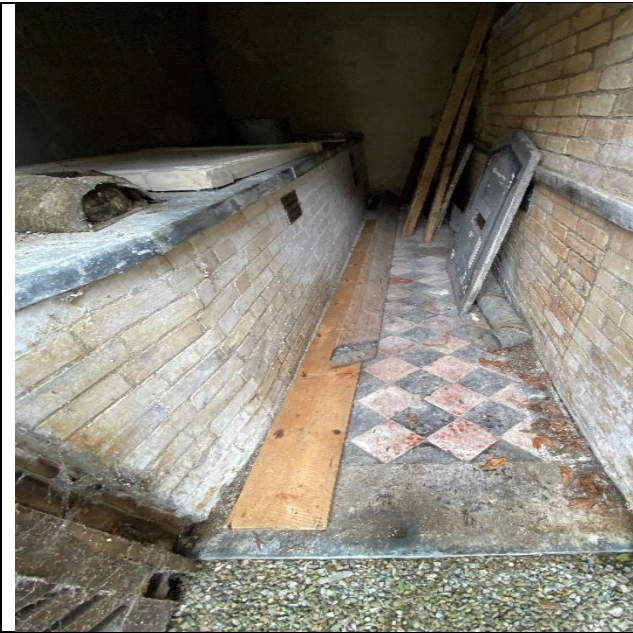
The chequerboard tiled floor is in good condition and only requires a gentle clean. A preservative water repellent may be useful also to preserve the surface of the tiles over time.

13. Chequerboard tiles in good condition on the ground, will benefit from general cleaning and possible a preservative surface treatment. Note brick built sarcophagi on either side of cell.

-Minor general maintenance to the chequered board floor tiles and the brass memorial plaques

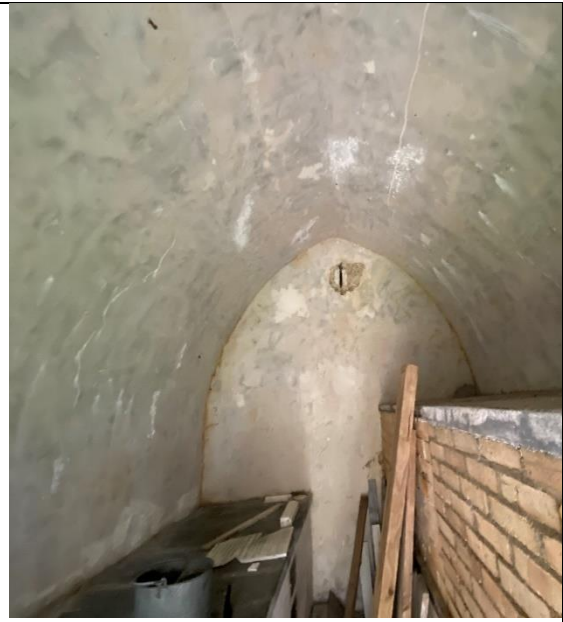
The internal pointed arch ceiling and plaster appear in good condition with no signs of serious water or damp ingress. The plaster appears to be composed of a cementitious mix. Some minor repairs to the plaster around the top of the rear wall opening and around the door in the front wall are envisaged.

14. Pointed Arch Vault ceiling rendered in an apparent cementitious plaster directly onto the masonry construction of the arch.

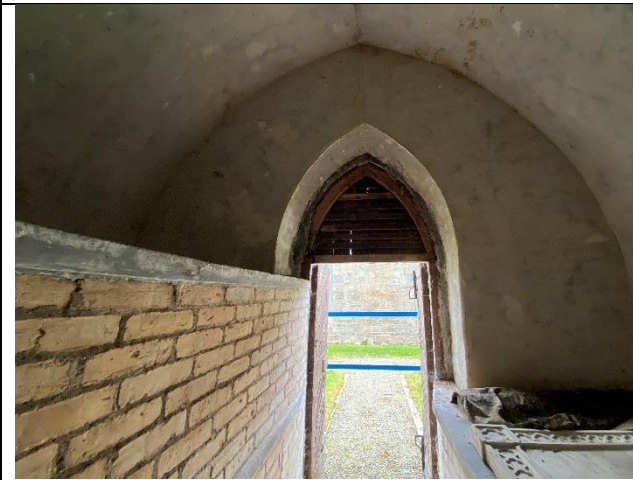
15. Louvered timbers above pointed arch door requiring minor splice repairs. Note double height brick built sarcophagus to left.

-Minor timber repairs to internal louvres and door frame on like for like basis

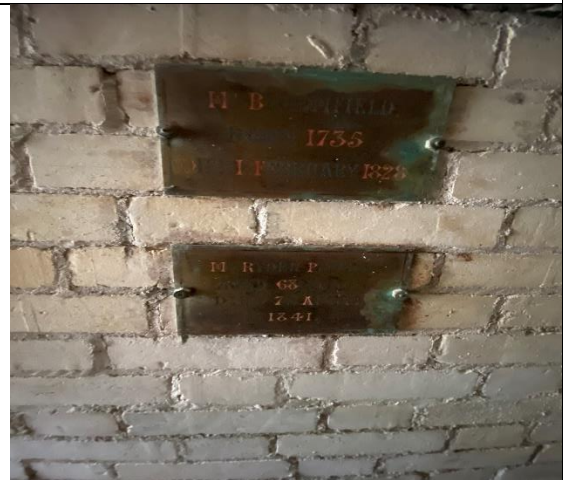
The brick sarcophagi and their stone capping stones are in good condition requiring no work. The brass plaques on the side of the structures would benefit from polishing.

16. Original memorial brass plaques will benefit from careful polishing and treatment with a suitable antique brass product.
