Stained Glass Windows

Six Roman Catholic Churches

County Offaly November 2010

Technical report

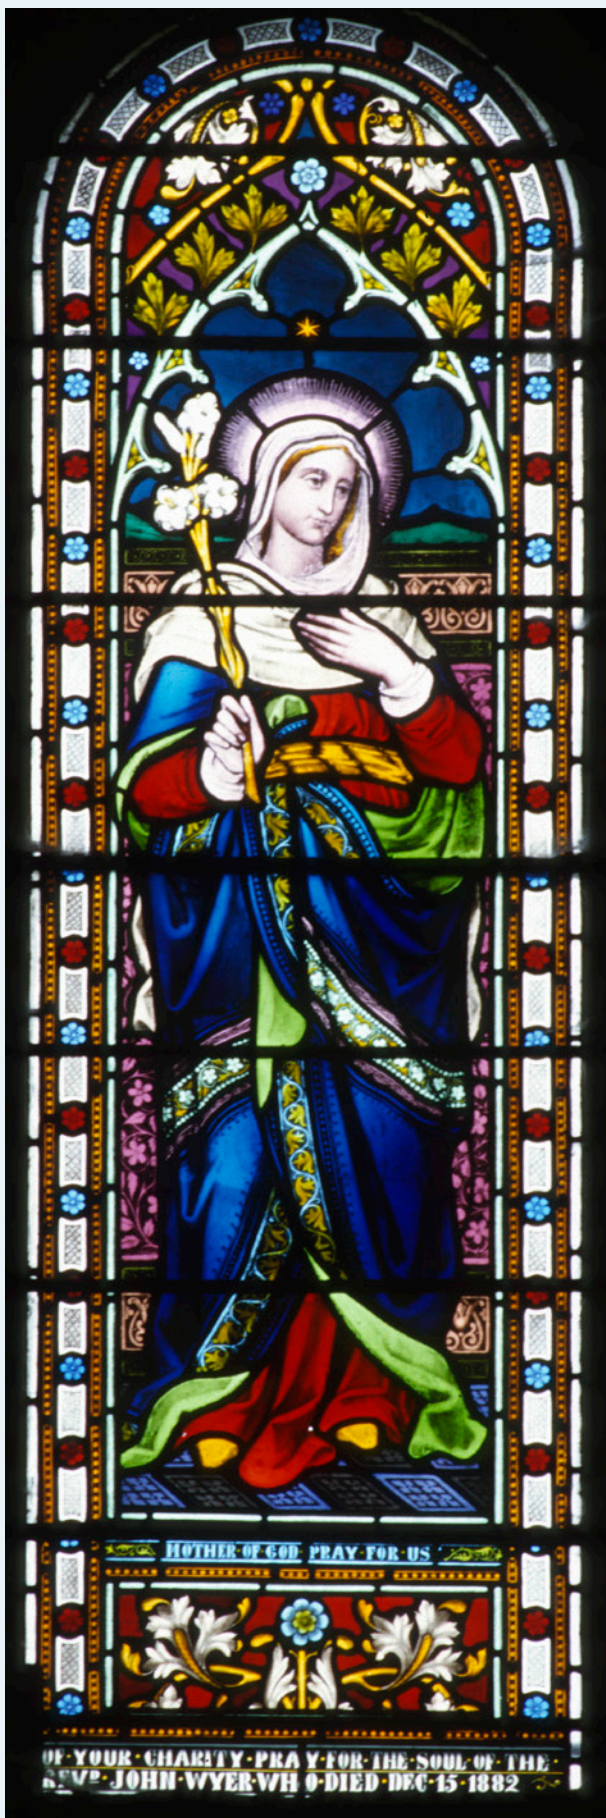
W11

Stained glass pre-dates the church building.

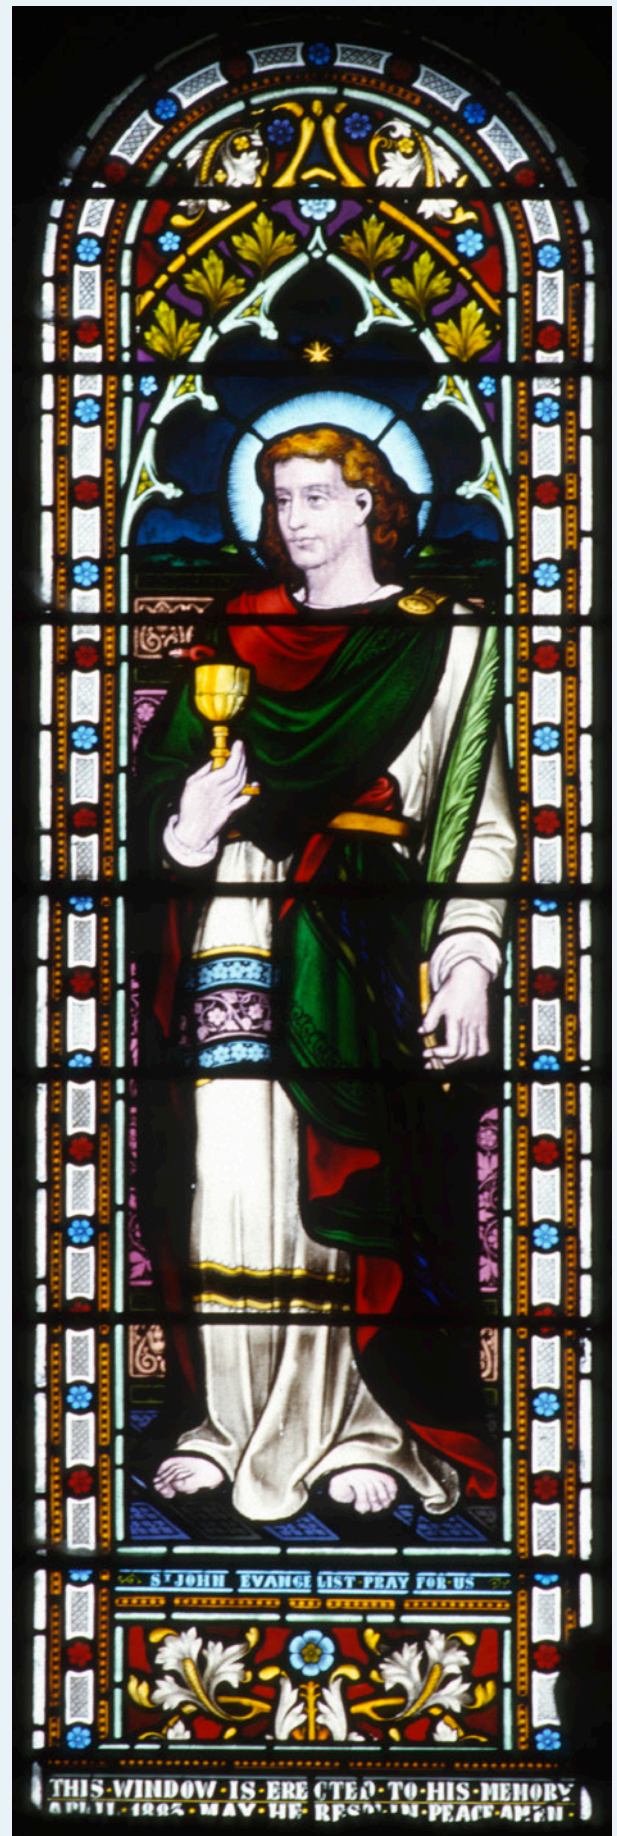
W12

Stained glass pre-dates the church building.

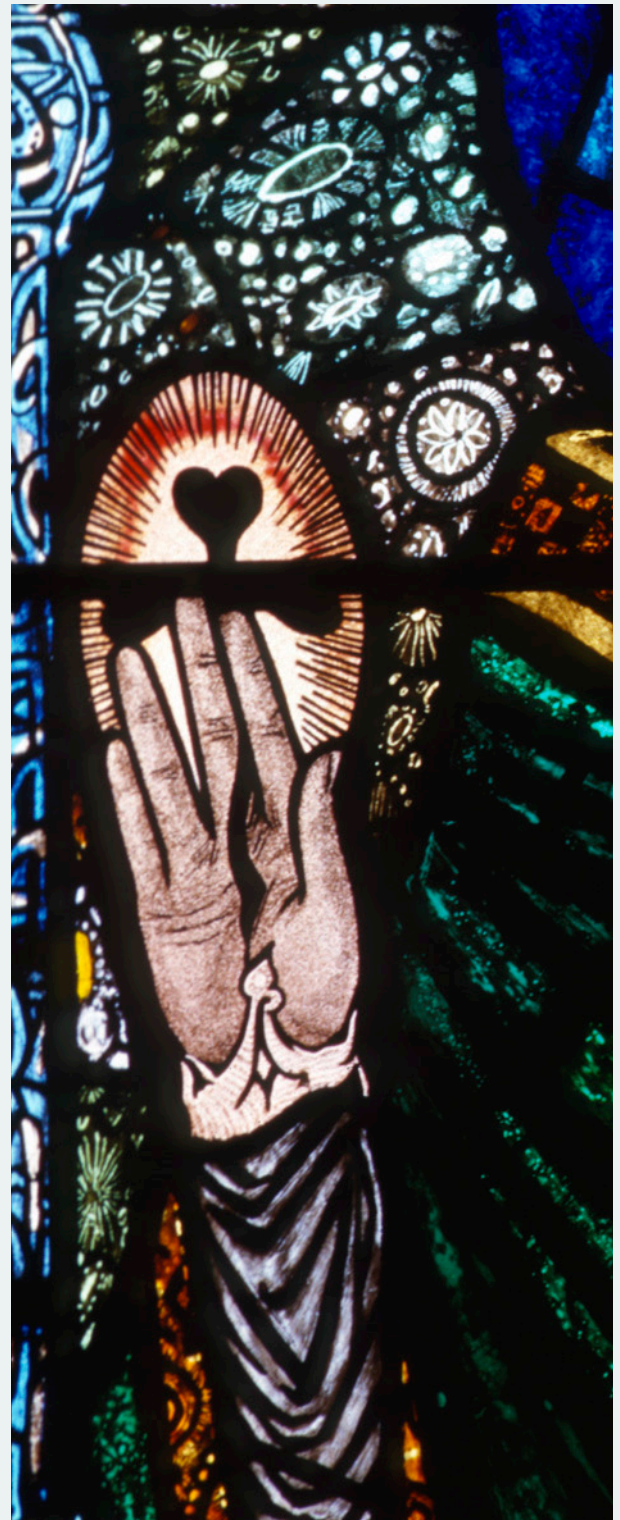
W19 North transept; west; south-most

Stained glass brought in from Rathfarnham Castle. Designed and executed by Clarke. The predella has been removed and placed at W18.

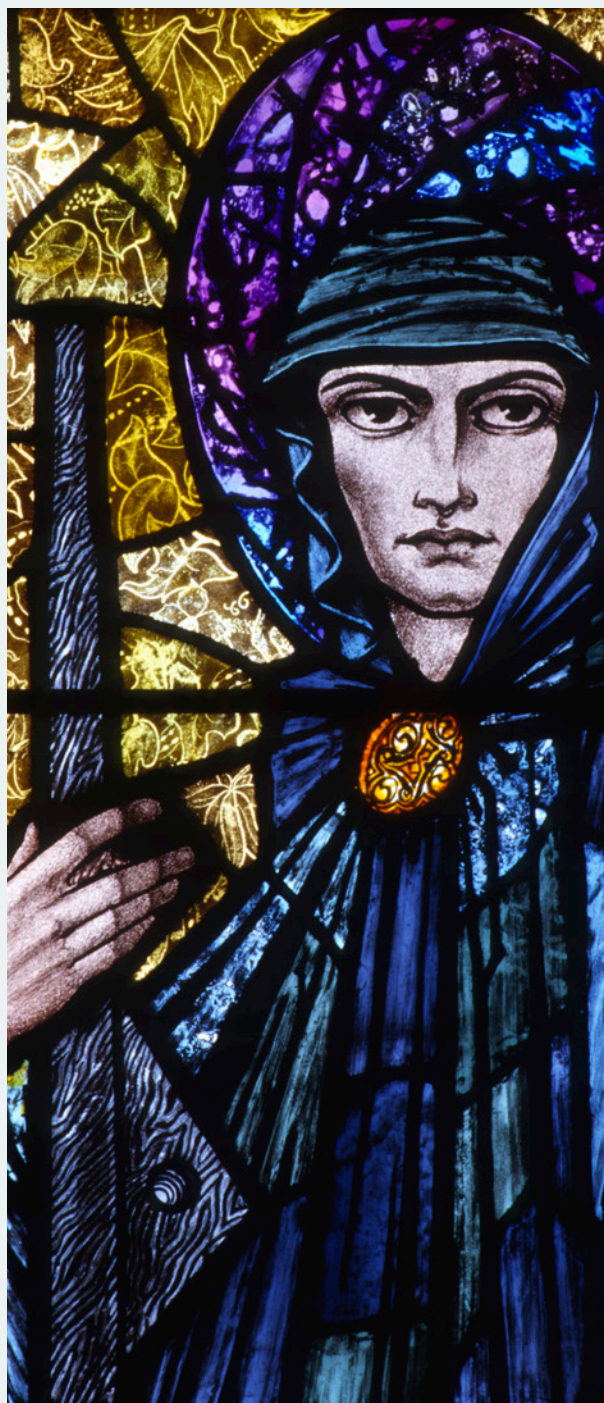
W20 North transept; west; north-most

Stained glass brought in from Rathfarnham Castle. Designed by Clarke but executed by his studio. The predella has been removed and placed, backlit, in a passage.

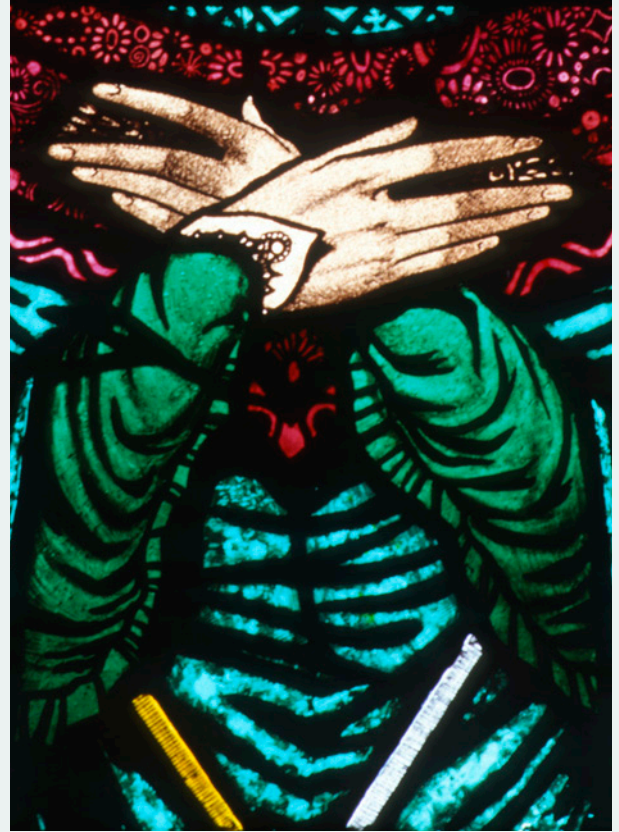
W21 North transept; north; west-most

Stained glass brought in from Rathfarnham Castle. Designed by Clarke but executed by his studio. Extended with unsuitable glass. The predella has been removed and placed at W8.

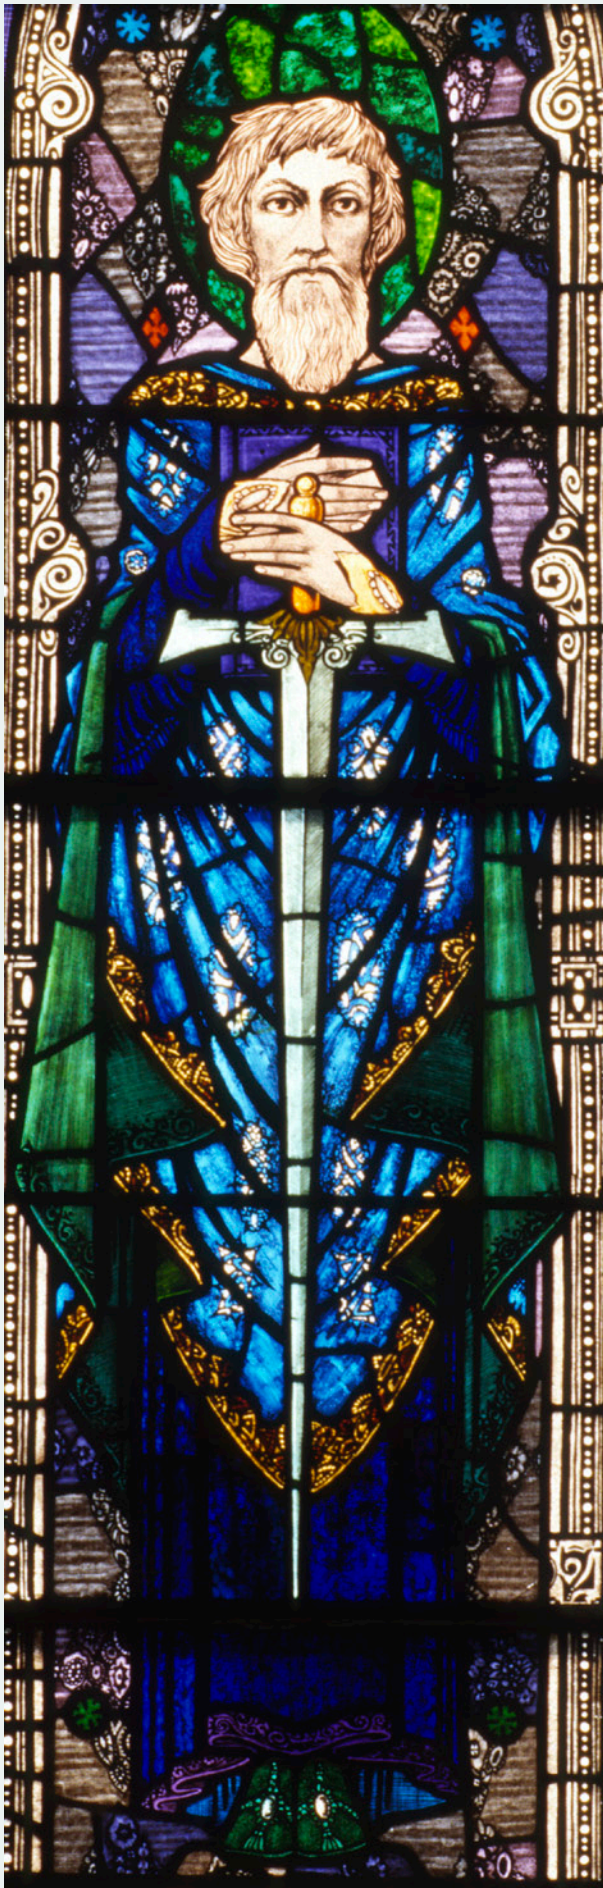
W23 North transept; north; east-most

Stained glass brought in from Rathfarnham Castle. Designed by Clarke but executed by his studio. Extended with unsuitable glass. The predella has been removed and placed at W8.

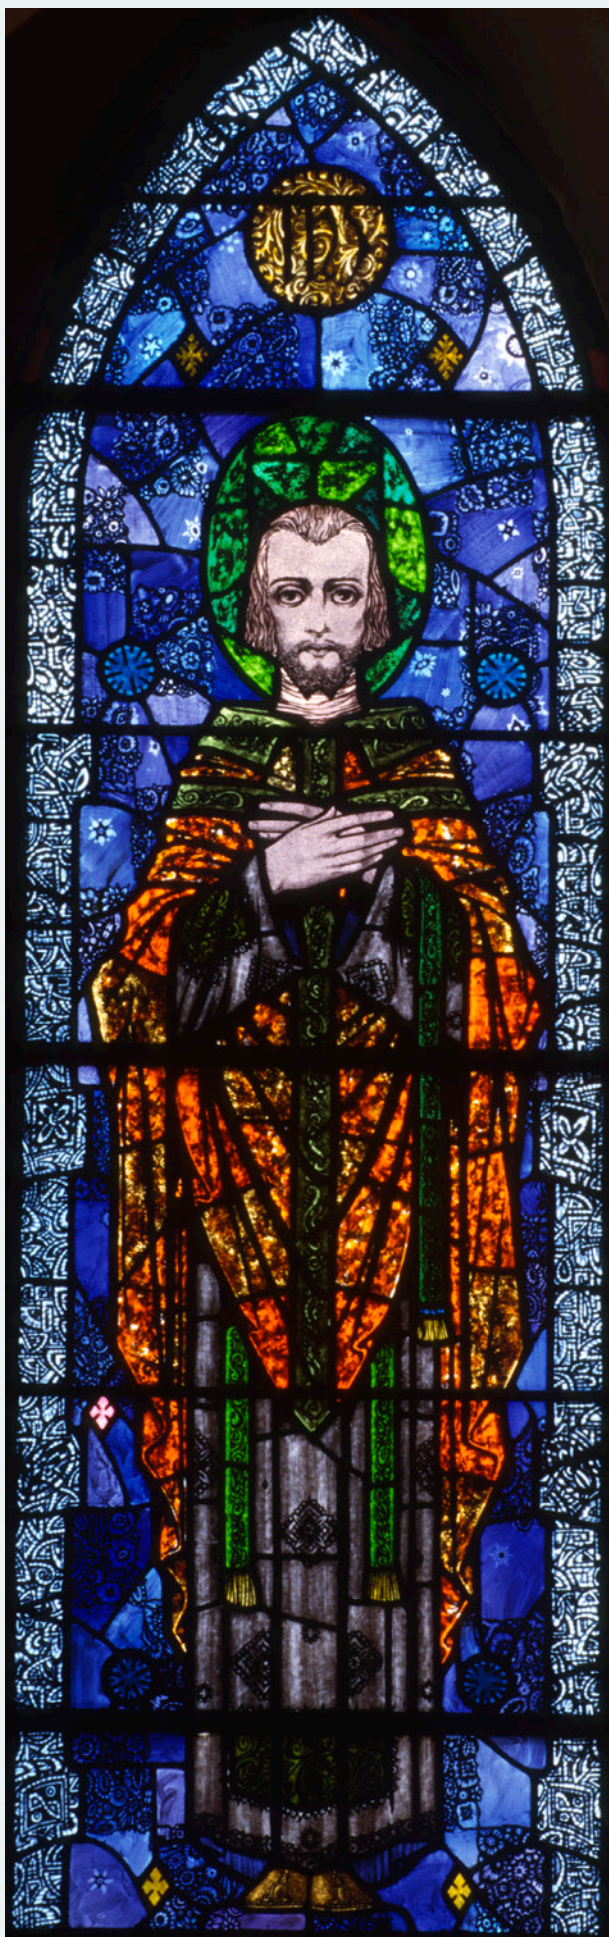
W24 North transept; east

Stained glass brought in from Rathfarnham Castle. Designed by Clarke but executed by his studio. Extended with unsuitable glass. The predella has been removed and placed at W18.
