## **REPORT**

**PEDESTRIAN FOOTBRIDGES AT**

**KINNITTY**

**COILLTE**

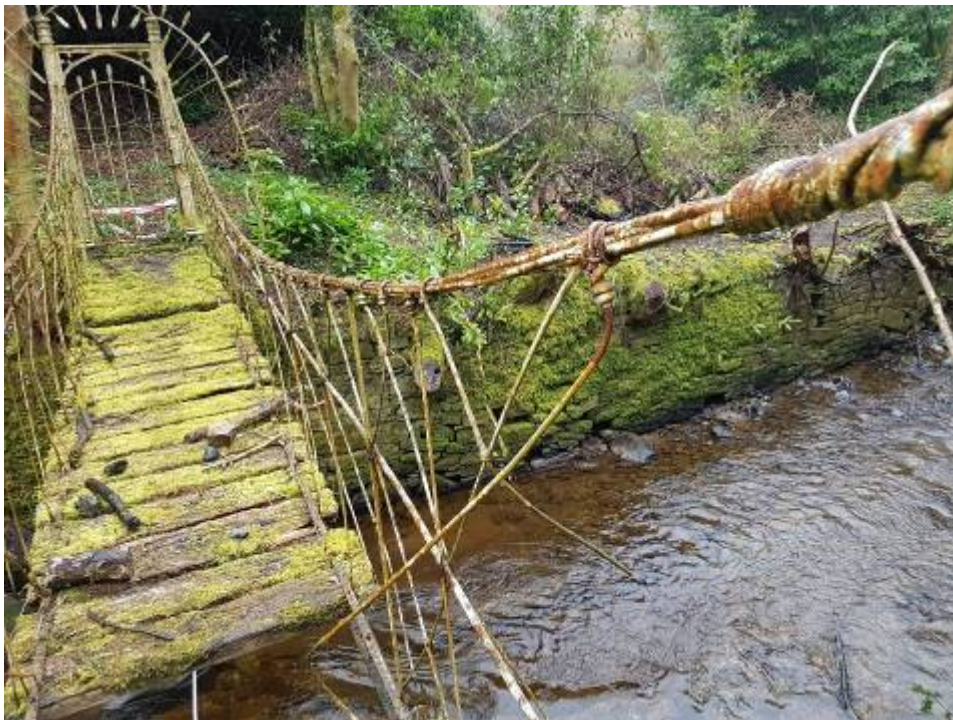
4. Main cable and some missing lattice work

These comprise around 16 No ¼ inch rods threaded at the base and wrapped around the cable like tying wire. Where these have corroded, they should be replaced on a like for like basis. They are stressed to about 1/3 of capacity.

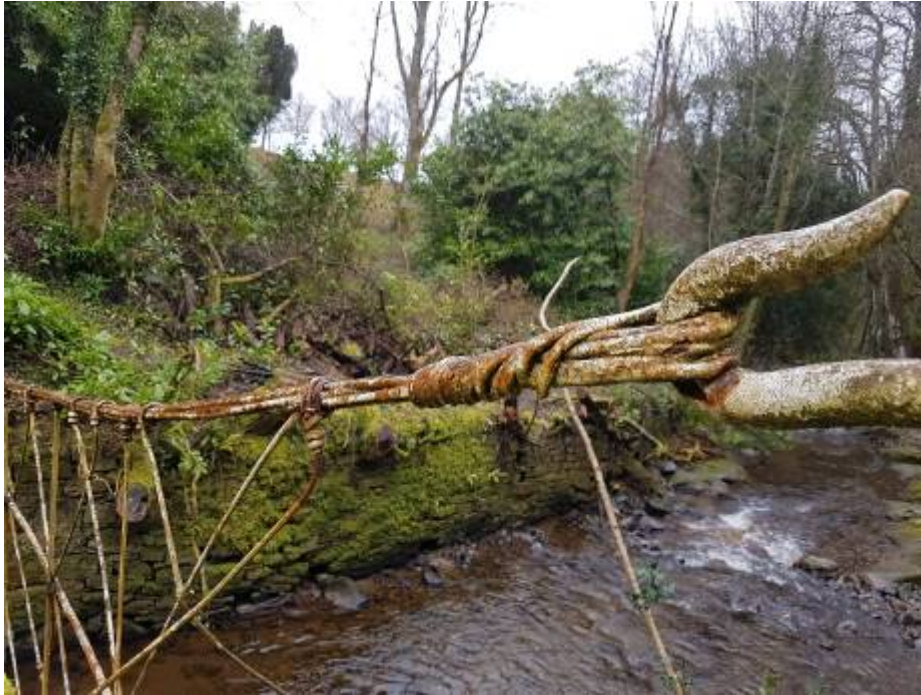
These have 8 No ¼ inch rods formed on site into a wire rope. This construction is both simple and has the advantage of additional safety in that it is unlikely to result in progressive collapse.

5. Main cable consists of 8 No ¼ inch wrought iron rods and is in reasonable condition

Once the bridge is scaffolded a thorough inspection of the wire cables for corrosion is recommended. We feel that it is unlikely that further problems will be found, and the critical members are the 1 ½ inch solid bars at the supports which we feel will need to be replaced.

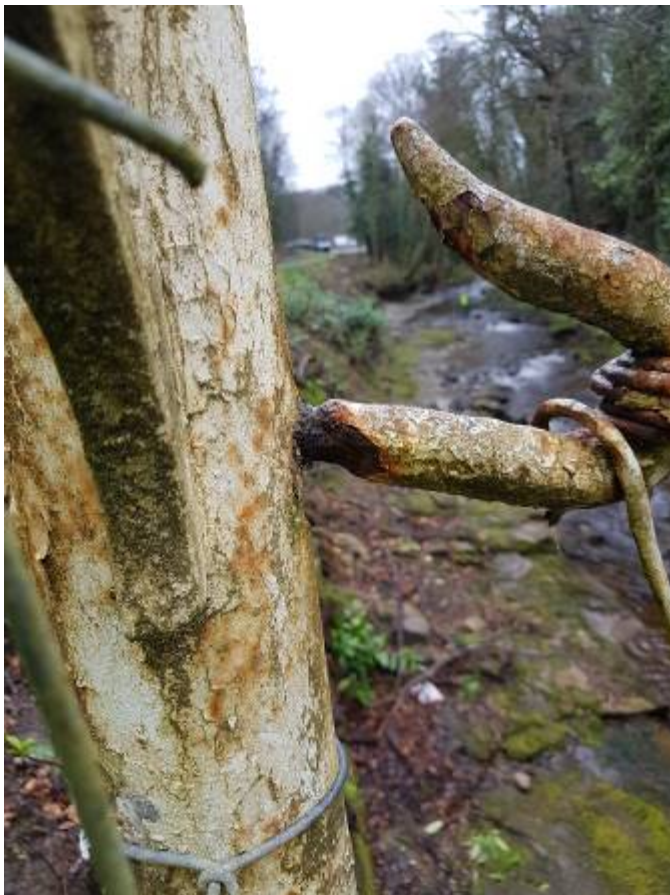
The tension stress in these members (1 ½ inch diameter wrought iron ) are calculated for the reduced live load recommended  $q^{fk}=1.5$  **kN/m<sup>2</sup>** and in this case the characteristic allowable tension stress is 100 N/mm<sup>2</sup> based on there being no corrosion. Where corroded these members will require replacement or strengthening. The assumption that no corrosion is present is not true for at least one stay and since the corrosion not only affects the stress in the bar but also the fracture toughness it is likely that 4 tension stays will have to be replaced.

6. Serious corrosion to critical 1 ½ inch tension stays implies replacement

These require strengthening as shown below, either by replacement in one instance or by providing additional safety cables. A final decision on the methodology will be made when both ends of each cable are carefully studied for corrosion.

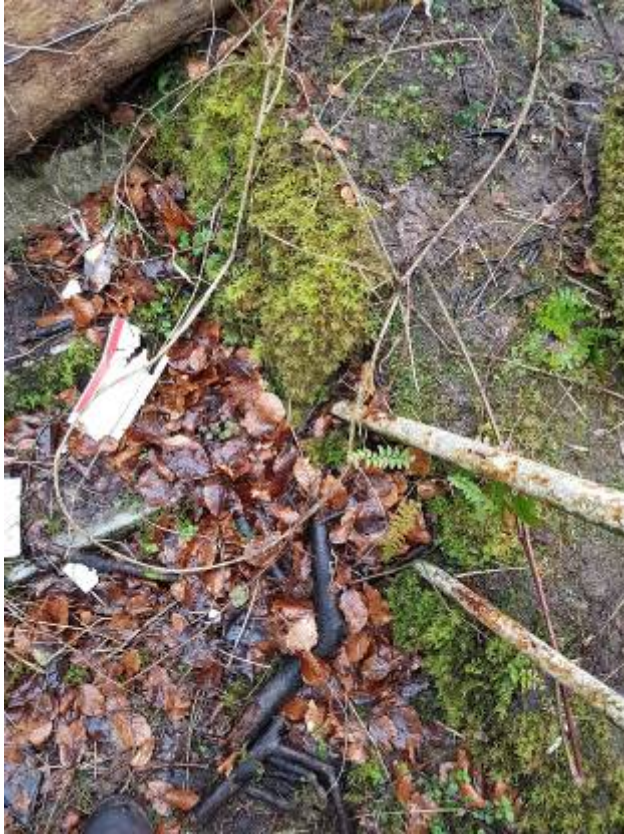
7. It is hoped to connect to the original cable above ground, but corrosion will have to be checked at the interface with the abutment all 4 upper rods are likely to require replacement

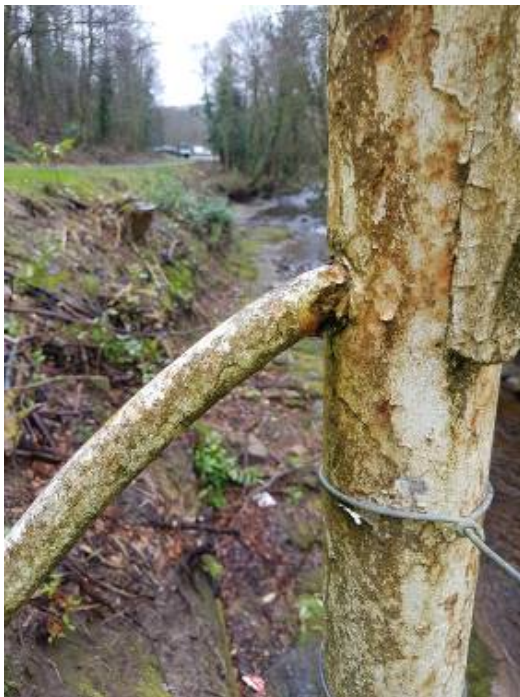
8. View of the same wrought iron stay on the land side to be replaced

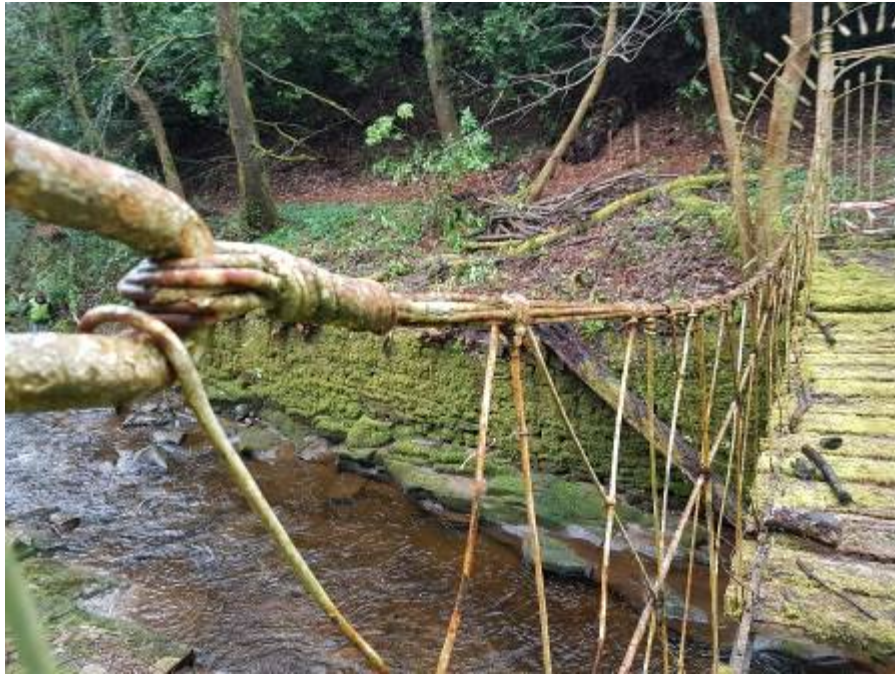
9. Wire cable appears in reasonable condition. Wire hangers are simply wrapped around and bent to suit on site presumably using heat. This is a good sign that they have not cracked or failed during considerable bending.

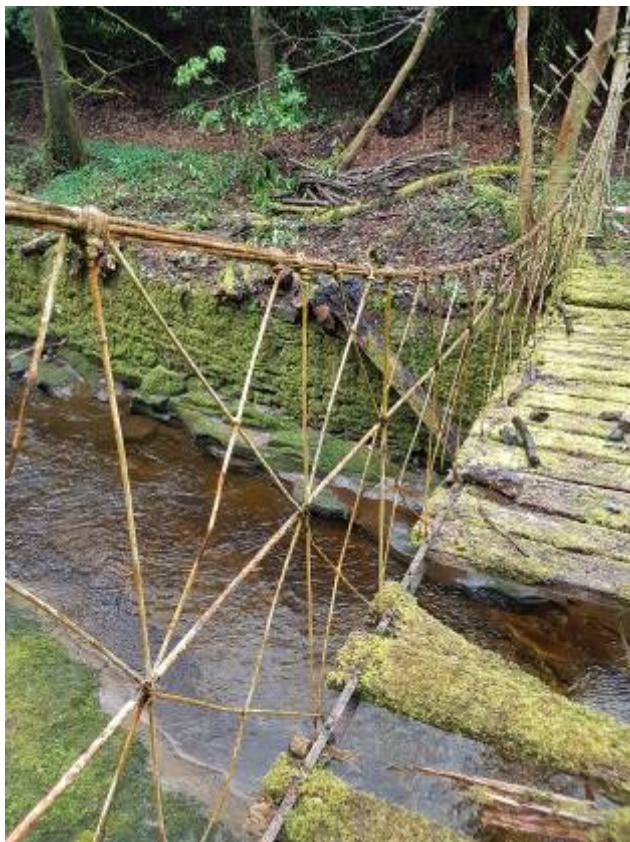
10. Wire hangers pass through 2 iron flats which support the oak floor. These are to be replaced with galvanised steel flats.

It is suggested that the secondary timber flats are replaced with new 50x50x5 and 50x50x10 galvanised steel.

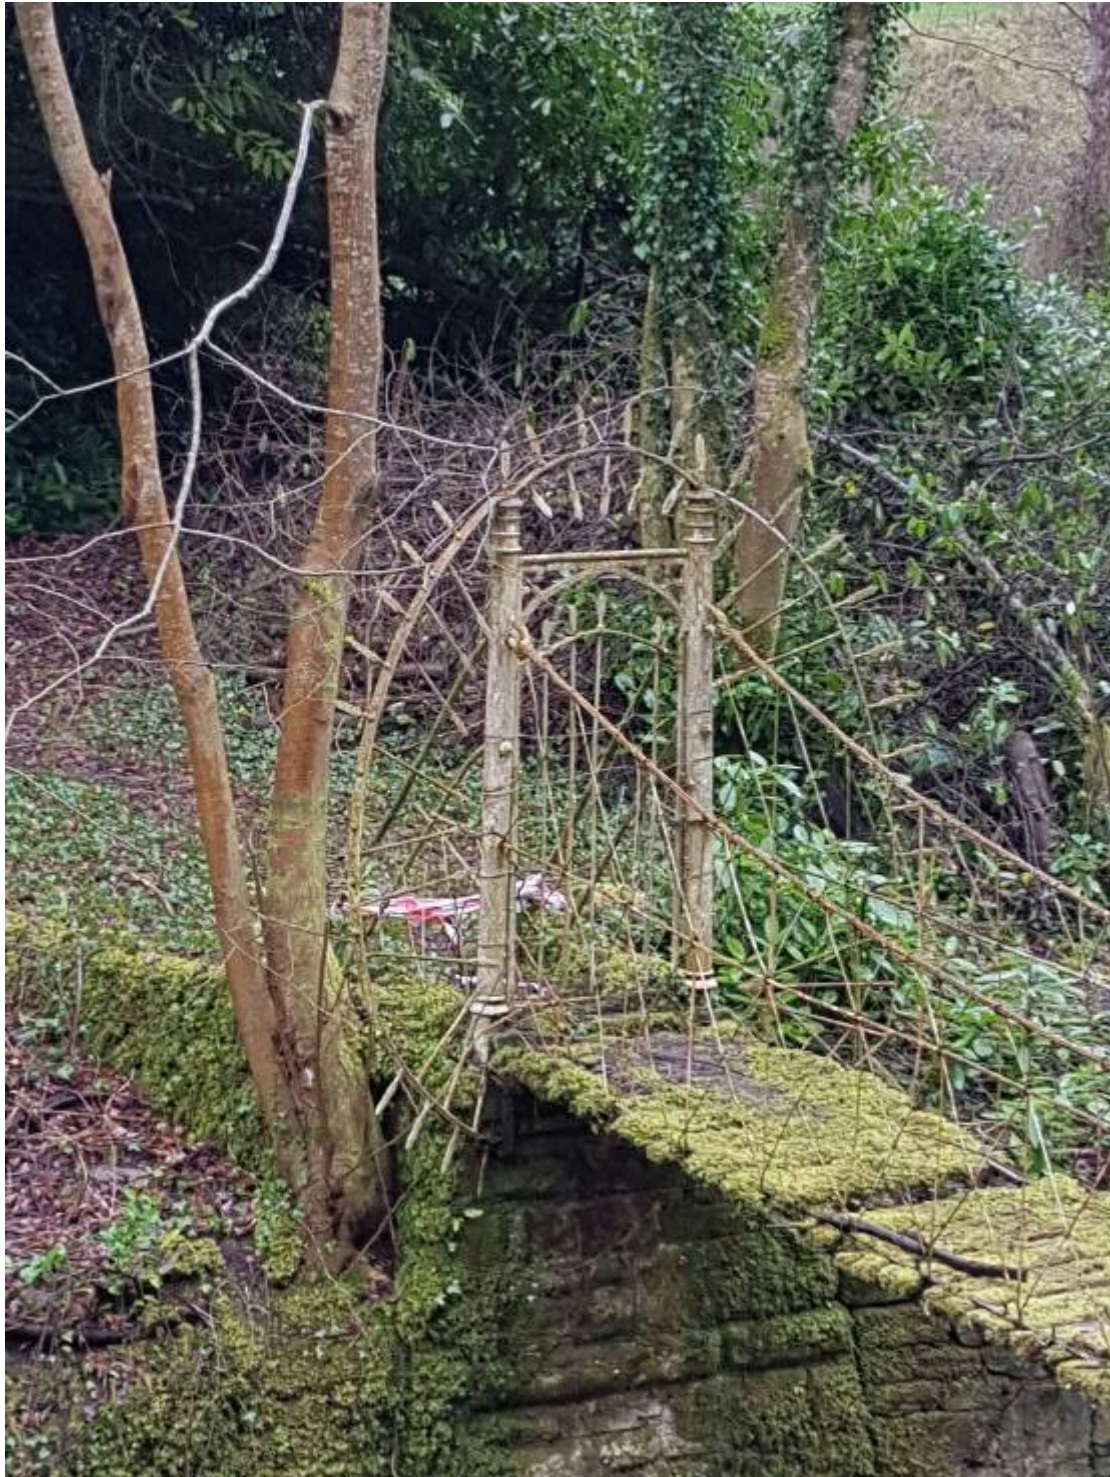
11. The structure on the far side has to be inspected once scaffold is available but appears reasonable

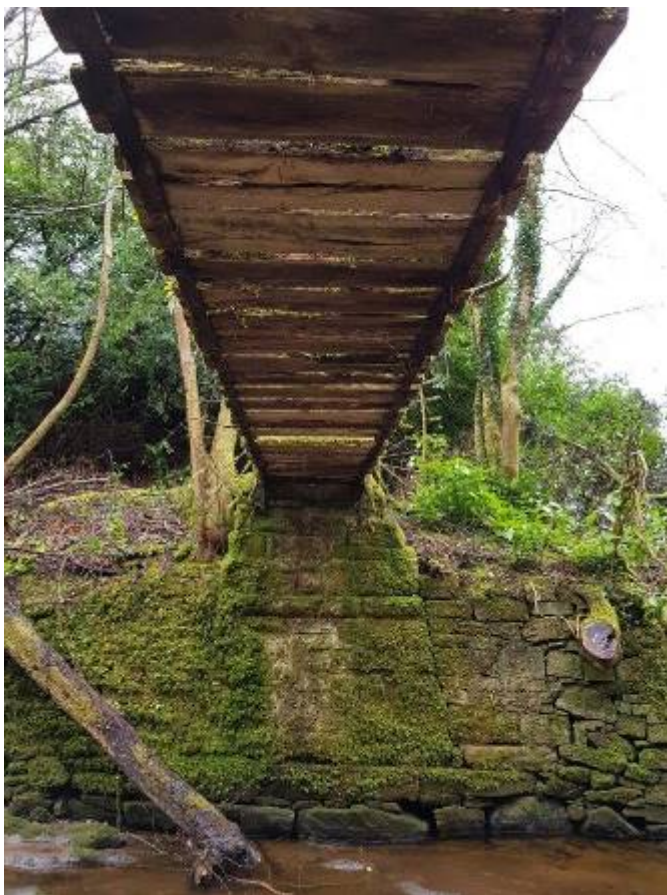
14. Flats appear to be bolted at hanger positions

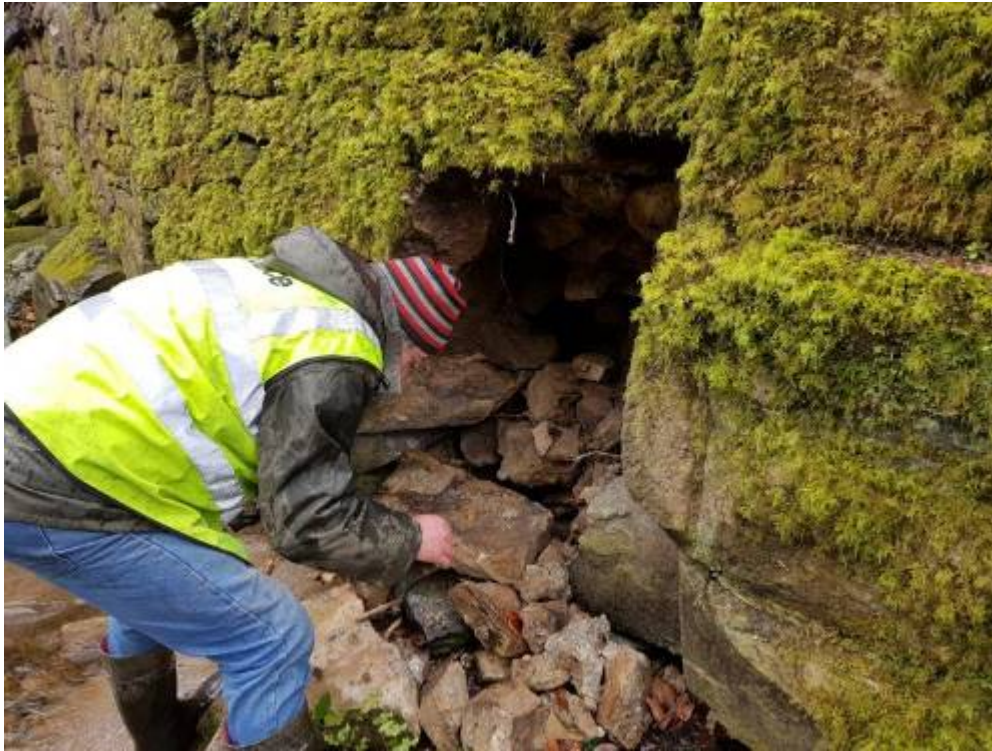
15. Masonry collapse in abutment stonework on Coillte side

On the Coillte side there is an area of stone missing and this should be replaced with similar stone on a like for like basis. Patch pointing will also be required in an NHL 3.5 lime mortar to Southgate Associates specifications.

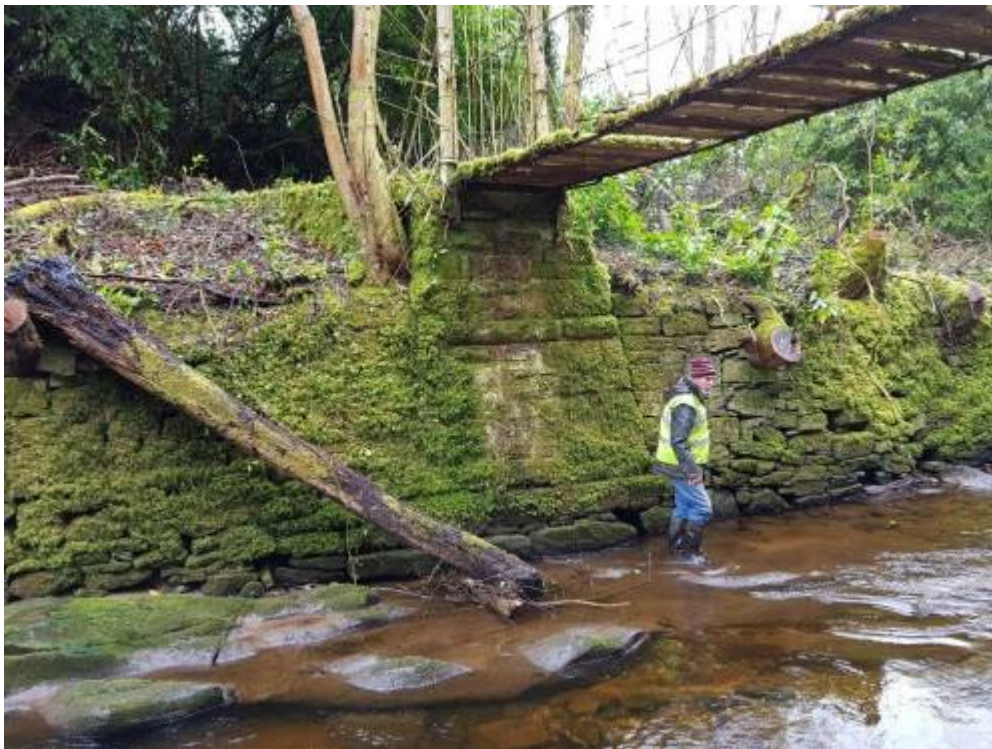
16. Far side stonework requires pointing only

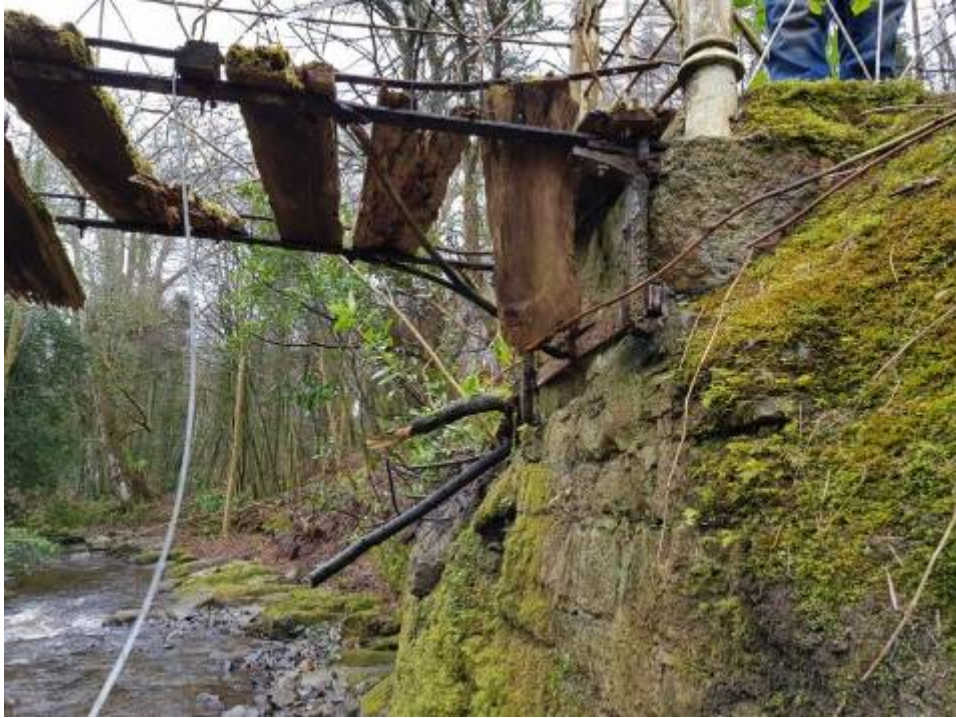
17. Detail of iron support to flats (not critical structurally)

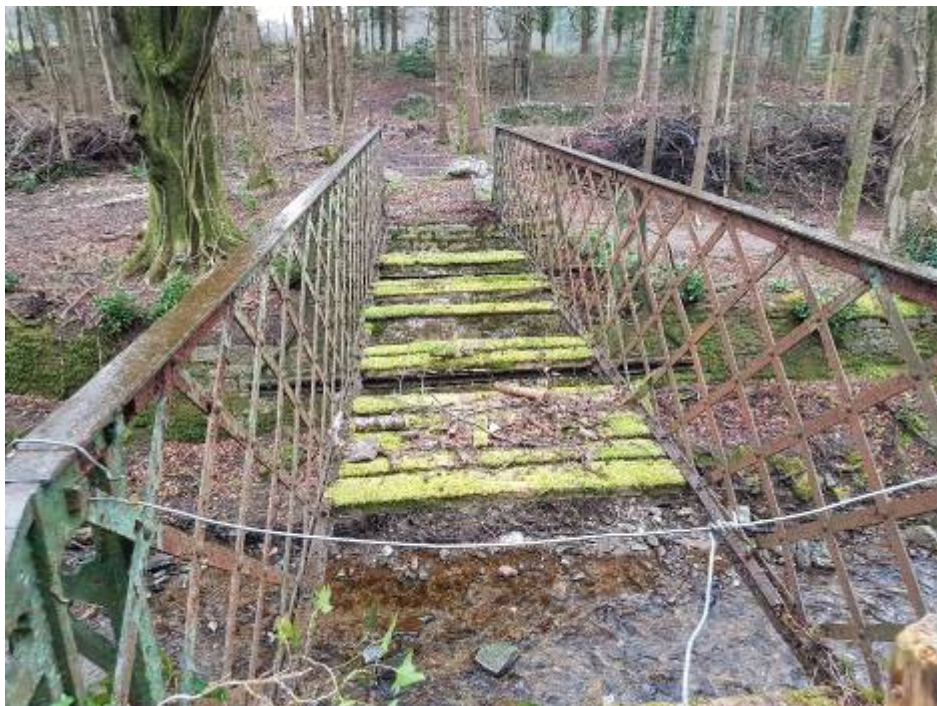
**22. Deck required complete replacement**

This will have to be replaced on a like for like basis using 9-inch x 2-inch oak from the Coillte forest. The wood should be slow growing and durable and should also be pressure impregnated. The stresses in the oak are not critical but it is important to ensure durability. It is also recommended to treat cut ends with an end grain sealer. A galvanised washer spaced could also be used to prevent water lodging on the bottom flat as shown below.

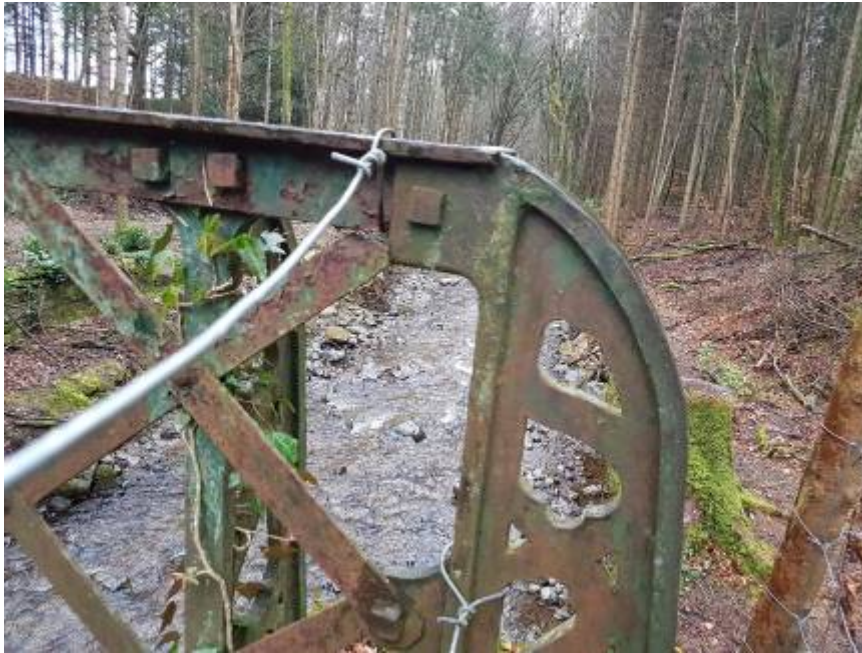
This is generally in good condition but at each end several members have corroded and require replacement on a like for like basis. Original rivets are to be replaced with domed headed bolts to match the existing fasteners.

23. A few diagonal lattices require replacement, but the top member is in good condition

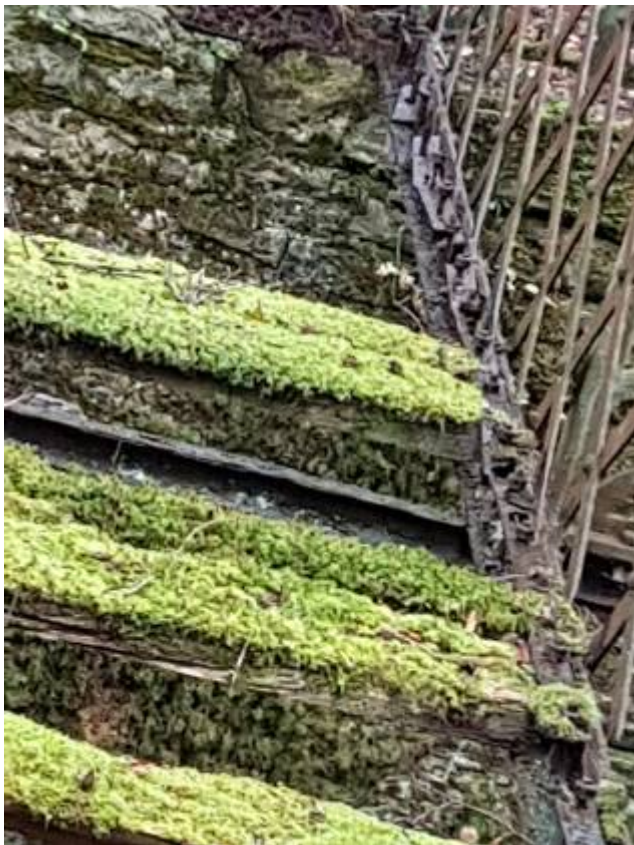
This is badly corroded due to water lodgement and we recommend complete replacement as shown in the sketch below.

24. The bottom 3-inch x 3-inch angle requires replacement together with the non-structural flat above since water has lodged in the deck area causing extensive corrosion

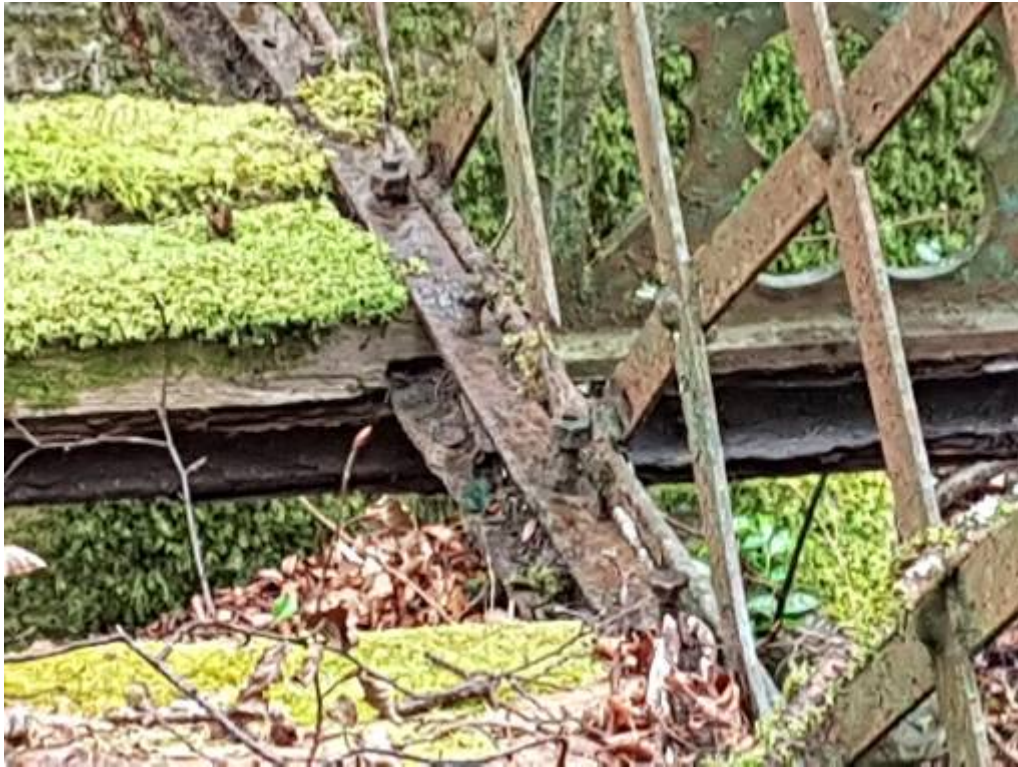
These are so badly corroded that we recommend complete replacement as shown in the sketch below.

25. 3 cross beams also require complete replacement on a like for like basis. New steel members should be galvanised and etch primed to receive the decorative paint coats

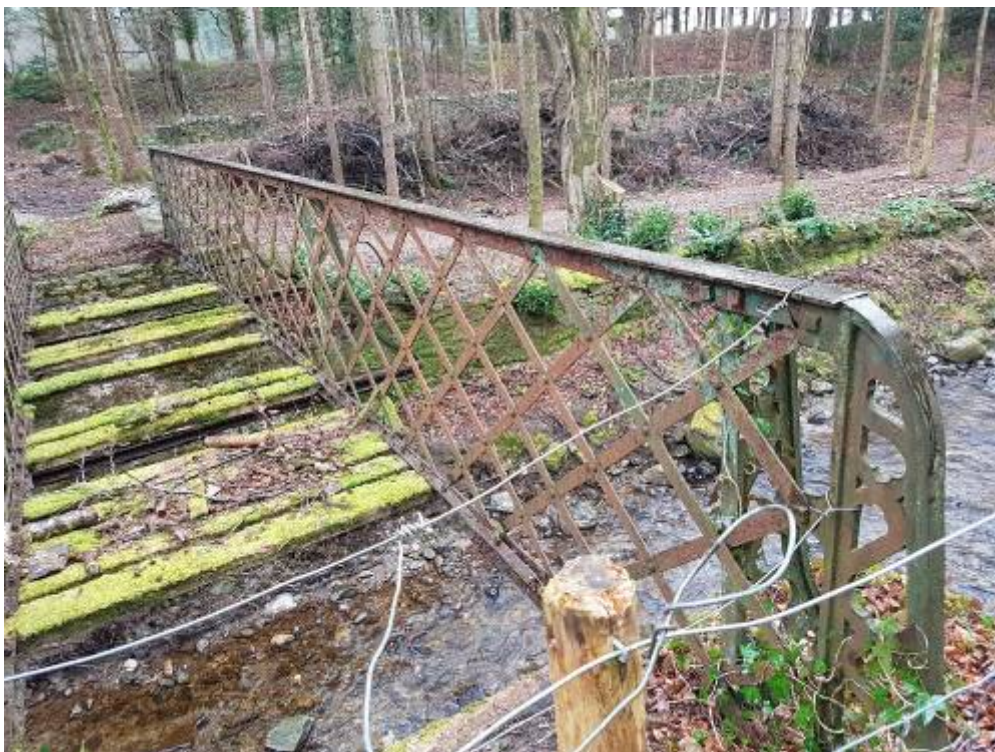
26. General view showing ridge has not deflected in spite of corroded members

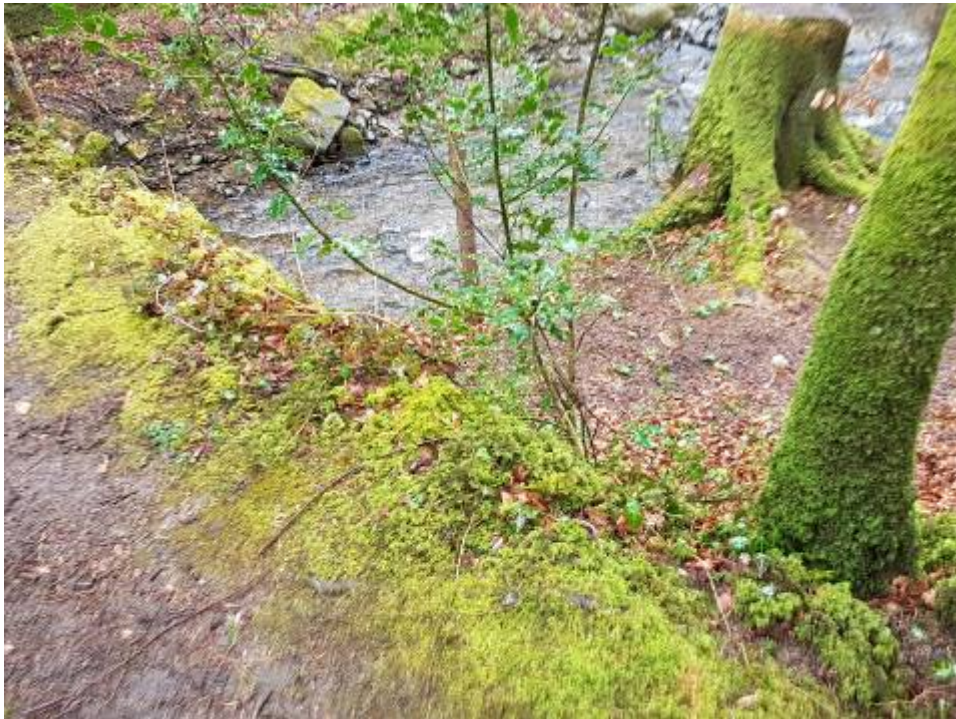
28. Guarding will be required at approach edges

There will be a responsibility if the bridge is open to the public to ensure adequate safety measures in the approach. This will involve non-slip finishes to the pathways and adequate guarding to prevent falls around changes in level
