OCC Local Authority application – Stream 2 – Birr Suspension Bridge

**Appendix III
FORM B
LOCAL AUTHORITY FINAL REPORT**

Summary	
Brief Description of Proposed Works	Repairs to nationally significant single-span suspension bridge at Birr Demesne	
Briefly summarise why the local authority considers that this project qualifies for this scheme having regard to:	<p>1. The bridge is one of only two suspension bridges in Offaly and is earlier and larger than the bridge at Kinnitty Castle. It is of significant technical interest as a rare surviving example of a multiple-wire cable suspension bridge, possibly the earliest surviving in Europe as it dates between 1821 and 1825. It is also significant in terms of its historical association with the innovative Parsons family. The bridge also lends interest to the riverscape and it contributes to the group of structures within Birr demesne by providing access across the River Camcor.</p> <p>2. Efficacy to enable repair of this nationally significant structure and with managed access will allow for its use once again. It will support the investment of private capital, encouraging and assisting the conservation this prominent, structure for com

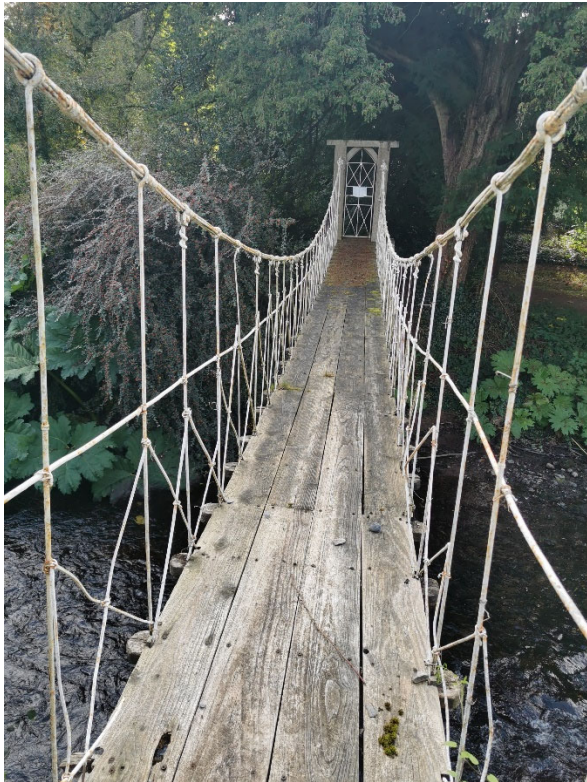
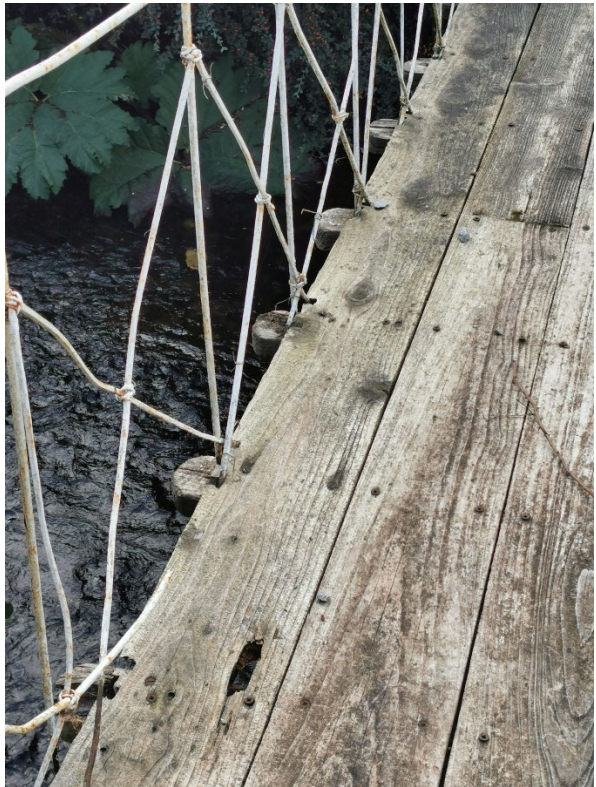
Condition of bridge and decking prior to works

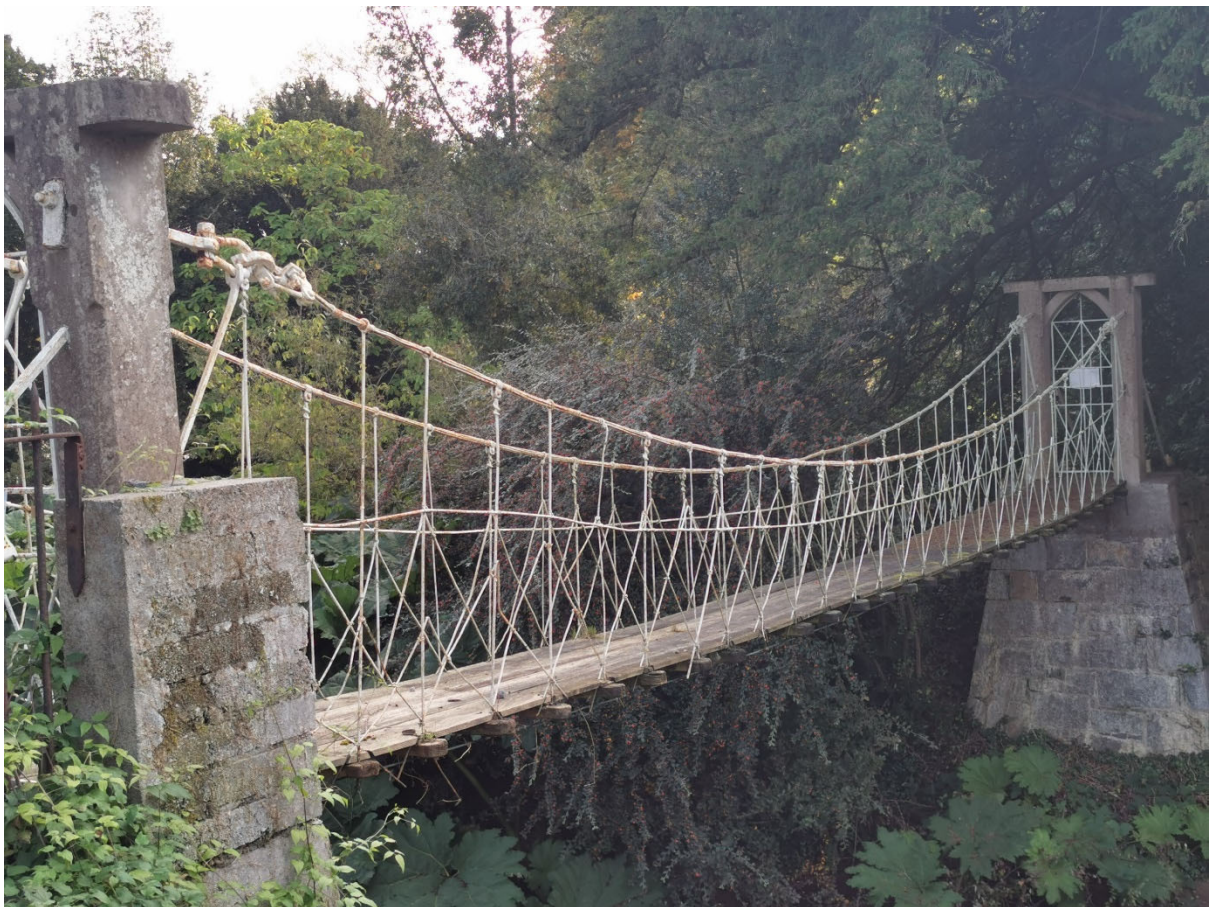
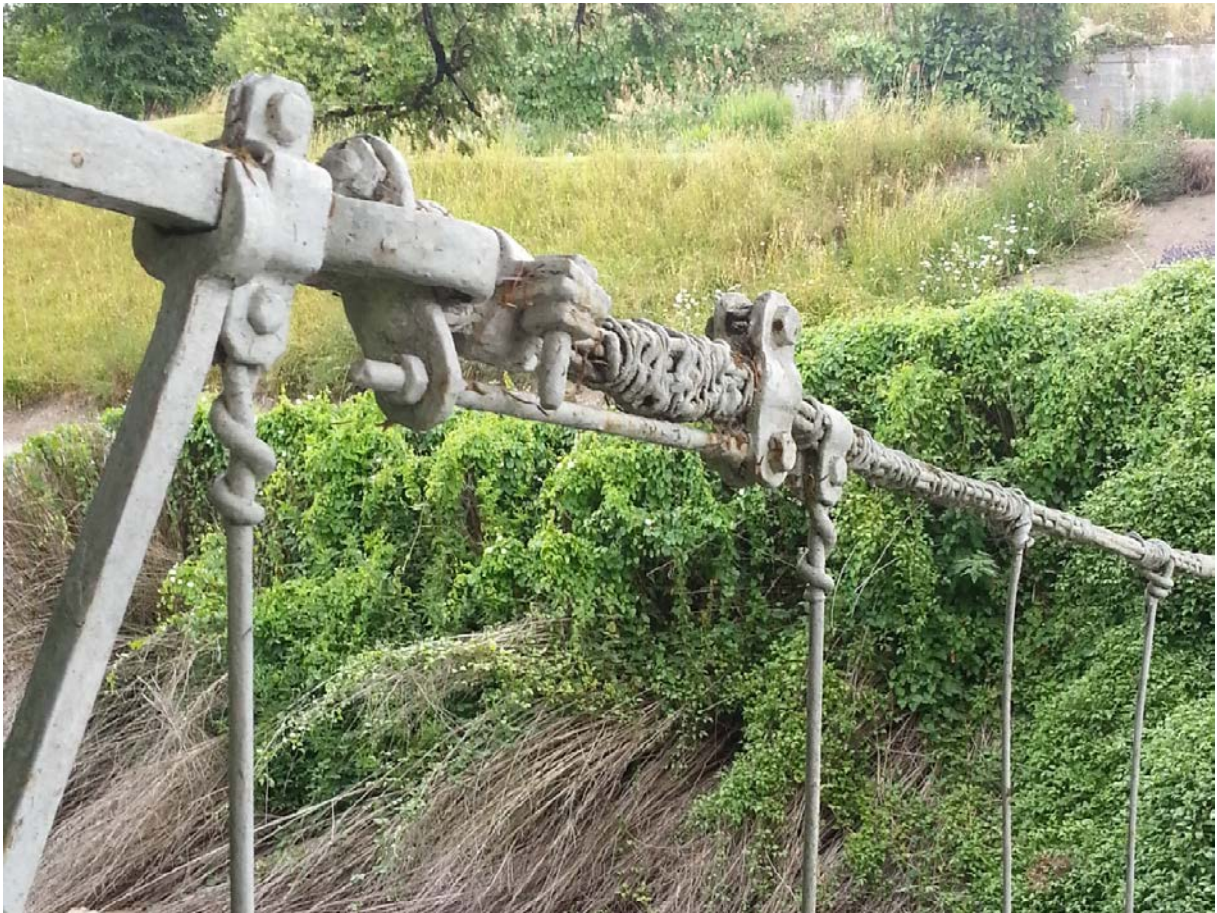
Fixing details – repairs over time. Note circular-ended connector, later repaired in Mackey’s

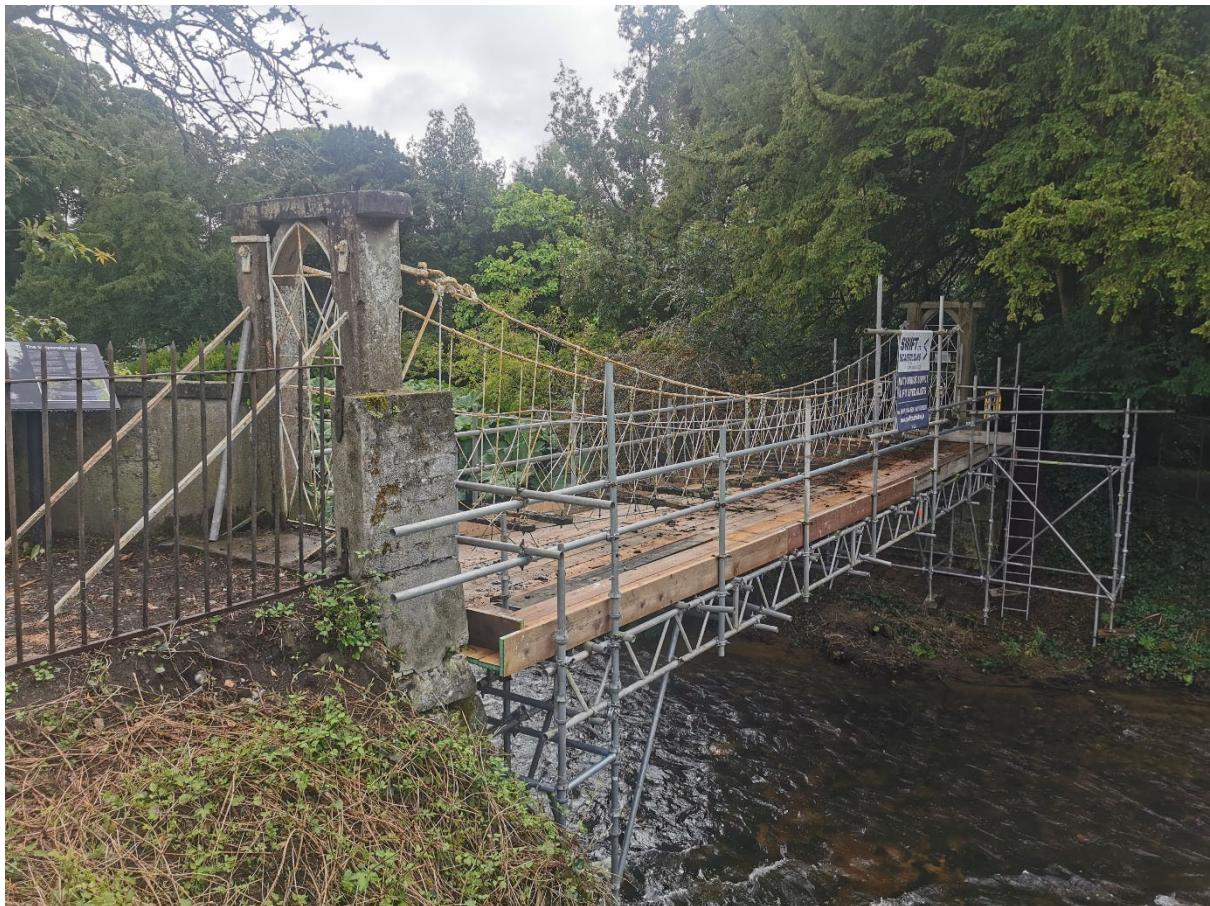
Scaffolding erected for bridge removal

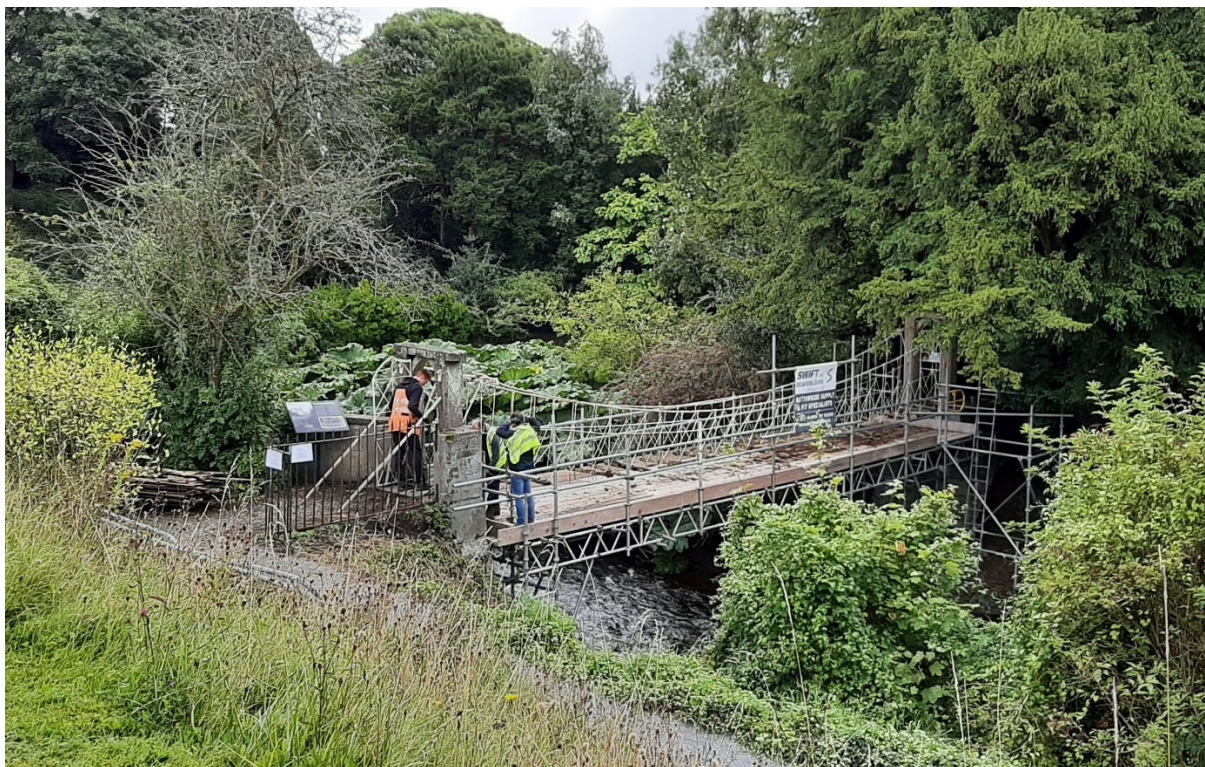
Bridge removed from site to Mackey's 2023_0828

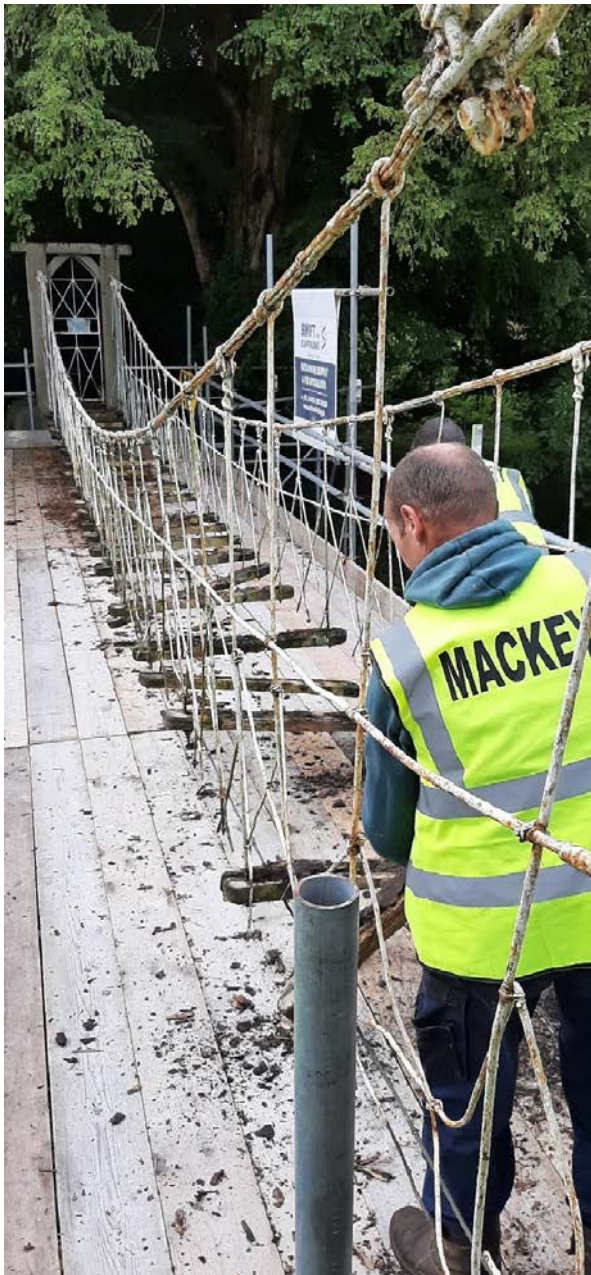
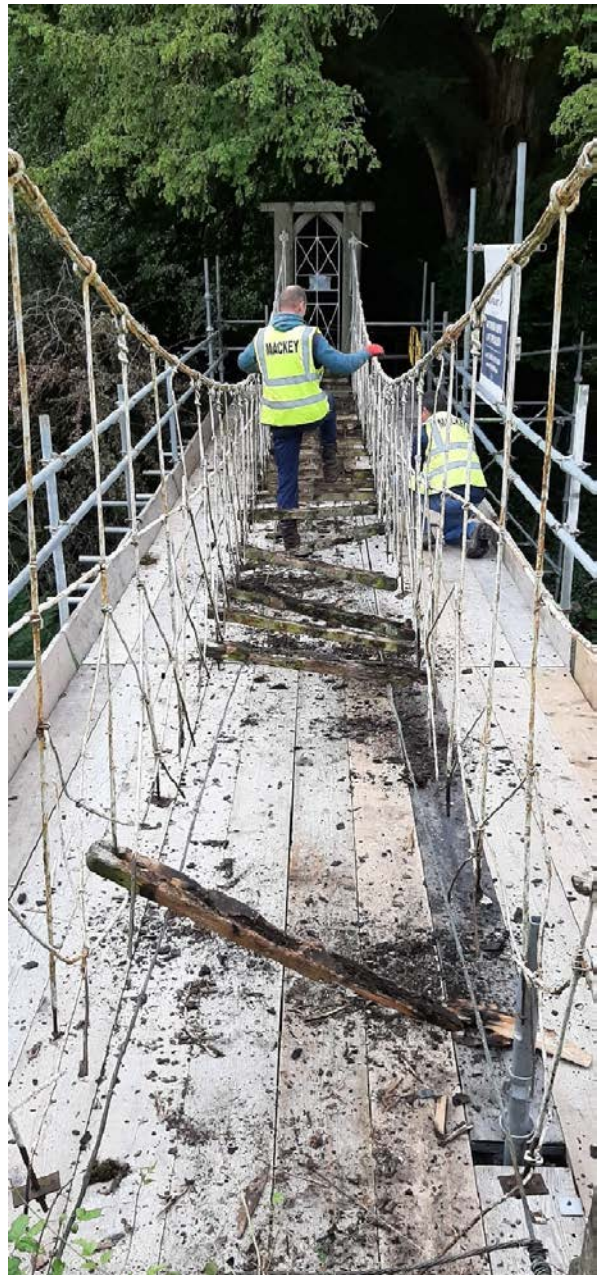
Custom frame made to support structure

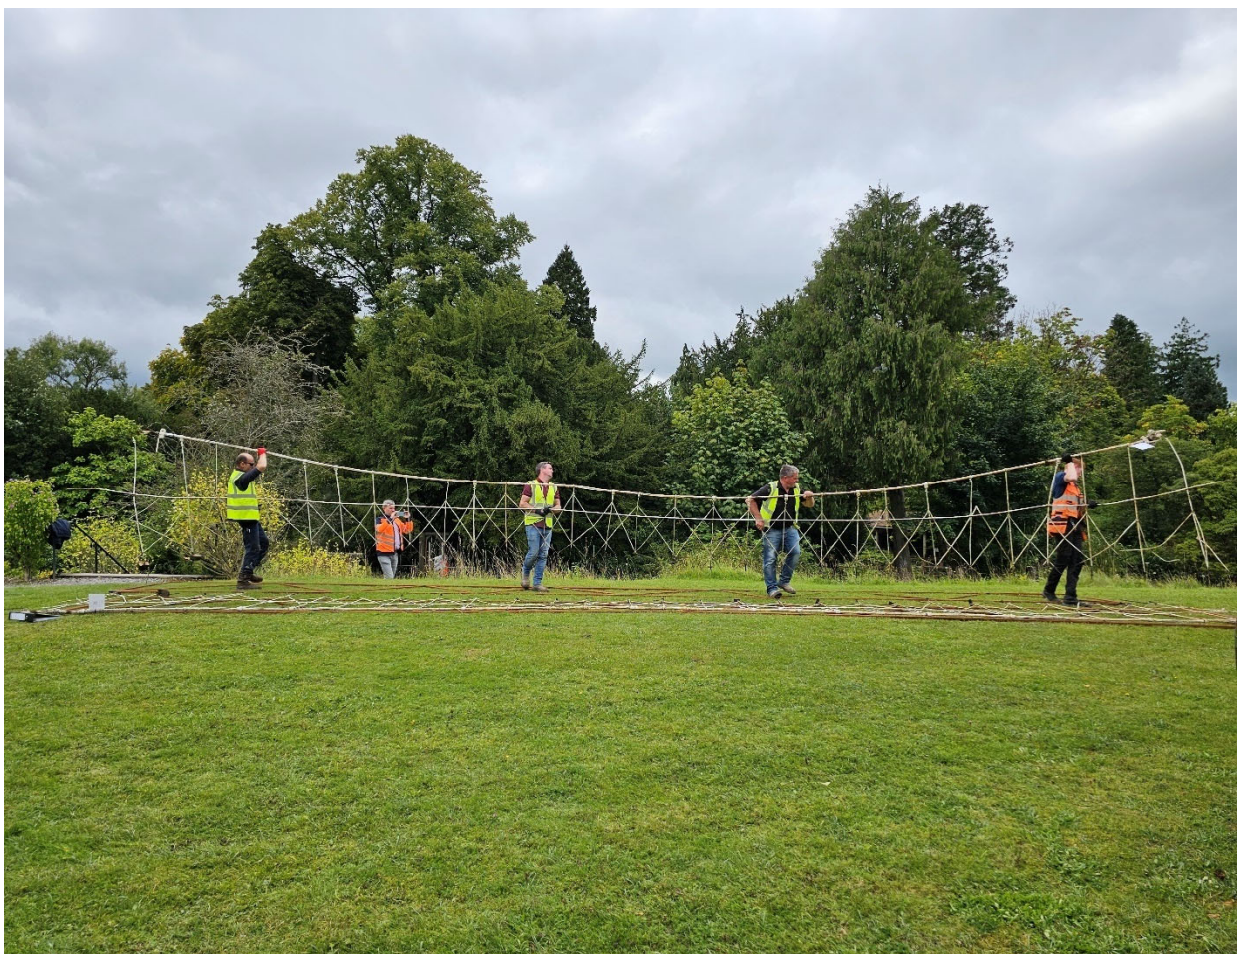
Bridge removed for setting on custom frame (frame also used in workshop)

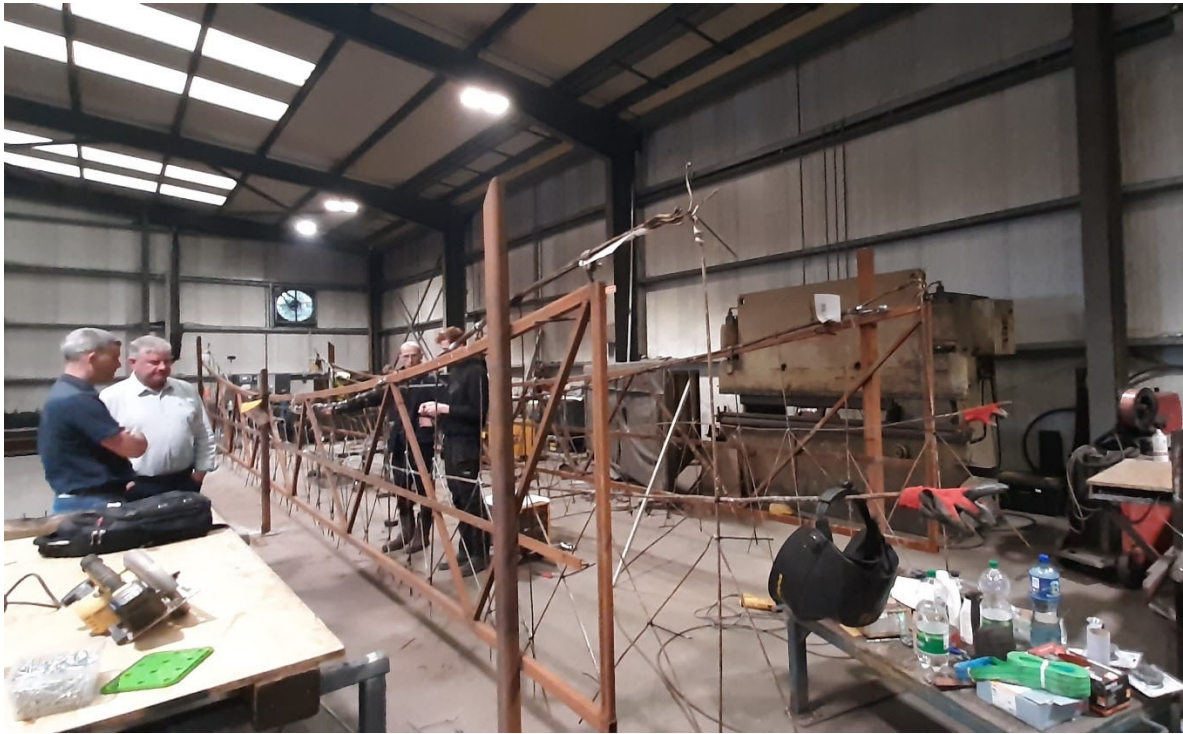
Both sides of suspension bridge, hanging on custom frame at Mackey's 2023_0911

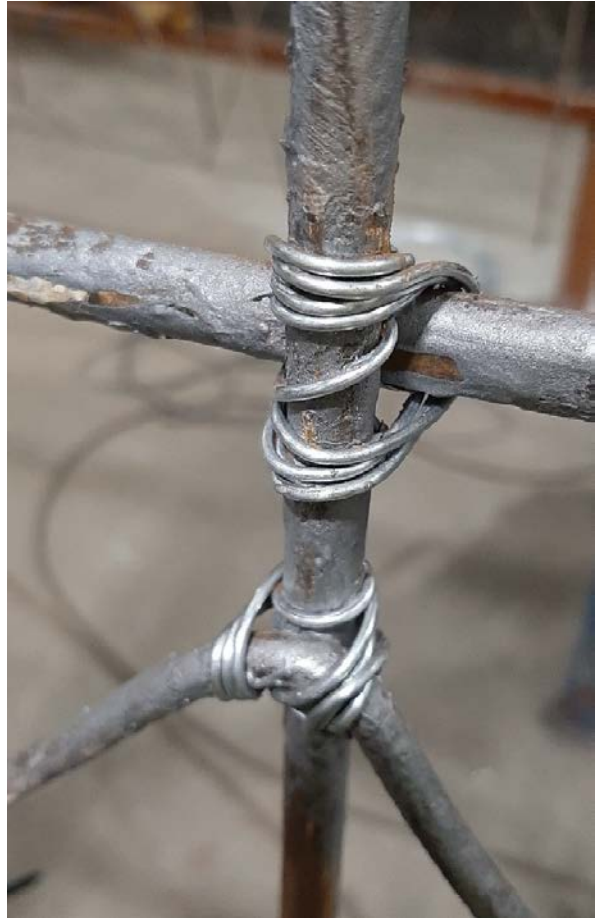
Repairs underway, new binding wire to strengthen structure

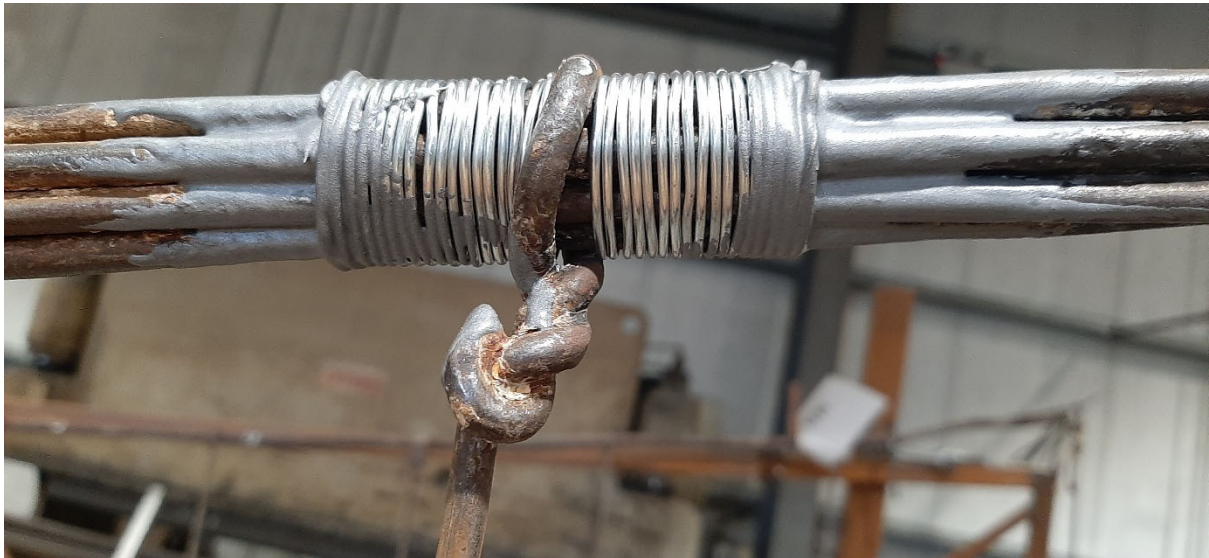
New binding wire under existing metal twists, to prevent future wearing through movement

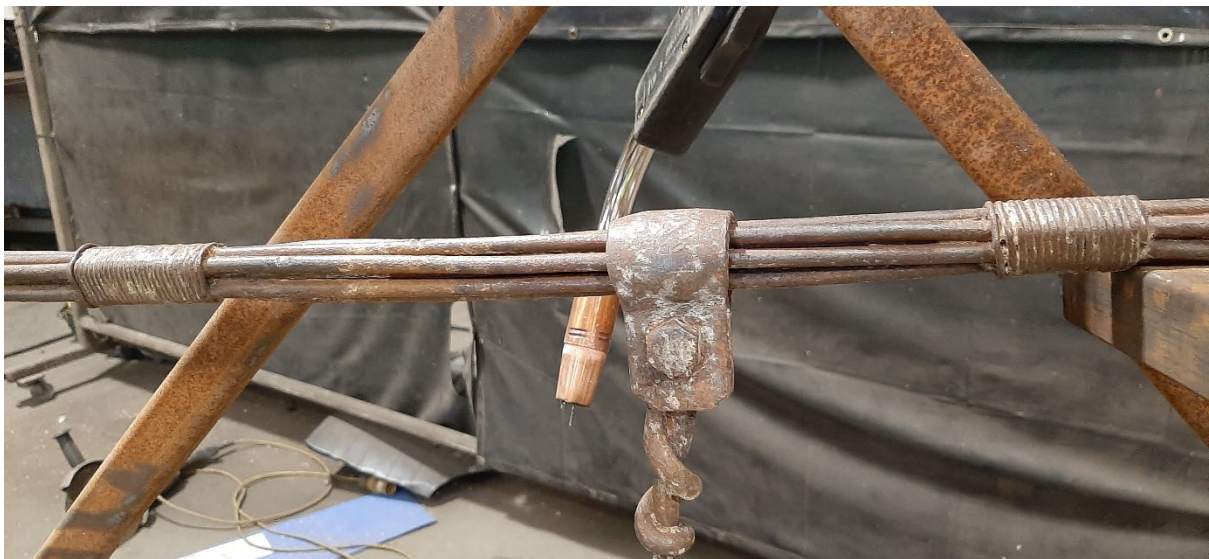
Existing binding retained where sound

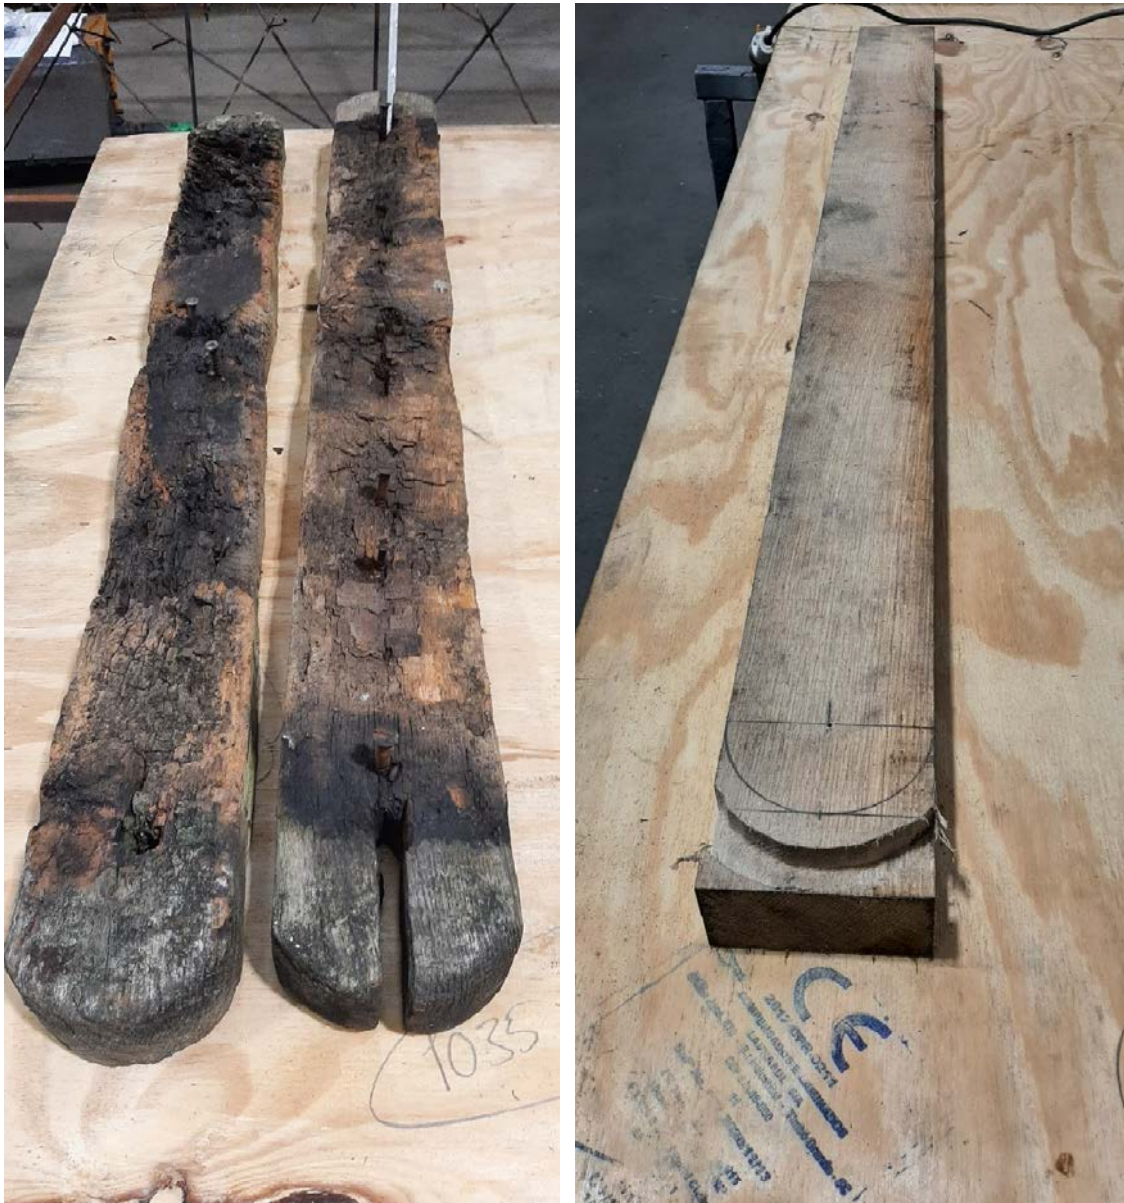
Existing timber deck cross-timbers used as replica for replacement sections

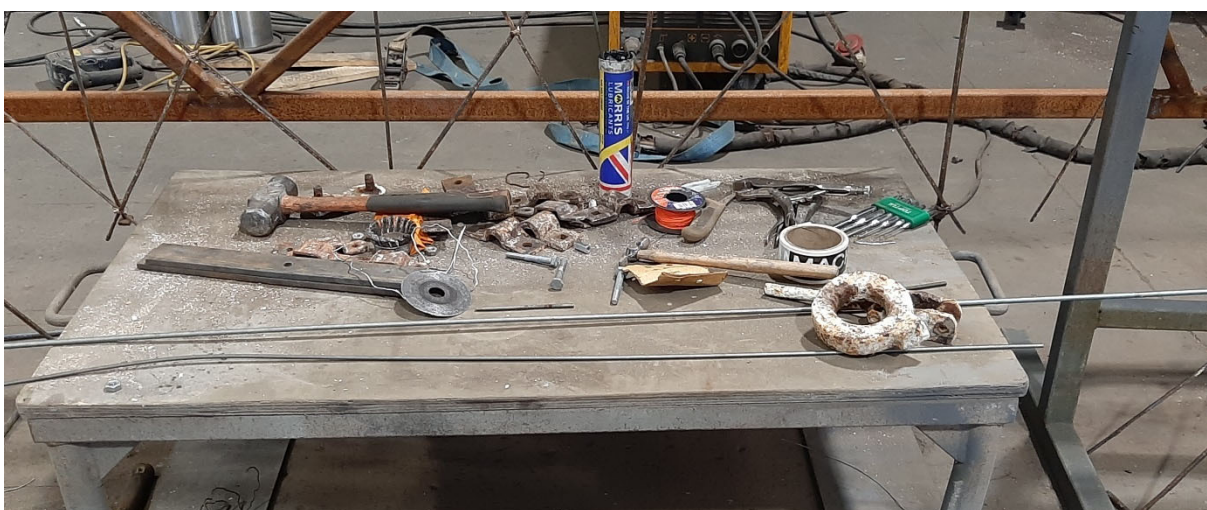
Circular-ended connector ready for new, replacement extension

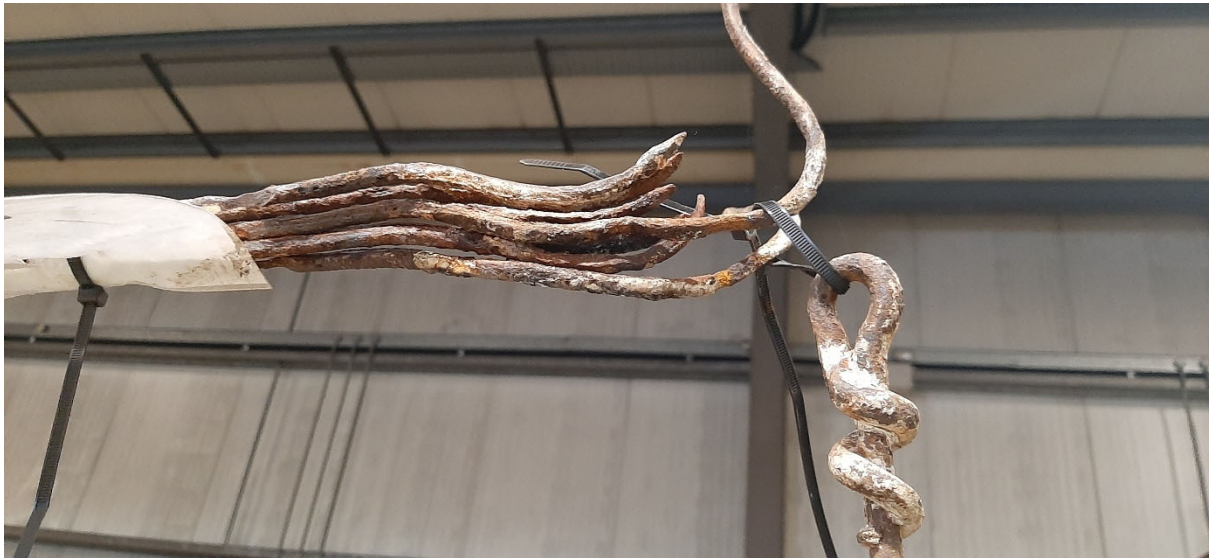
Top chord multi-strand – connecting detail required, proposed below

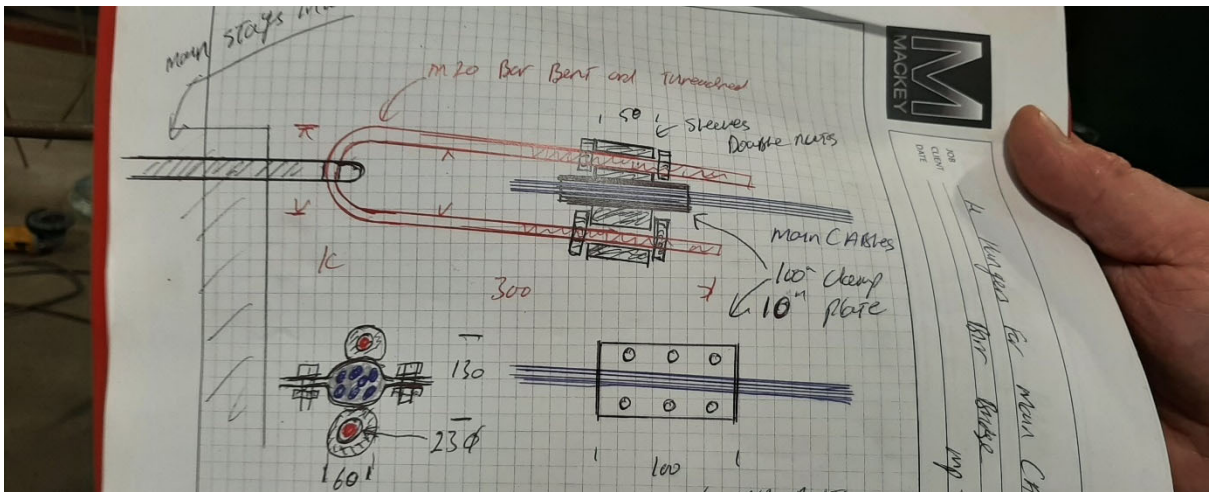
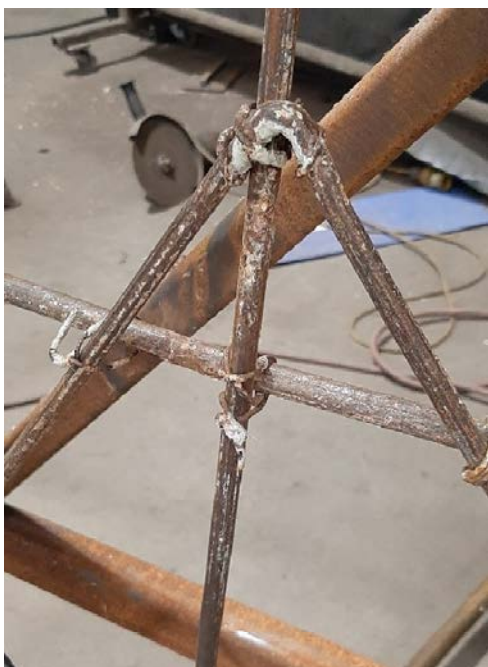
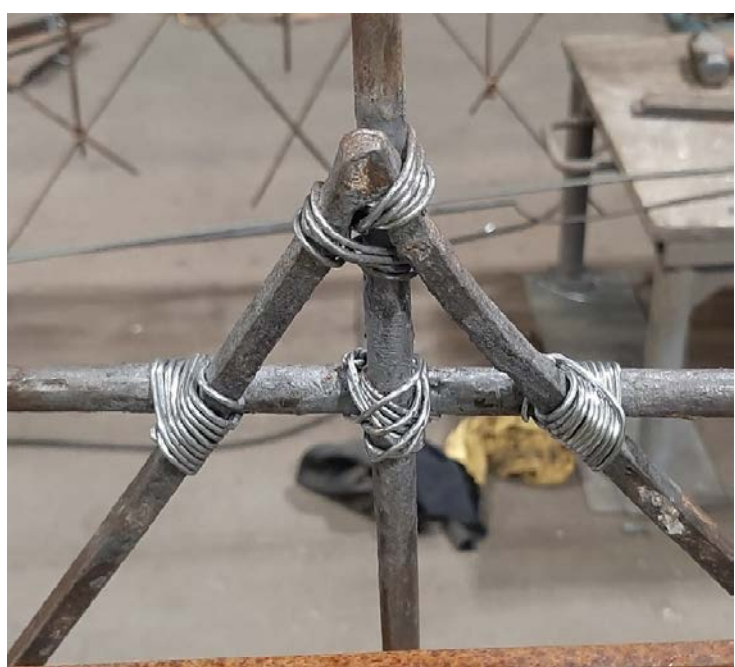
Existing and repair works

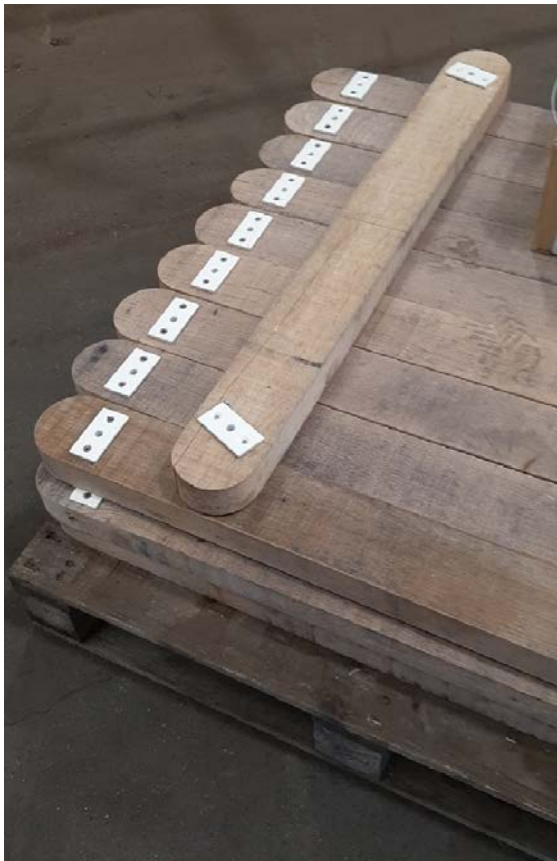
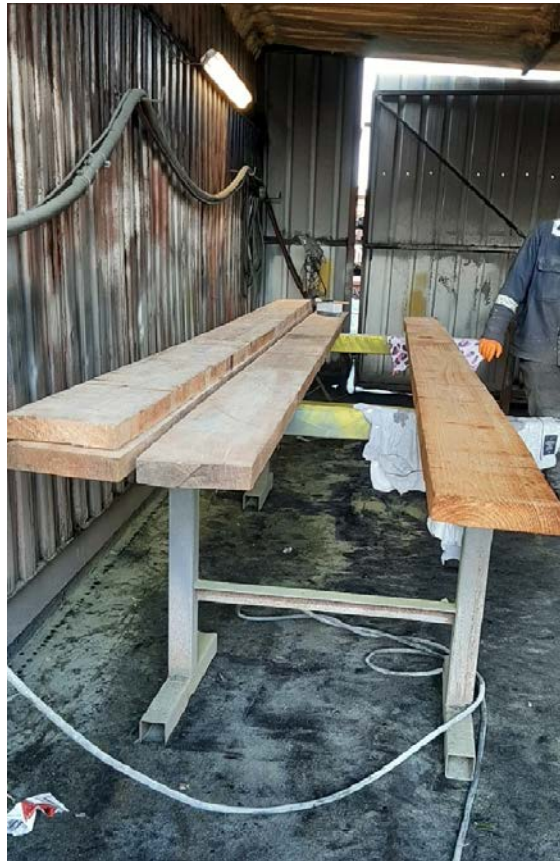
2023_0926 timber deck cross-timbers with underside fitting to allow for movement and timber decking prepared – all timbers from Birr estate

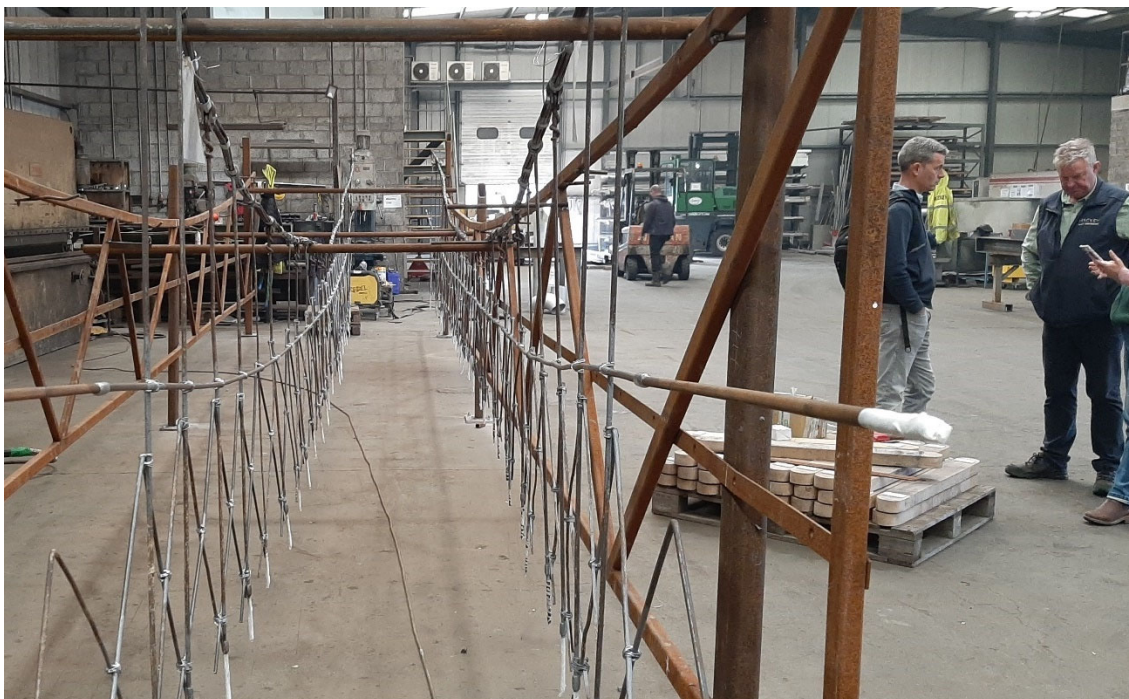
Frame considerably strengthened with binding throughout

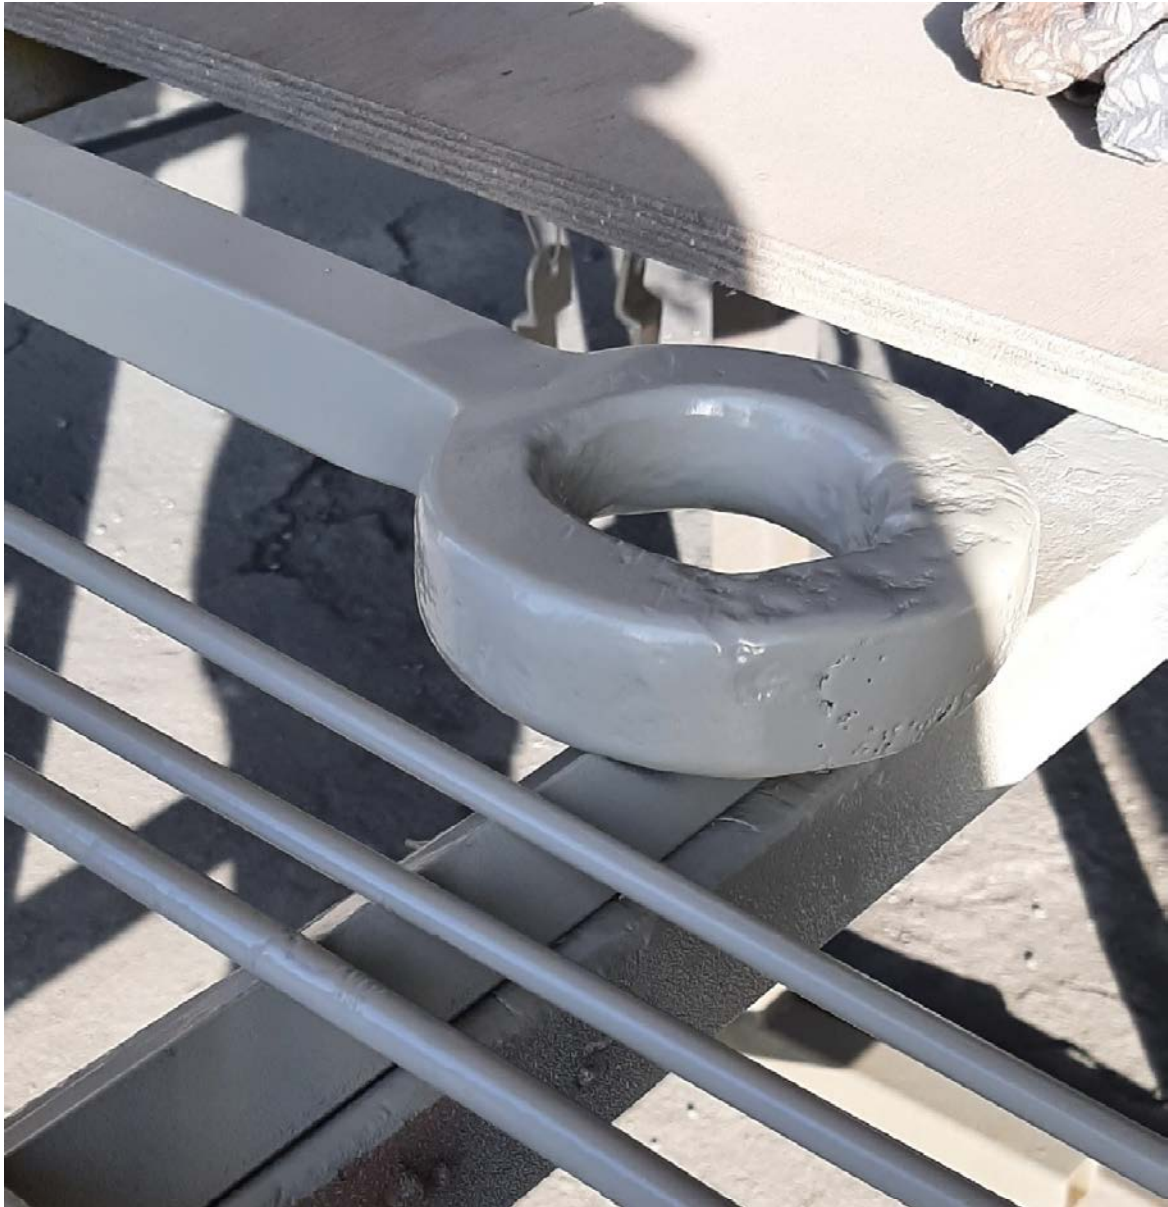
Circular-ended connector with replacement extension, first coat of 12y undercoat applied

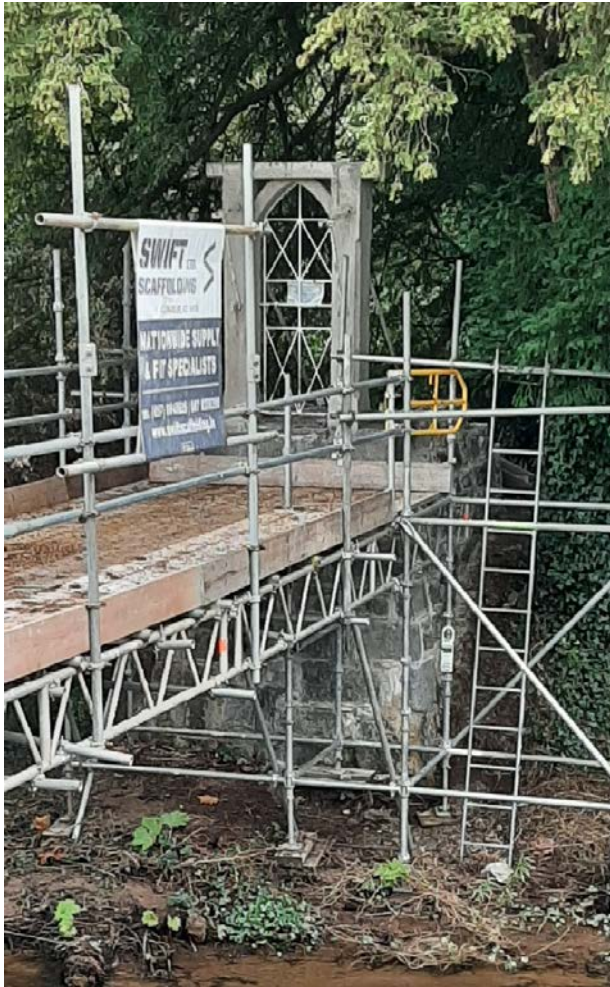
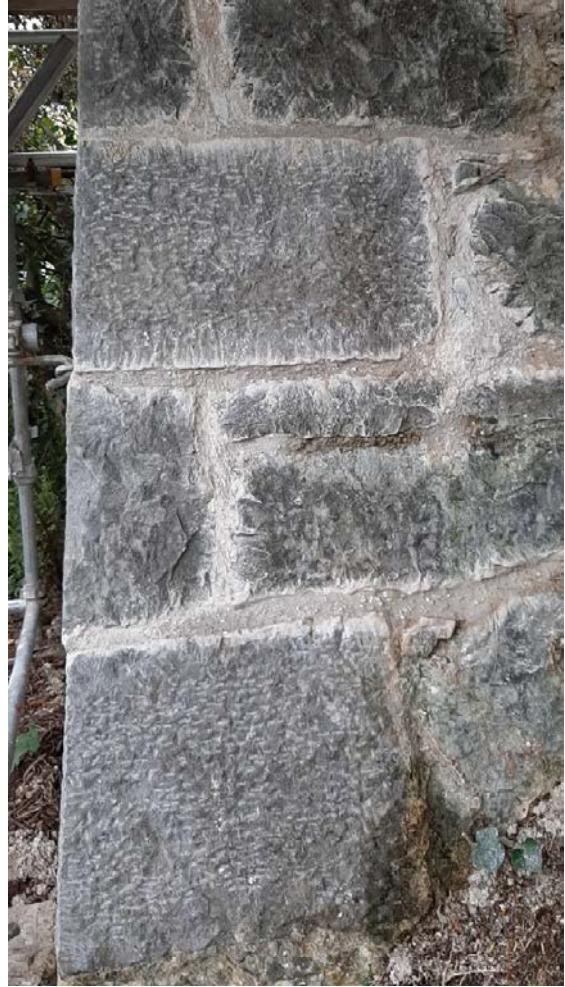
Both embankments repaired, including sloping side to far bank

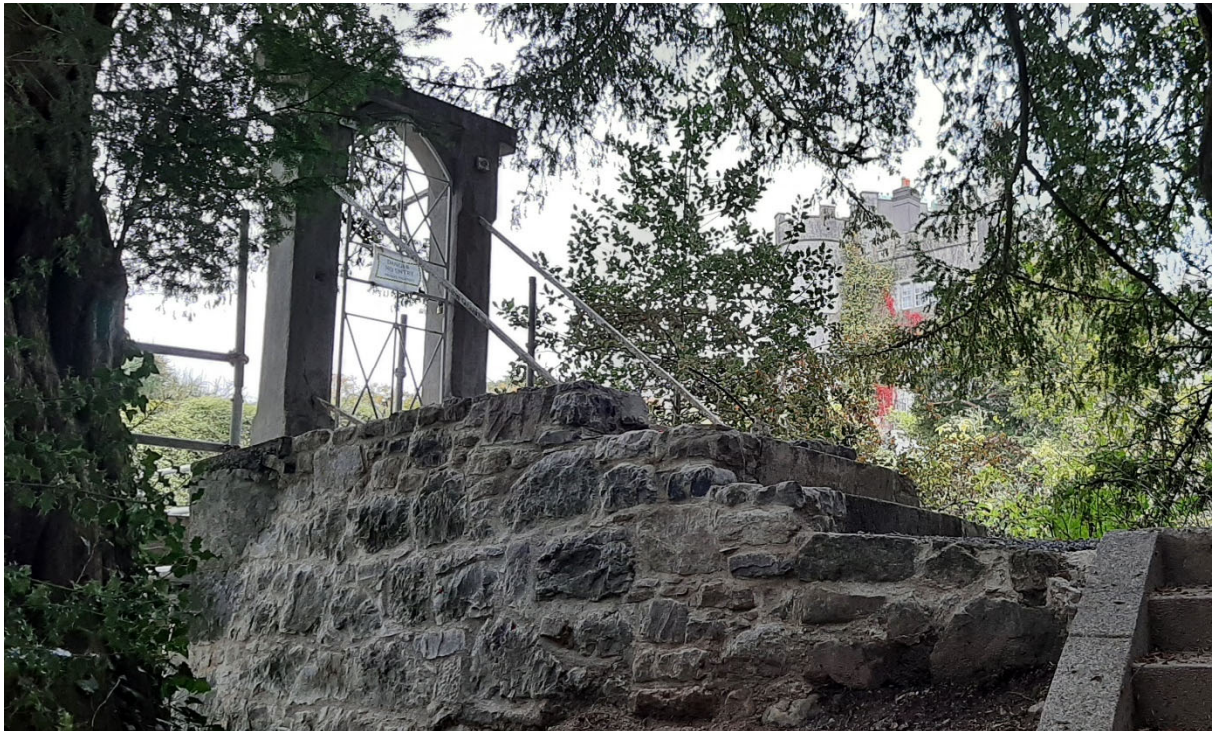
Raised embankment to far bank

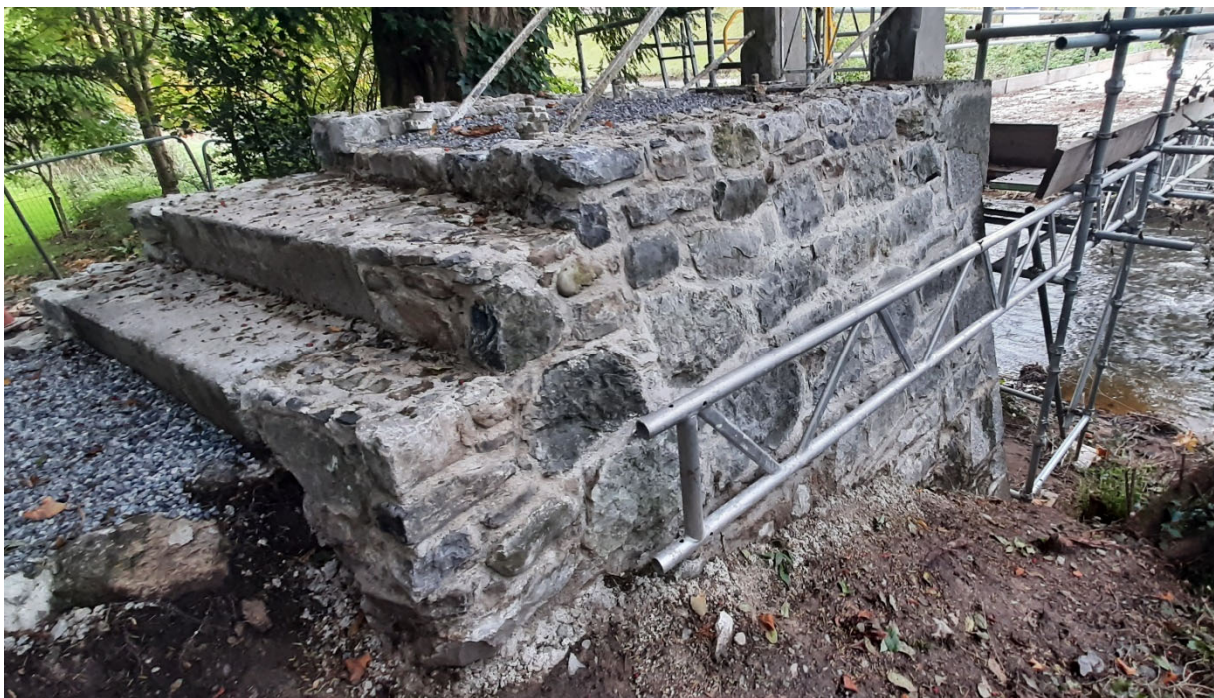
Existing stepped approach repaired

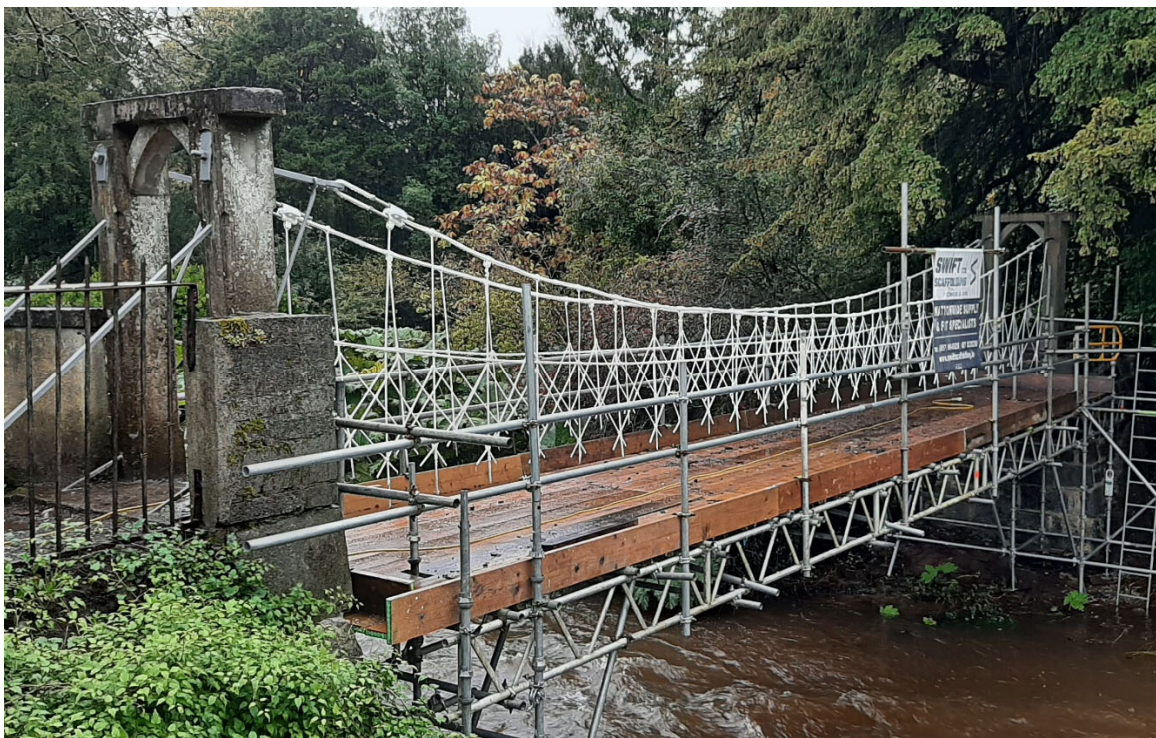
2023_1025 – timber decking fitted in place, final touch up of joints
