OCC Local Authority application – Stream 2 – Birr Suspension Bridge

**Appendix III
FORM B
LOCAL AUTHORITY FINAL REPORT**

Summary	
Brief Description of Proposed Works	Repairs to nationally significant single-span suspension bridge at Birr Demesne	
Briefly summarise why the local authority considers that this project qualifies for this scheme having regard to:	<p>1. The bridge is one of only two suspension bridges in Offaly and is earlier and larger than the bridge at Kinnitty Castle. It is of significant technical interest as a rare surviving example of a multiple-wire cable suspension bridge, possibly the earliest surviving in Europe as it dates between 1821 and 1825. It is also significant in terms of its historical association with the innovative Parsons family. The bridge also lends interest to the riverscape and it contributes to the group of structures within Birr demesne by providing access across the River Camcor.</p> <p>2. Efficacy to enable repair of this nationally significant structure and with managed access will allow for its use once again. It will support the investment of private capital, encouraging and assisting the conservation this prominent, structure for com

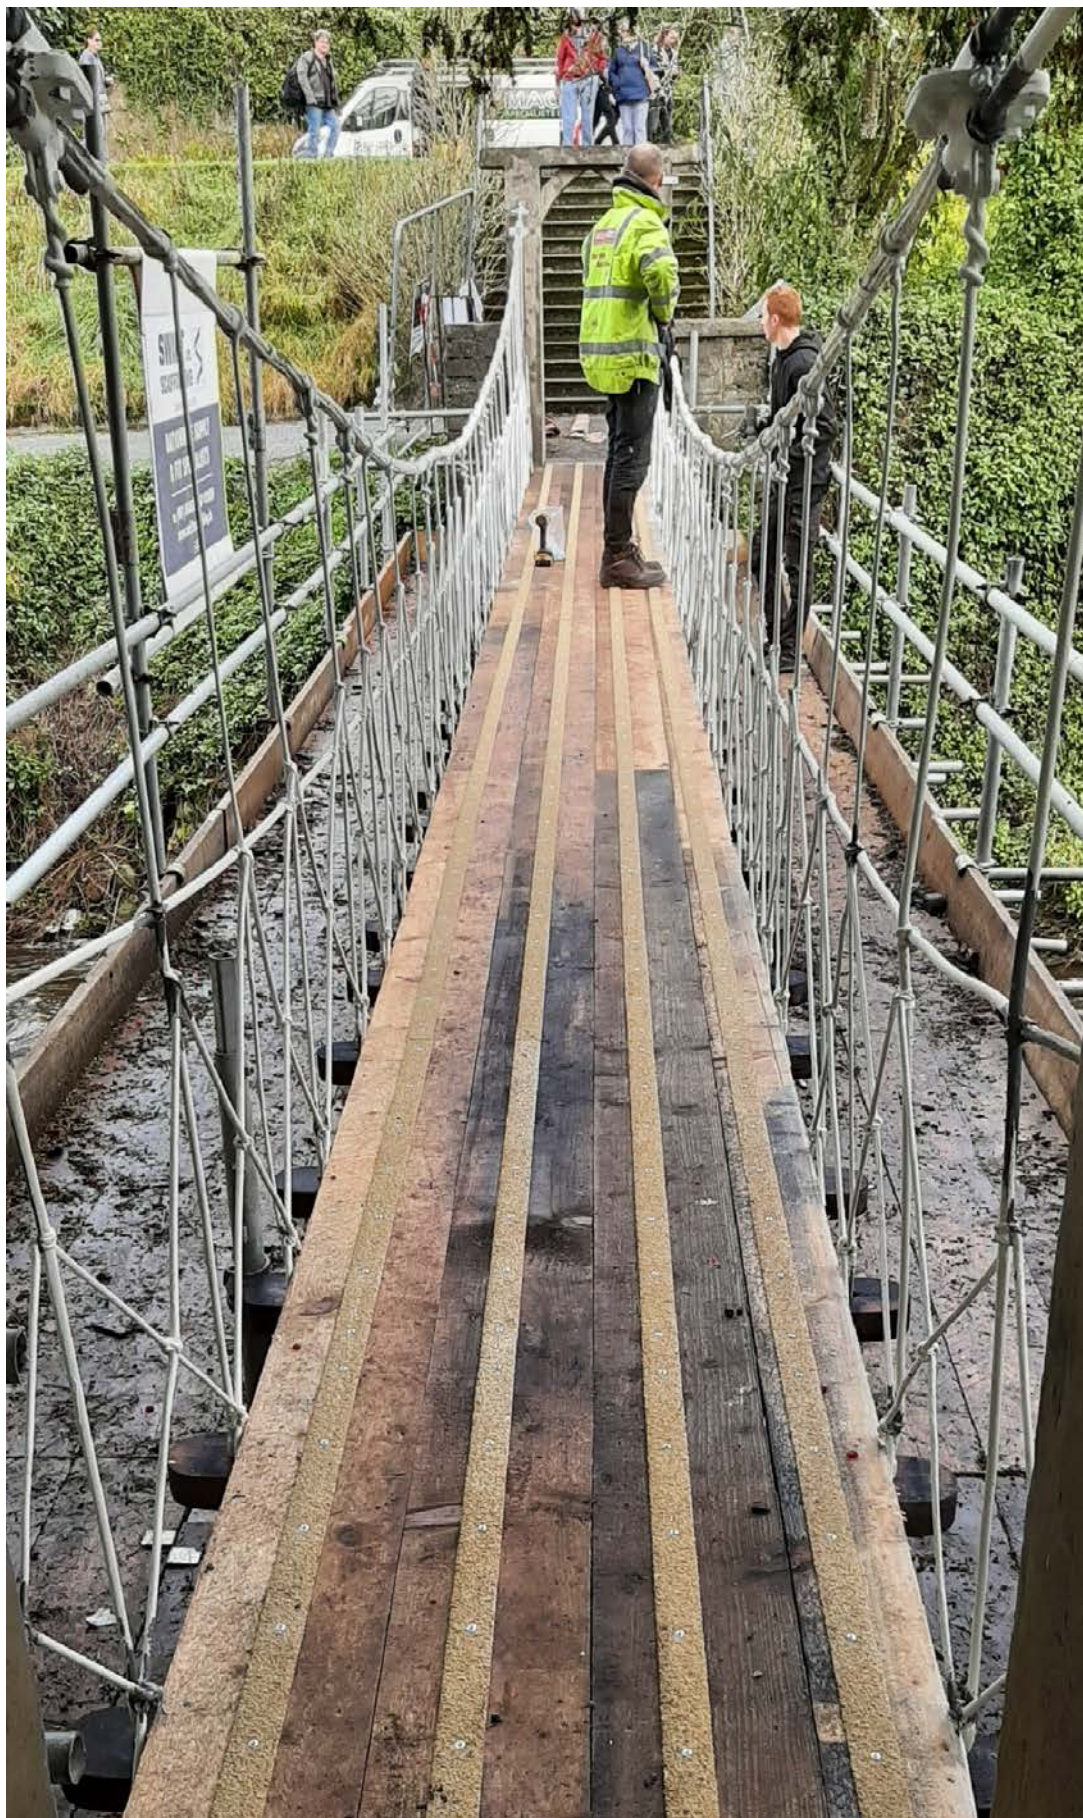
Decking with non-slip finish
