STRUCTURES AT RISK FUND CIRCULAR SRF/2017 OffalyCountyCouncil– SRF17-52KeepGate

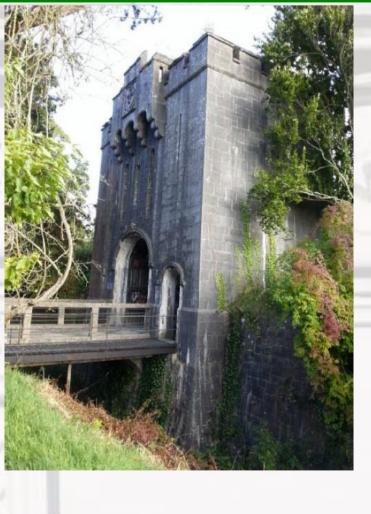
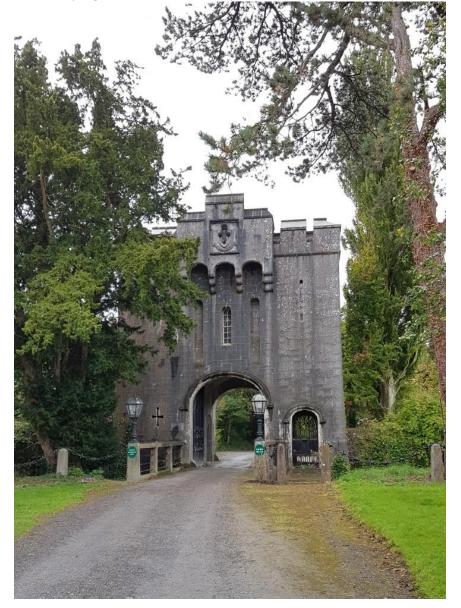
• Work has progressed well at the Keep Gate Birr and is now complete.

• The castellated parapet has been repaired by stripping back the existing damaged finish, re filling each castellated section and topping with a strengthened lime mix.

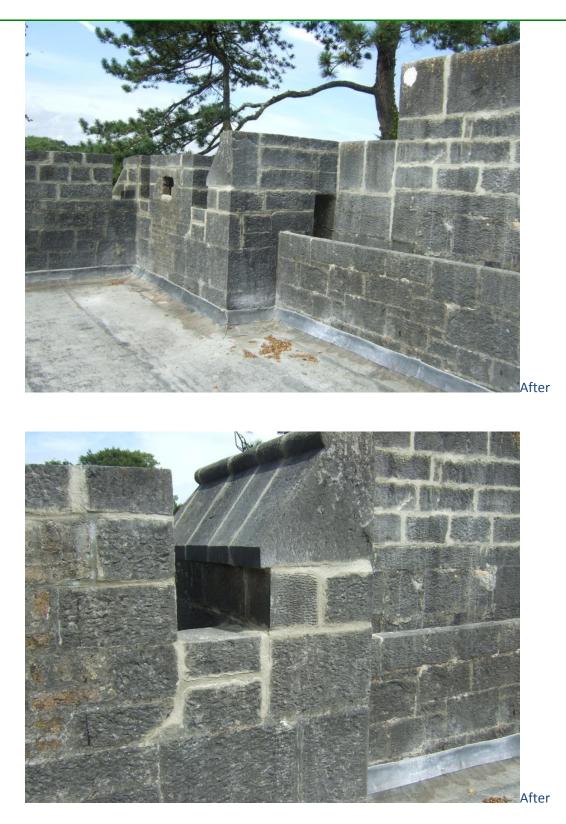
• The areas of damaged mortar have been repaired on all four sides of the high parapet and on the stone capping.

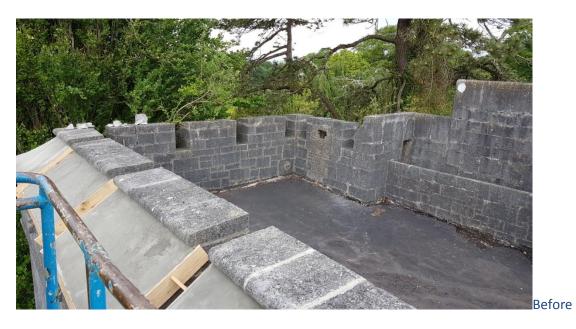
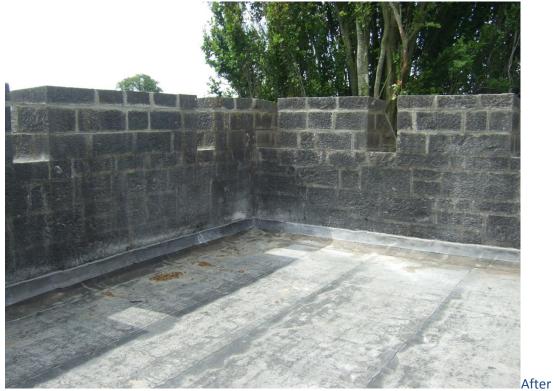
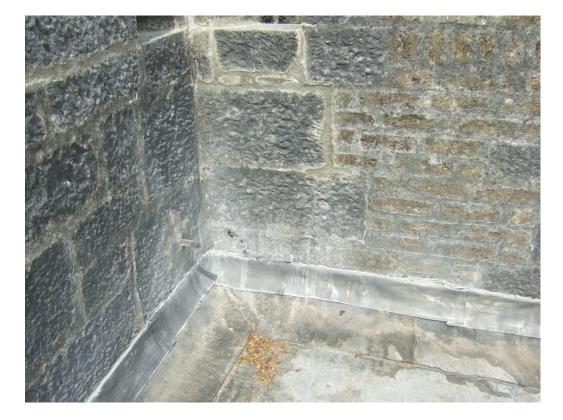
• Lead flashing has been installed to assist water run off onto the flat roof
