Appendix III

APPLICATION FORM B

Final Report – October 2019

HSF1976
Keep Gate, Birr Demesne
Co. Offaly
Stream 1

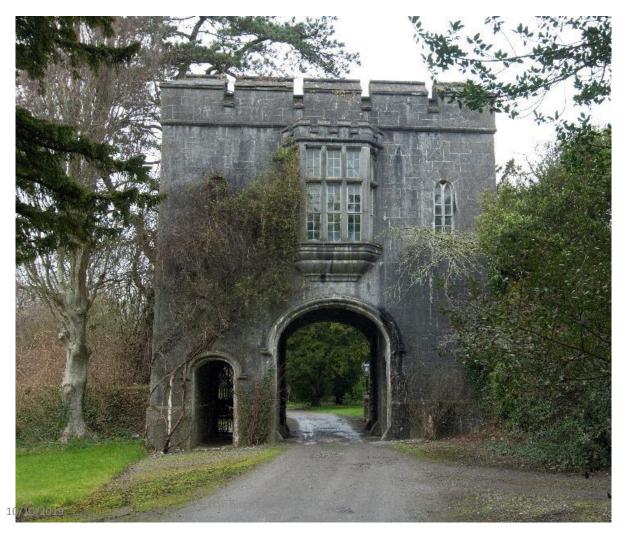
Works have been completed – David Kelly conservation consultants with Dermot Clancy carried out initial works in the form of external repointing and leading above the window. This work was completed in May.

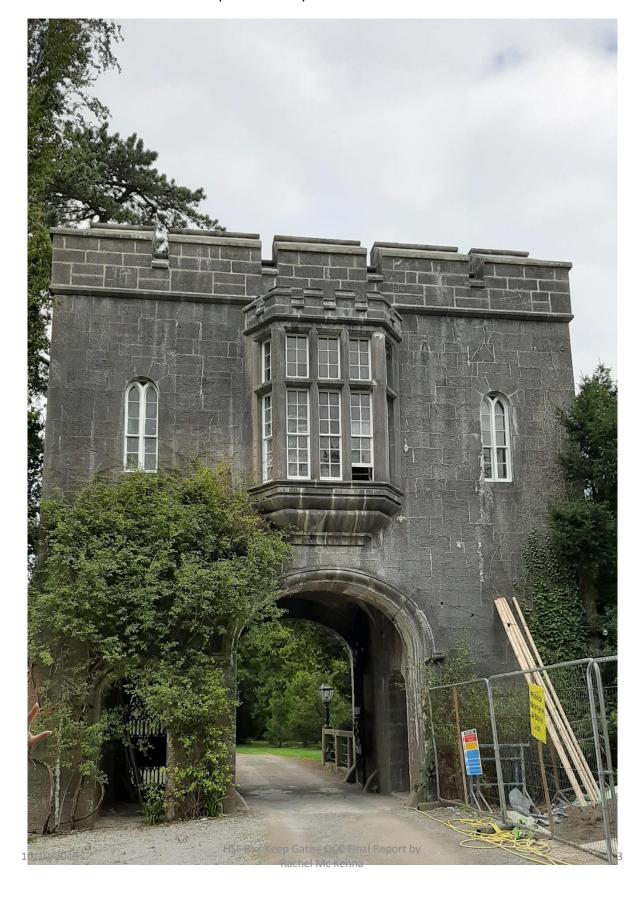
Extract from Method Statement by David Kelly Partnership with Margaret Quinlan Architects

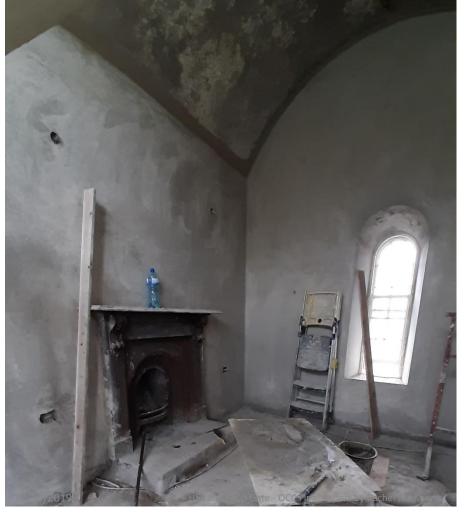
A steel flue has been installed and the chimney cleared ensuring a viable fireplace in the main central room.

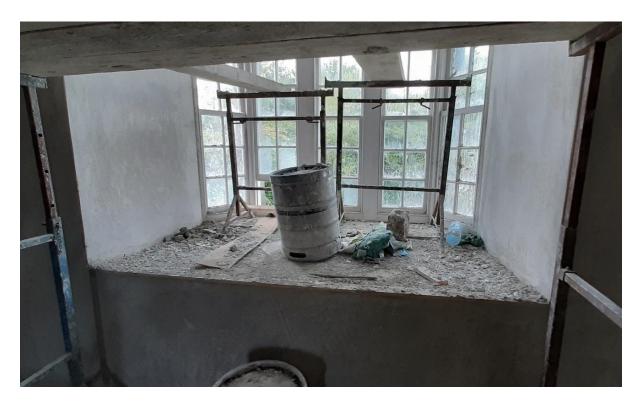
Due to future plans for the stairs the consultants decided to not proceed with opening up the roof access and have decided to work on sealing the internal windows instead.

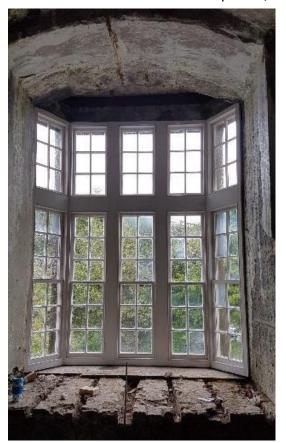
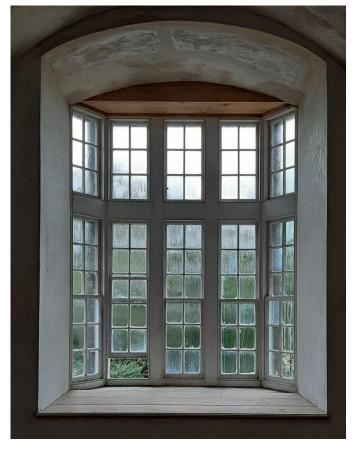
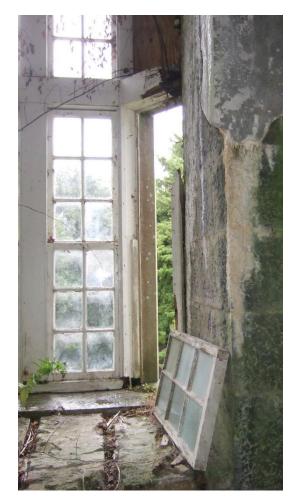
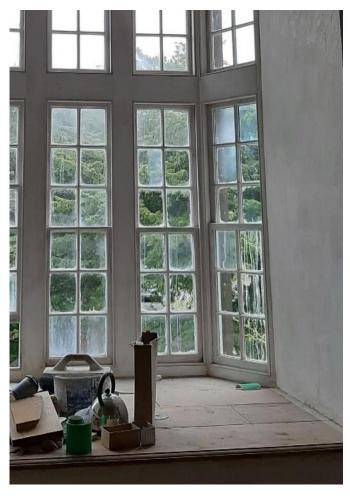
Before + After – Window: Lime plaster, timber sill and head.

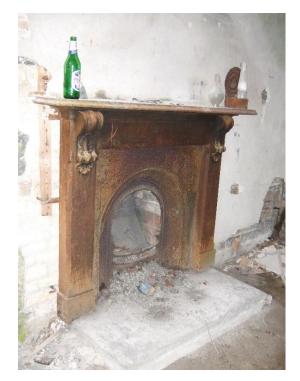
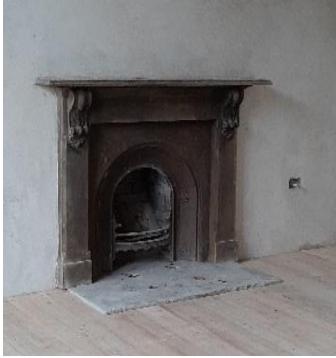
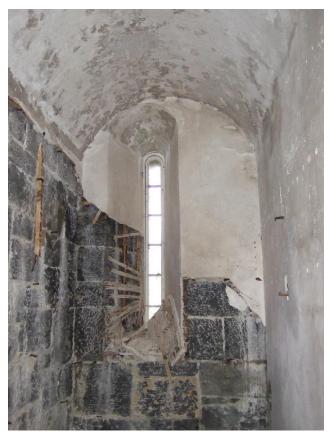
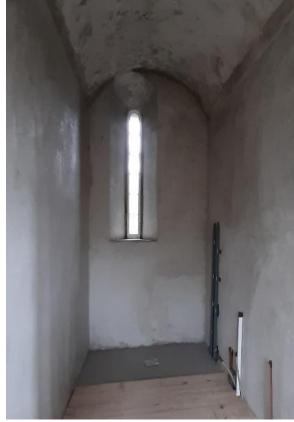
Before + After – Fireplace restored and small ante room with lime plaster and original ceiling

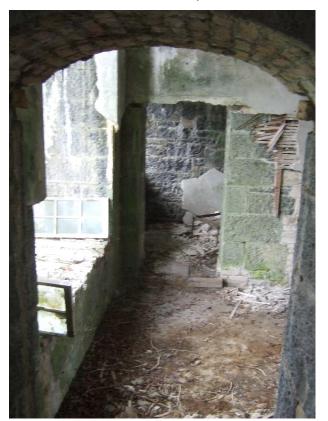
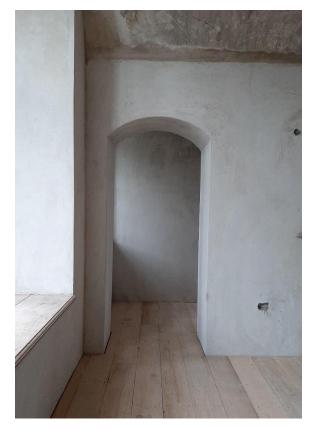
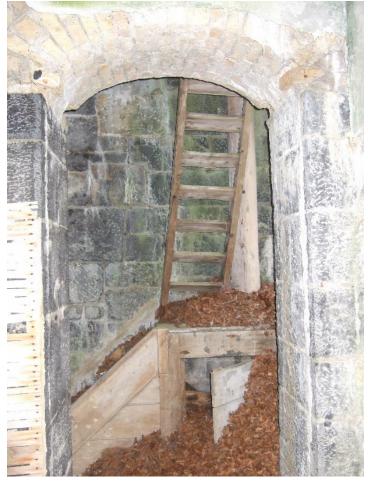
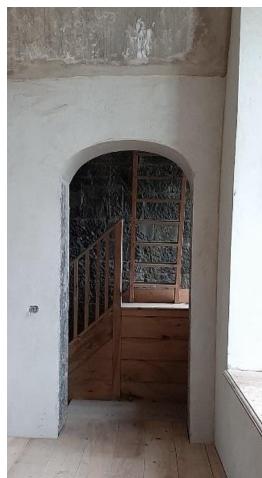
Before + After –Walls: lime plaster and timber floors

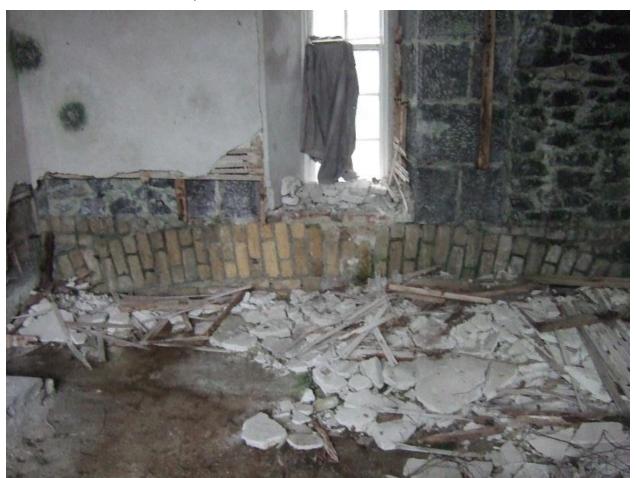
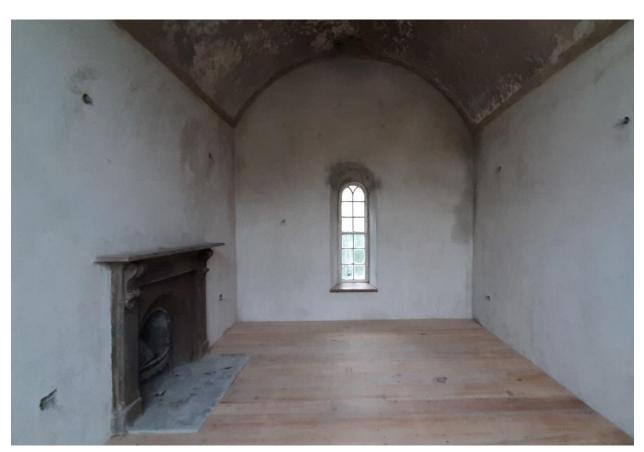
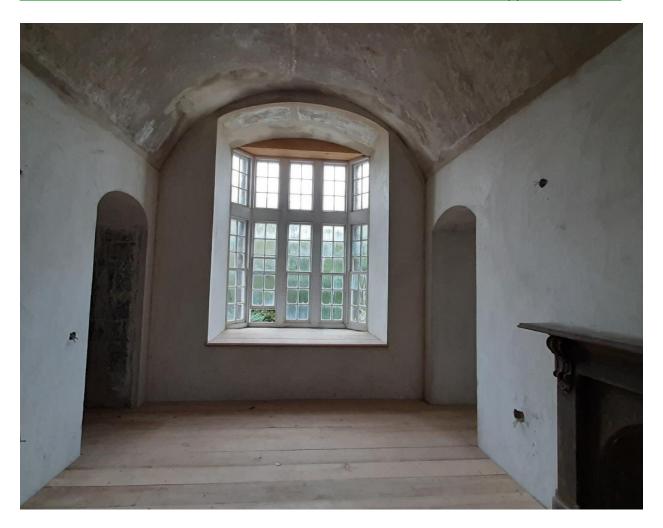
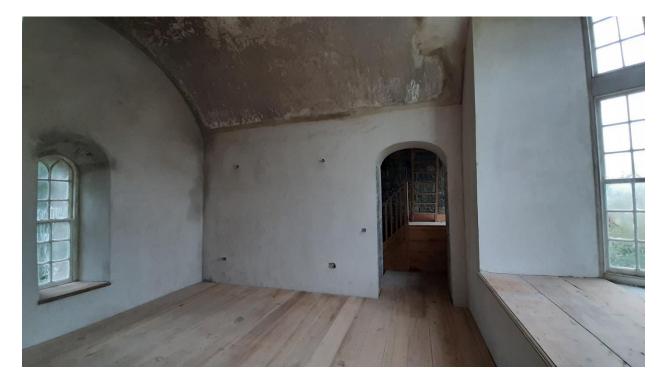
Before + After –Walls: lime plaster and timber floors

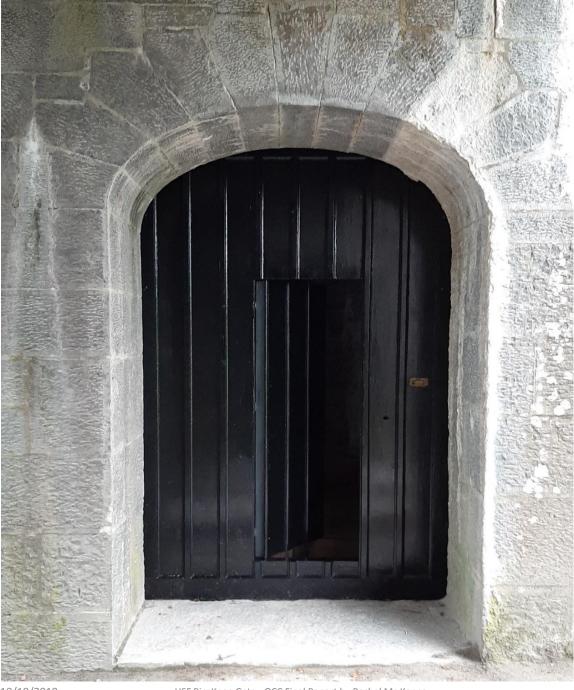
Before + After - Original sliding door repaired with new wicket door incorporated
