Ballycumber Folly

Conservation Works 2019

- In 2018 the owner commissioned a report on proposed repairs to the folly carried out by Southgate and Associates
- Works commenced on site in July 2019 with Clancy and Partners
- Phase 1 Repair existing, 2019
- (Phase 2 Options for roof reconstruction)
- Funding was secured as follows to carry out Phase 1:
 - Owner
 - Creative Ireland
 - Irish Georgian Society
 - The Follies Trust
 - Offaly County Council

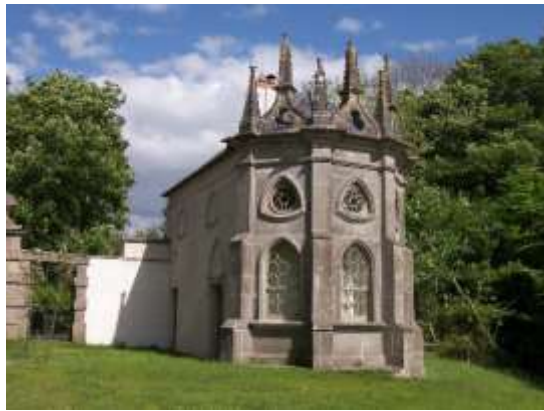
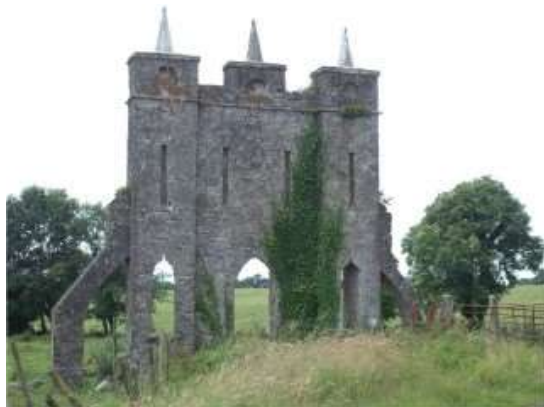
1. Ground clearance – internal and external

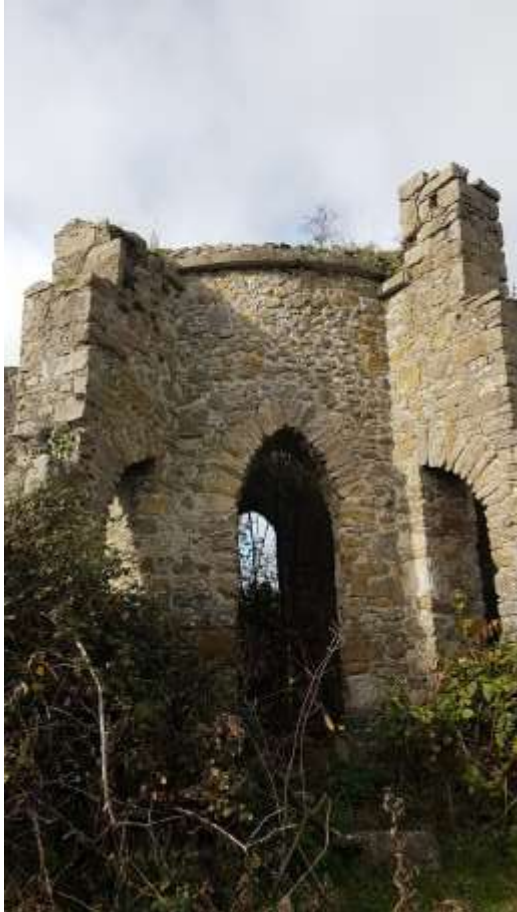
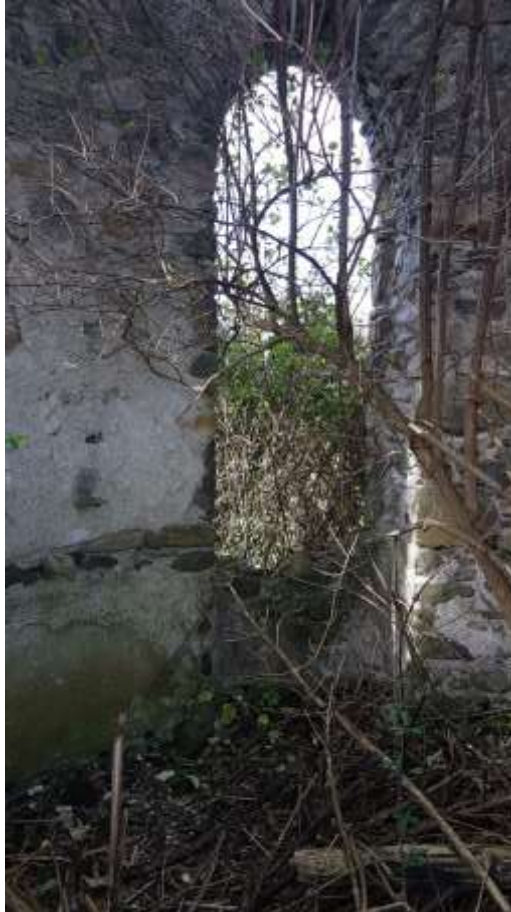
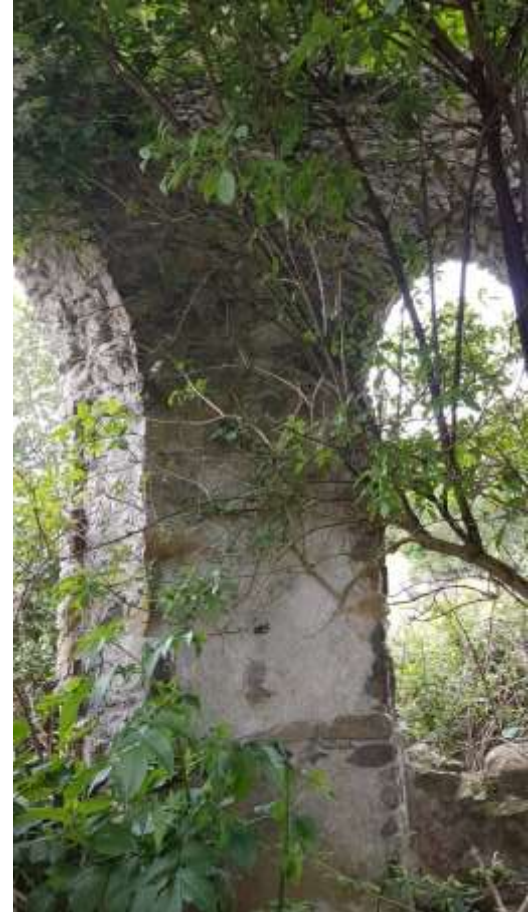
2. Vegetation removal and Scaffolding

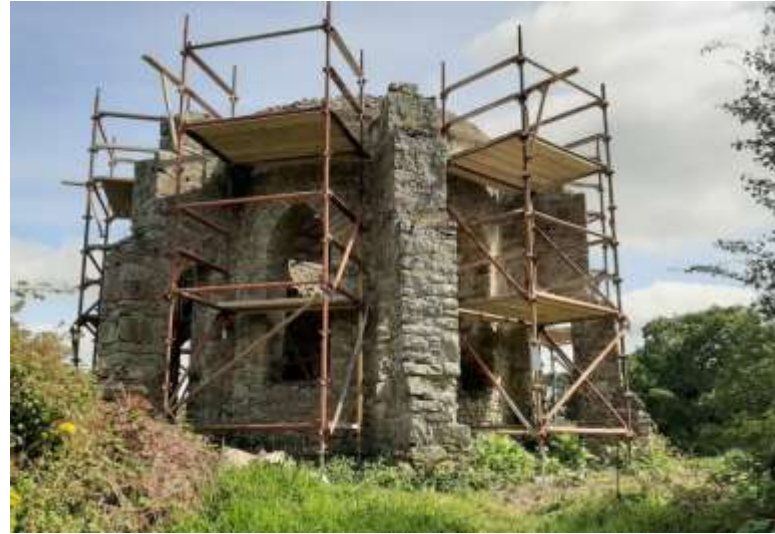
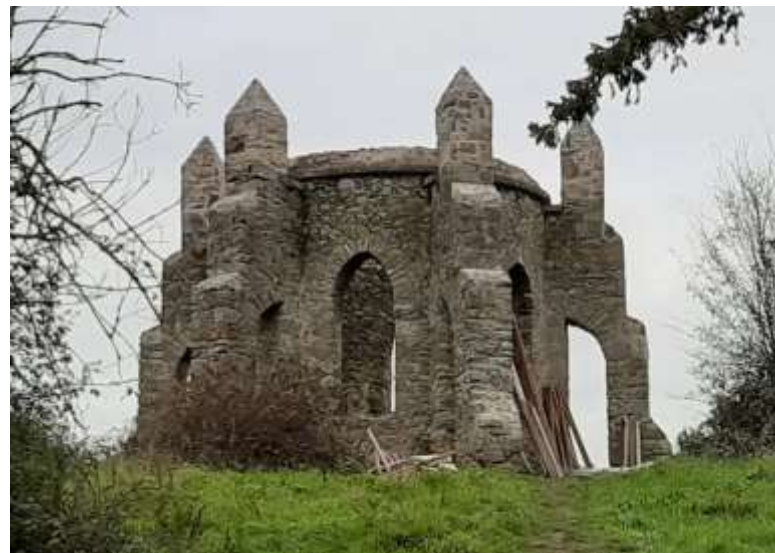
3. Consolidation of stonework

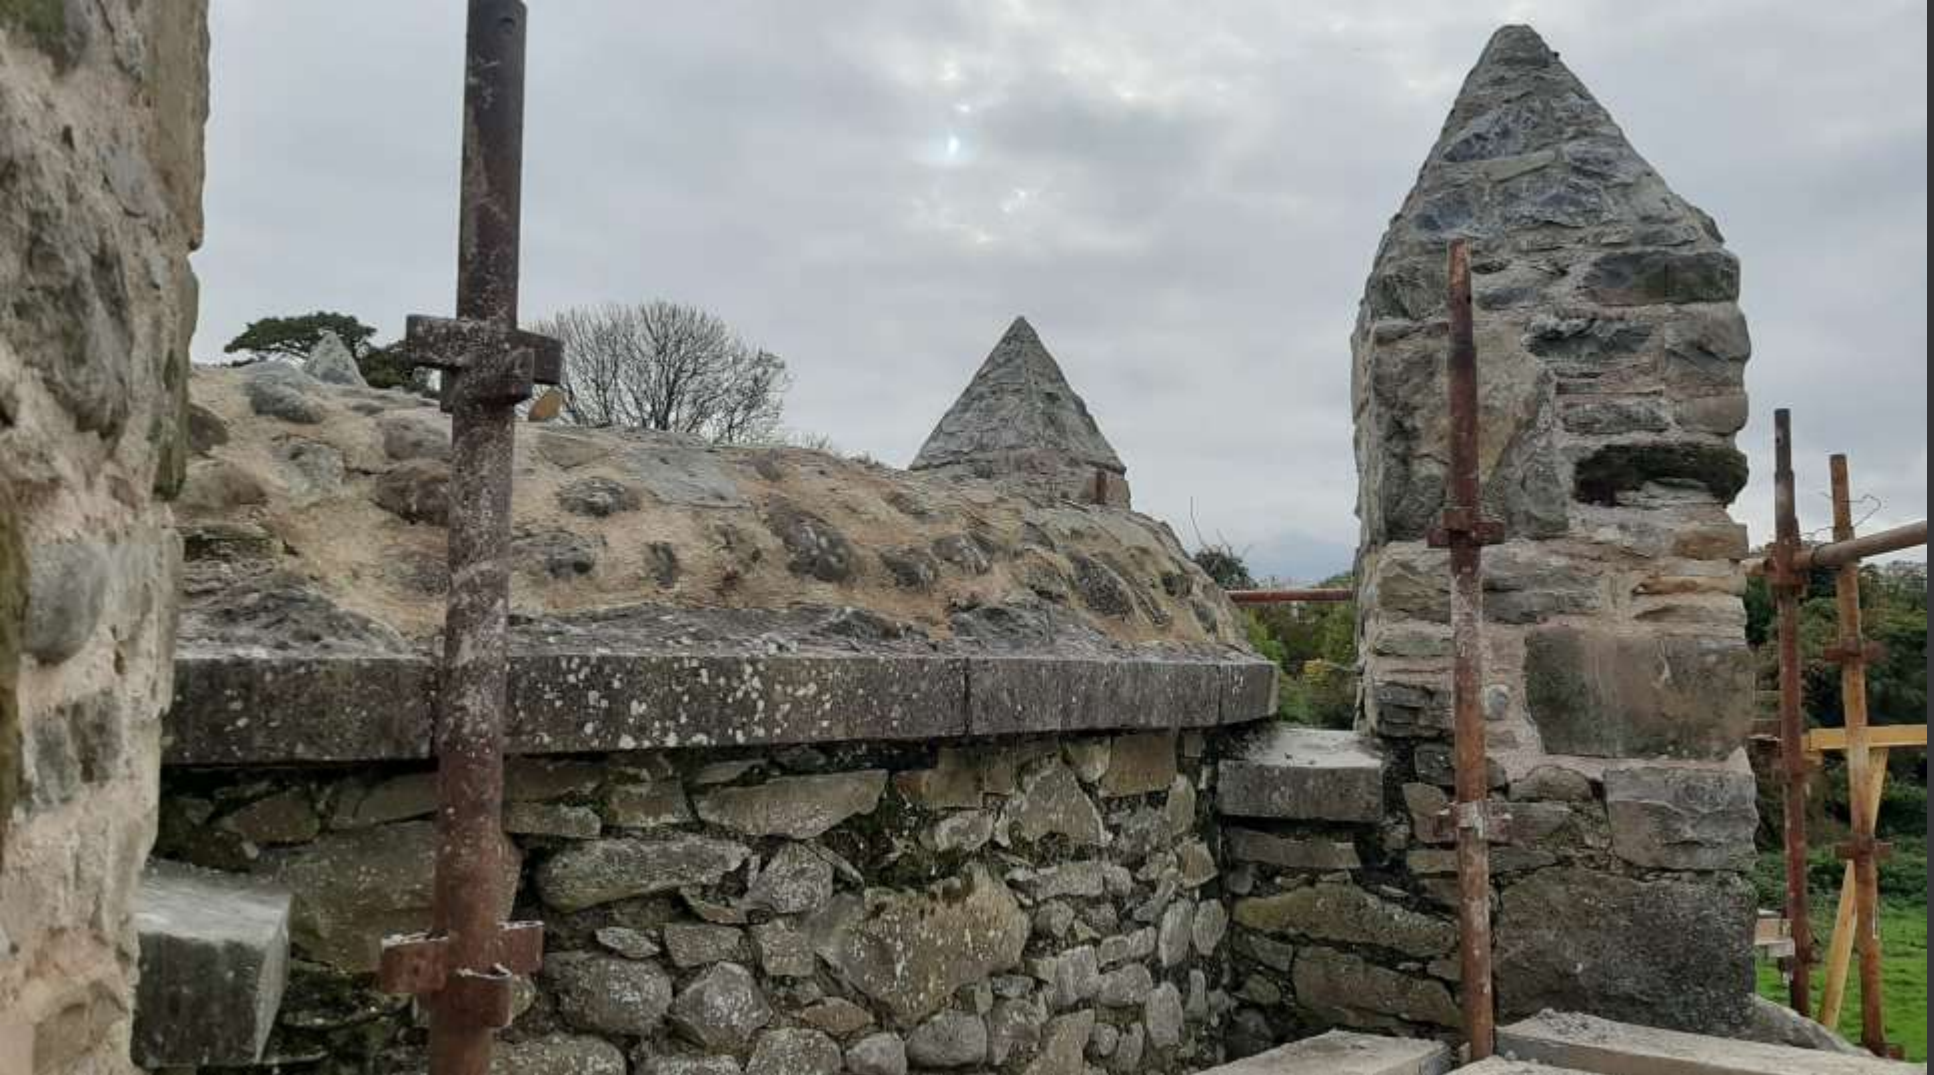
Site photos 2019_1022

Consolidation and Buttress repair

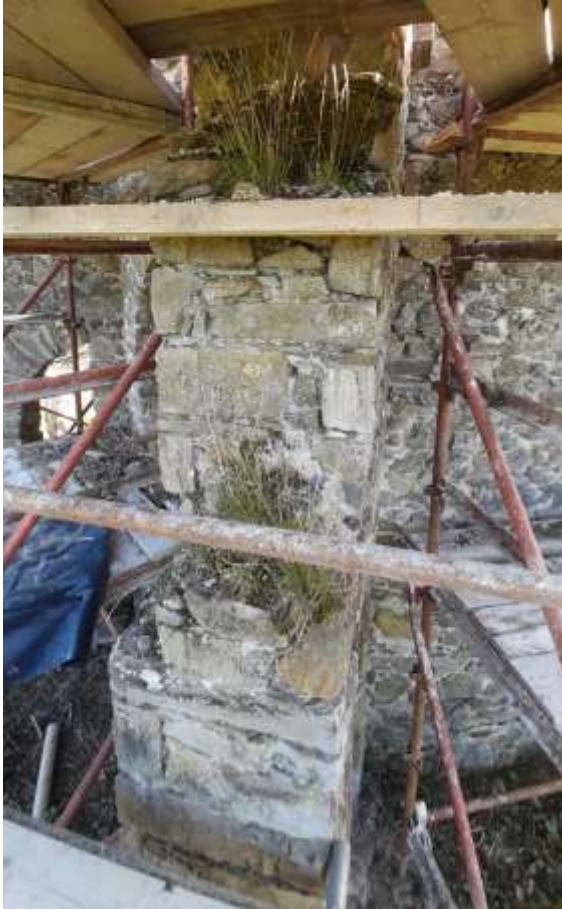
- Vegetation growth and mortar loss
- Works involved treating and removing ivy

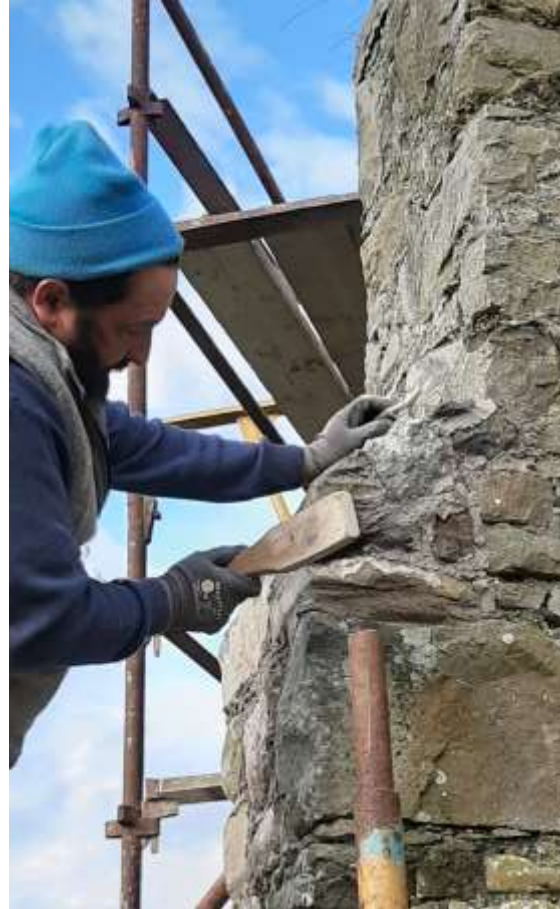
- Deterioration to the stonework eaves level
- Deep pointed with lime mix and pinning stones to match

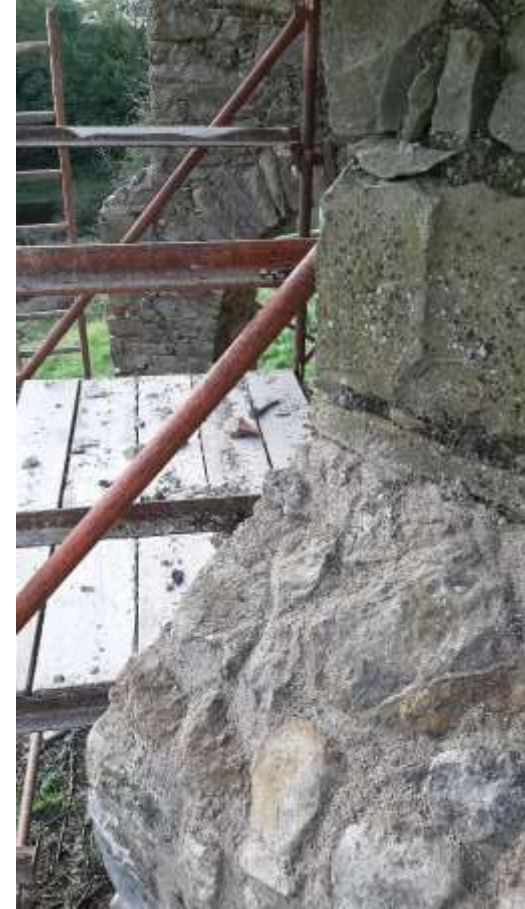
- Mortar was pressed and recessed and pigmented with burnt umber to match original pointing.

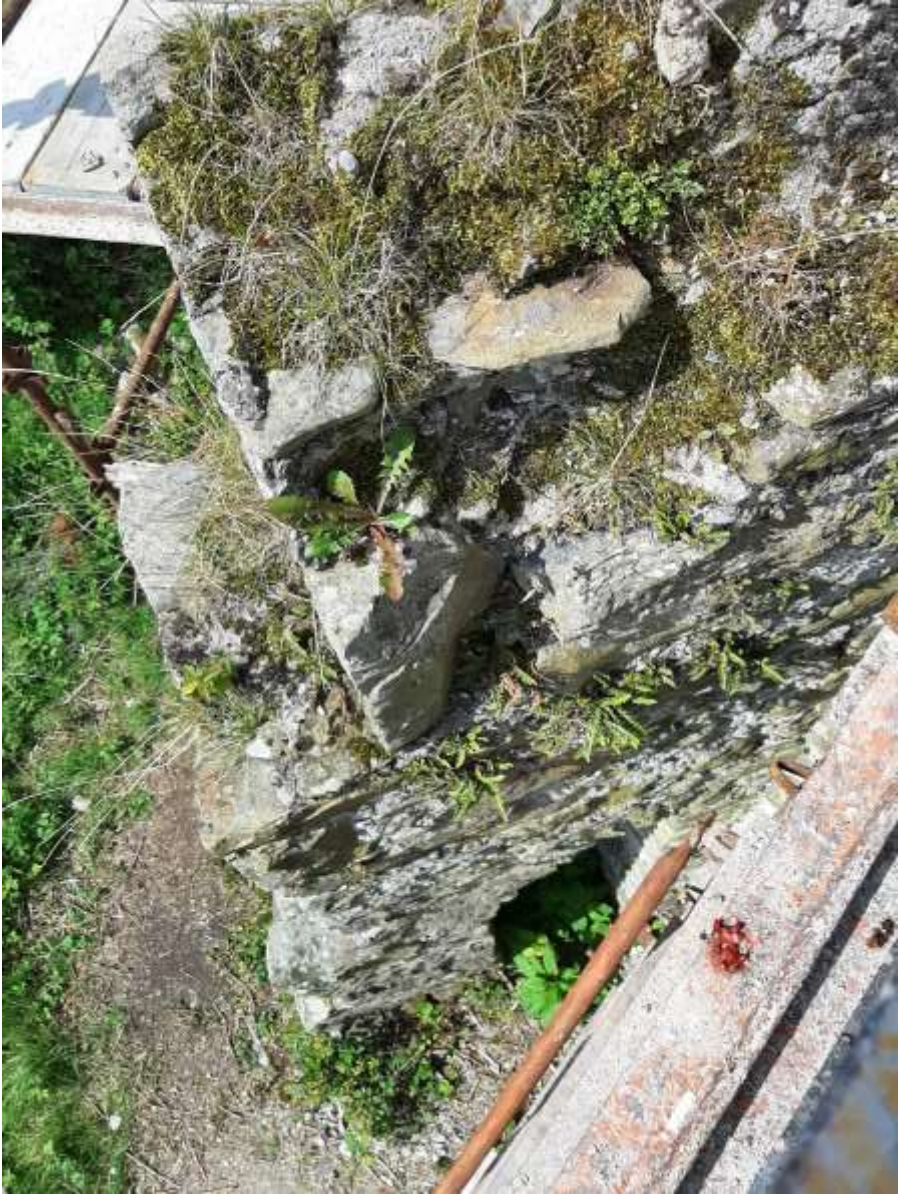
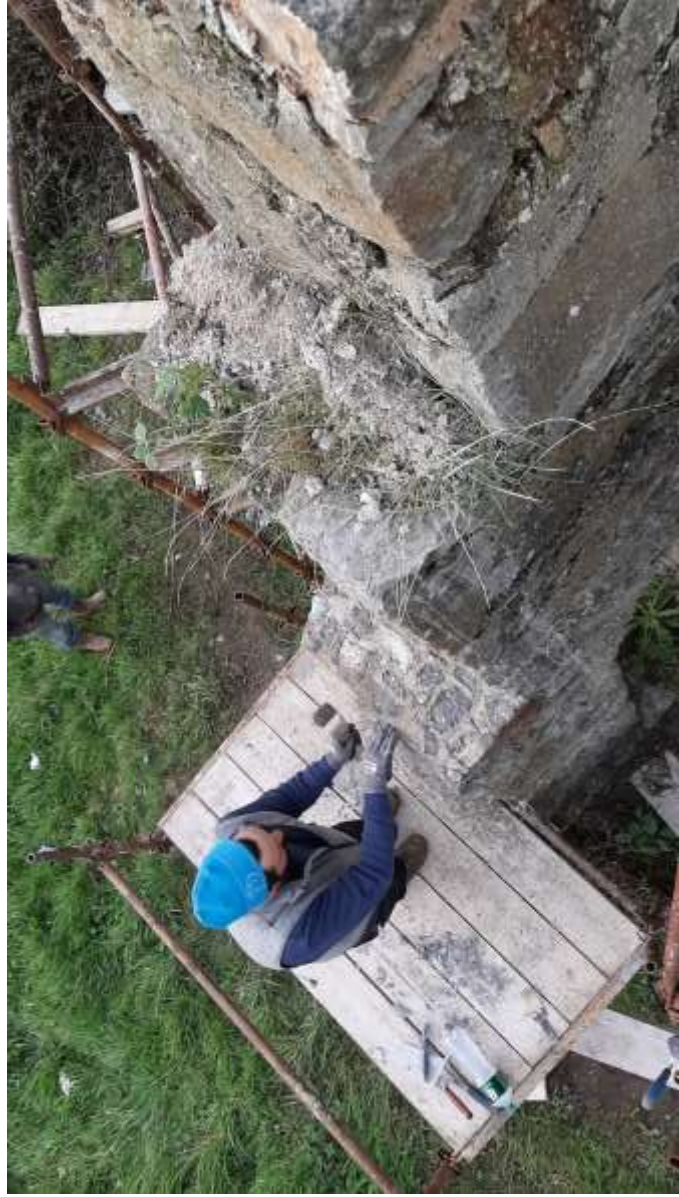
Chimney – unblock and repair

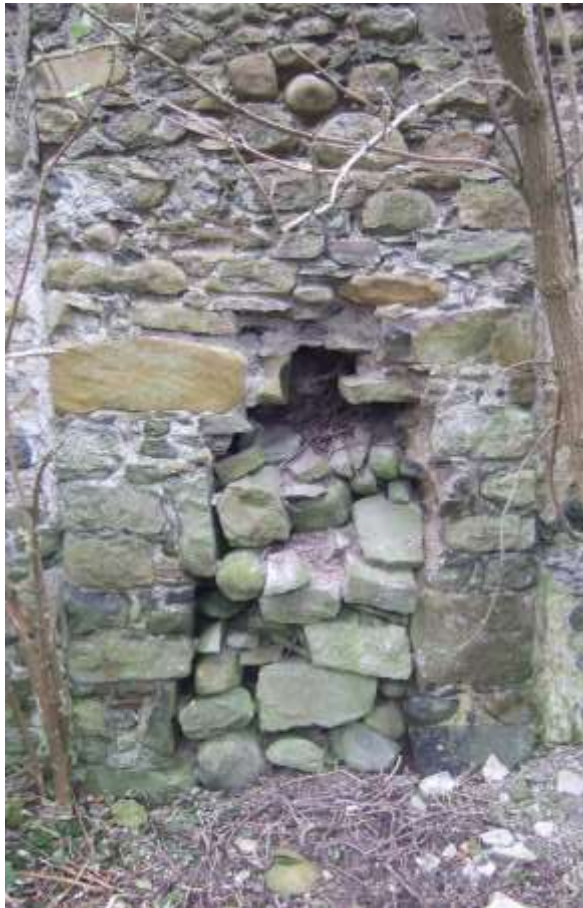
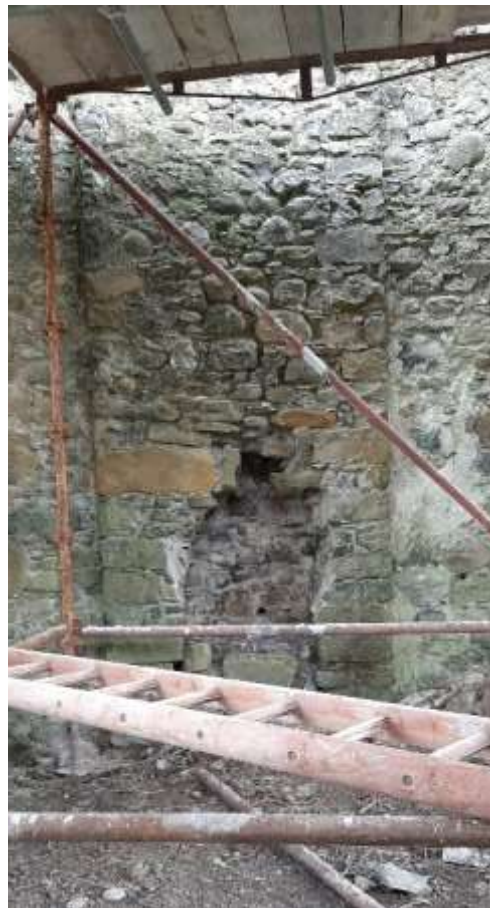
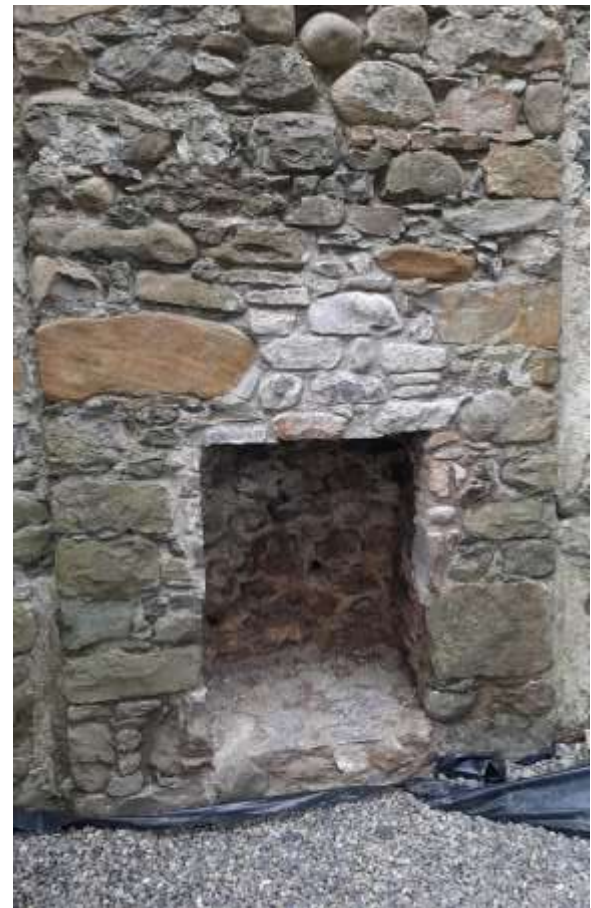
Chimney and flue (through buttress)

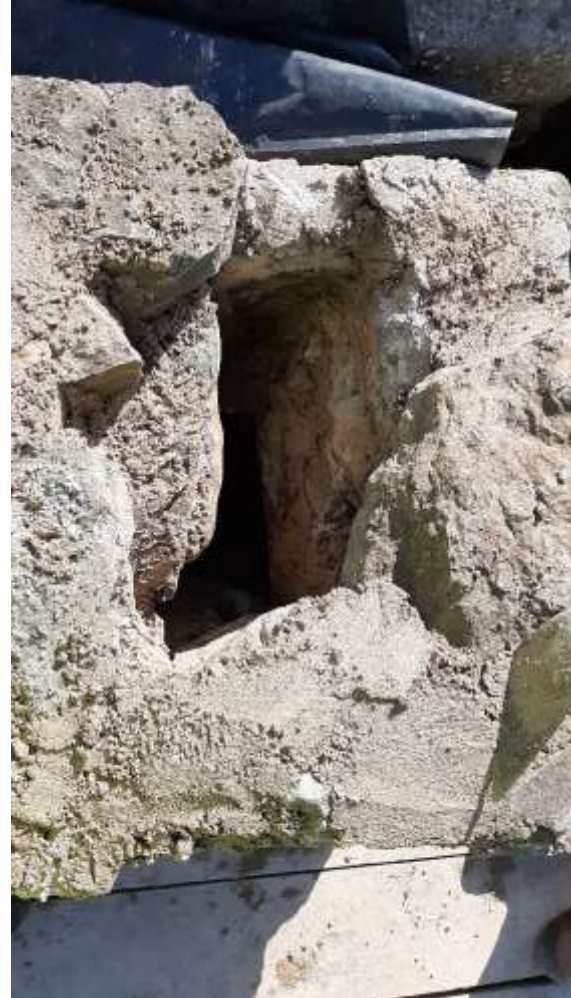
4. Buttress repair
