# BLOOMFIELD MAUSOLEUM

EMERGENCY CONSERVATION REPAIRS  
TO BLOOMFIELD MAUSOLEUM,  
BORRISNAFARNEY, COUNTY OFFALY

Rachel McKenna  
Offaly County Council

## Bloomfield Mausoleum RPS 65-07, NIAH 14946011

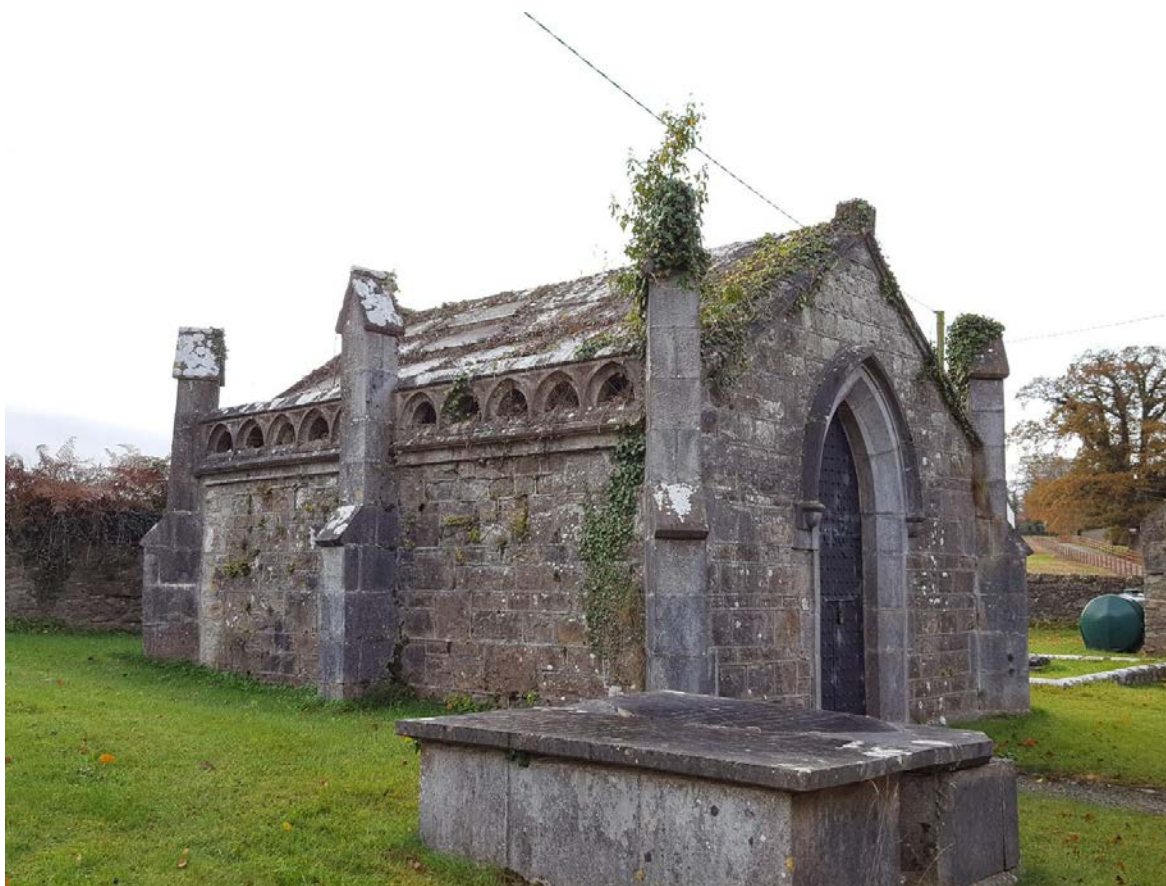
2016 External view

Detached single-cell mausoleum, built c.1830, with interred remains of the Bloomfield family. Set within graveyard at Borrisnafarney Church of Ireland church. Pitched stone roof with moulded stone coping to gables. Snecked stone walls with buttresses and arcaded cornice to north-east and south-west sides. Pointed arched door opening with tooled stone surround, hoodmoulding and studded timber door having metal cruciform hinges. Plaster to interior walls with bricked-up shelves bearing name plaques of those interred.

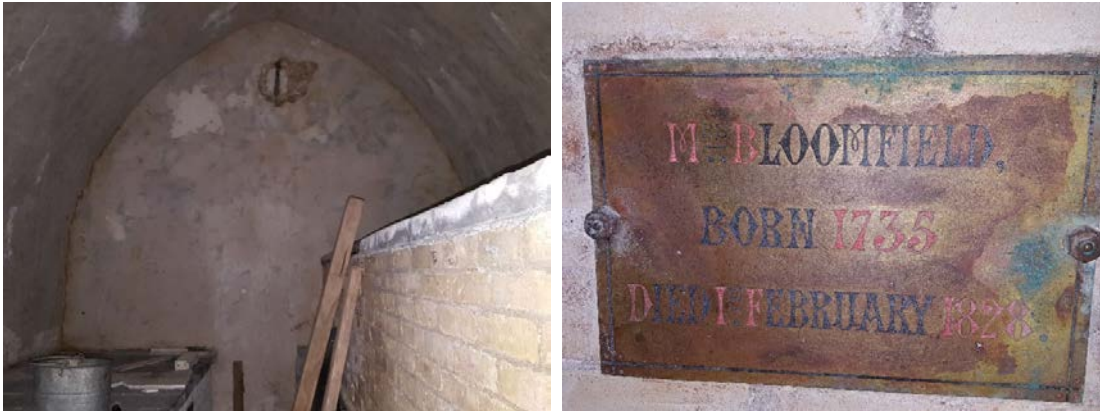
2016 Internal view and Mrs Bloomfield Plaque (1735-1828)

Over time, the local group became concerned for the structural stability of the mausoleum, as the buttresses appeared to have come away from the main structure. As a temporary measure, the building was strapped to secure the structure.

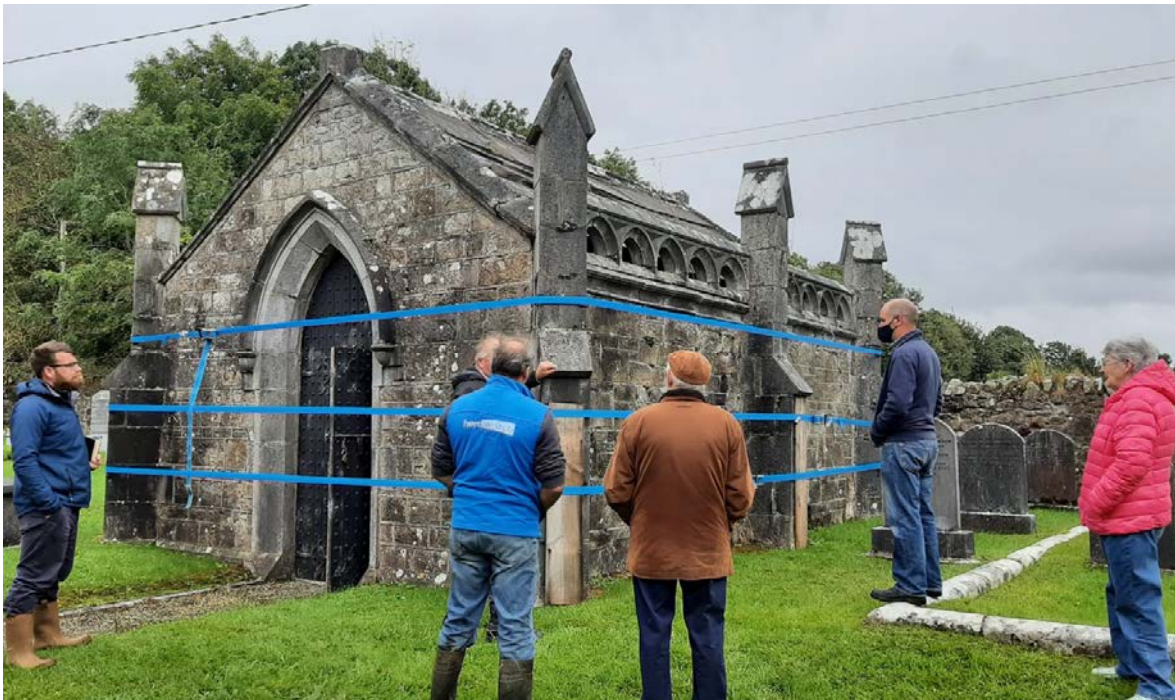
#### 2021 Group assessing the structure with Southgate Conservation Engineers

The local group engaged Southgate Conservation Engineers to assess the structure and propose recommendations for repairs. A Condition Assessment, Recommendations and Method Statement was prepared in December 2021. It set out a detailed description of each element of the structure and proposed a phased approach to repairs.

Six buttresses surround the structure. These are cut stone with a kneeler stone approximately half way up the buttress. The buttresses have shifted recently, predominantly on the right hand side of the mausoleum and the rear left corner. The buttresses appear to have shifted downwards and outwards away from the structure likely due to subsidence and the lack of a suitable foundation. The buttresses have been recently held in place by high tension strapping which has also served to pull the leaning buttresses somewhat back into their correct positions. It is possible the buttresses are largely decorative as they appear to have minimal ties into the main structure.

Stainless Steel tie plate and M20 rod to be cored into wall behind kneeler stone and kneeler stone put back in place, this is for the two central buttresses on either side of the structure. For corner angled buttresses x2 Stainless Steel tie plate and M20 rod running from the centre of the buttress behind the kneeler stone and into the masonry. Other works to include careful underpinning of each buttress with a concrete pad and repointing of buttresses in lime mortar.

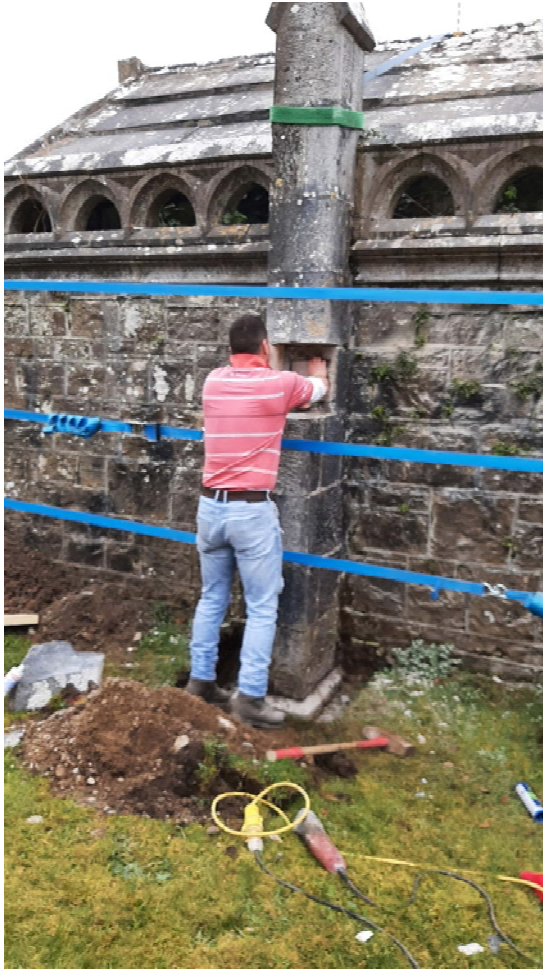
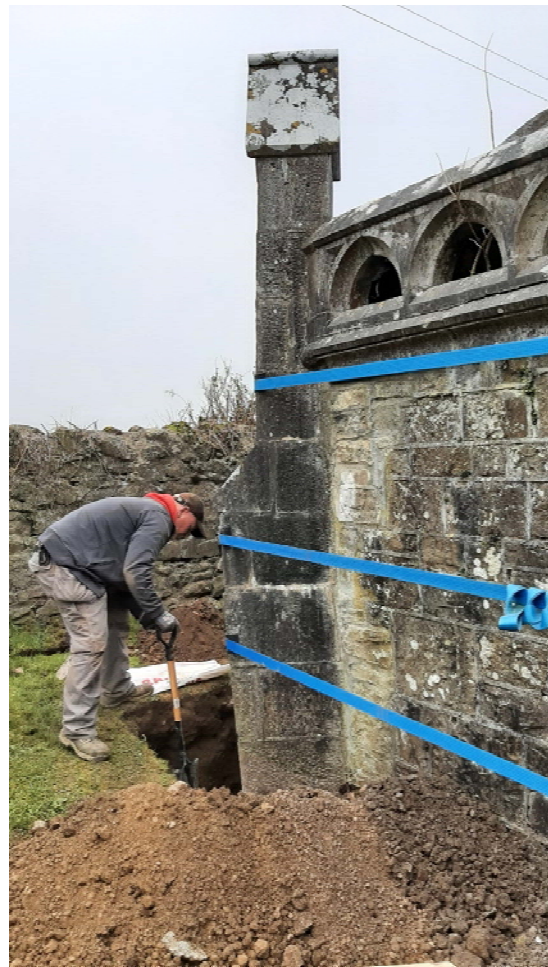
*Steel rod and plate underway to buttress and new underpinning, 30 March 2022*

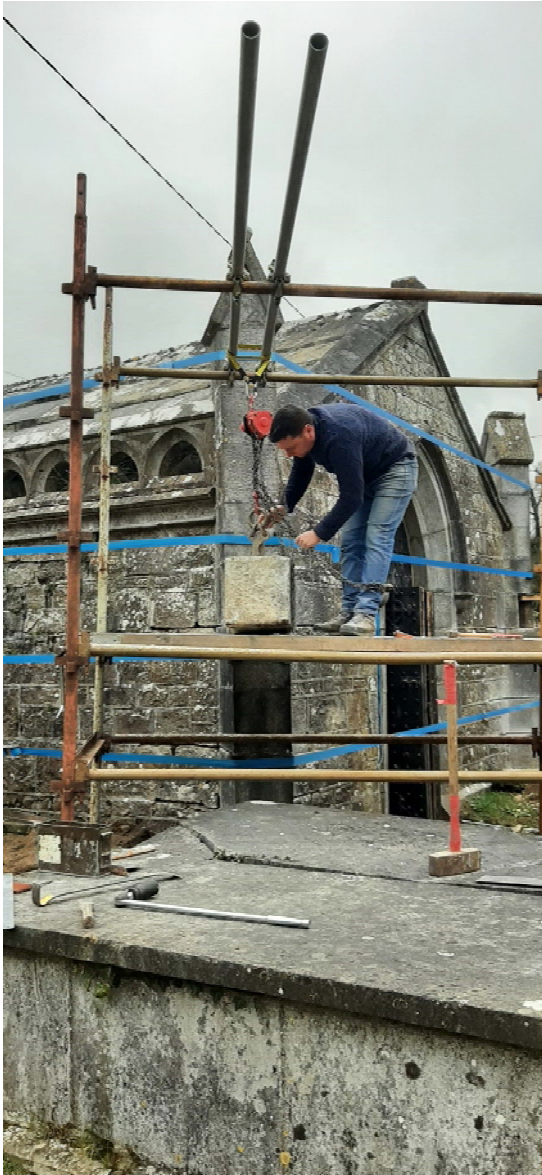
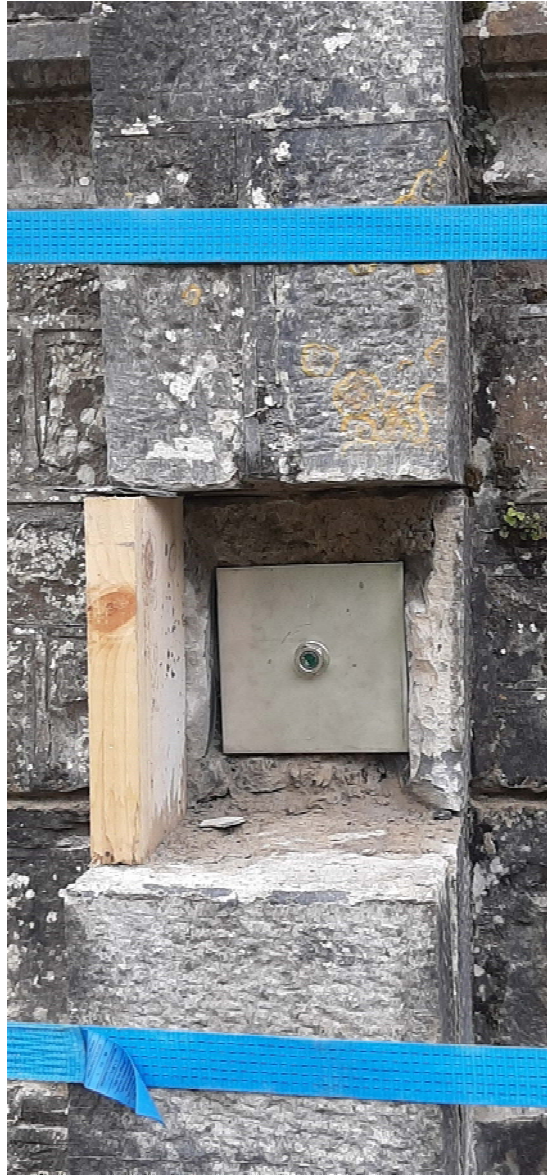
*Kneeler stone carefully removed, for plate. Plate and tie-rod inserted 05 April 2022*

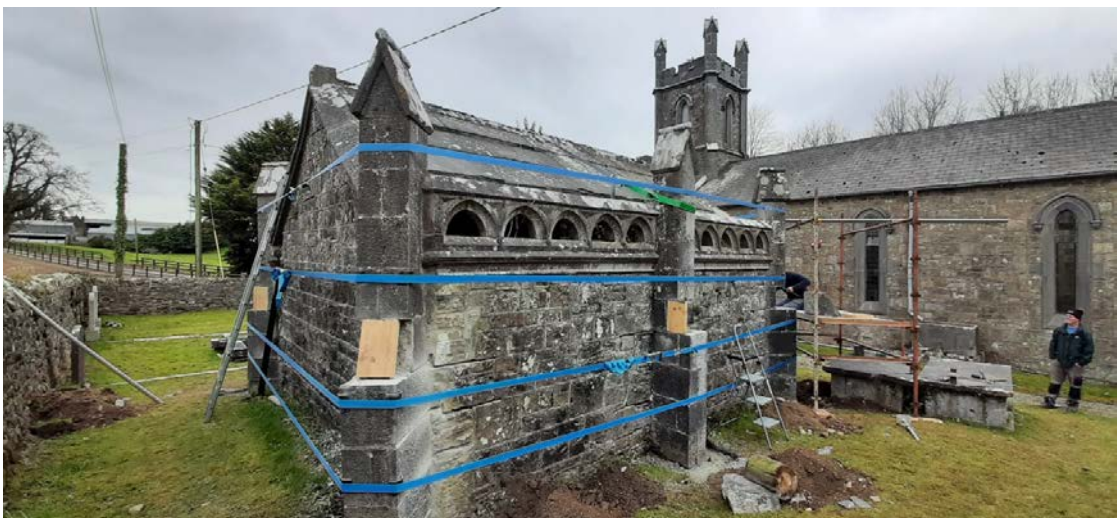
26 April 2022 – works practically complete

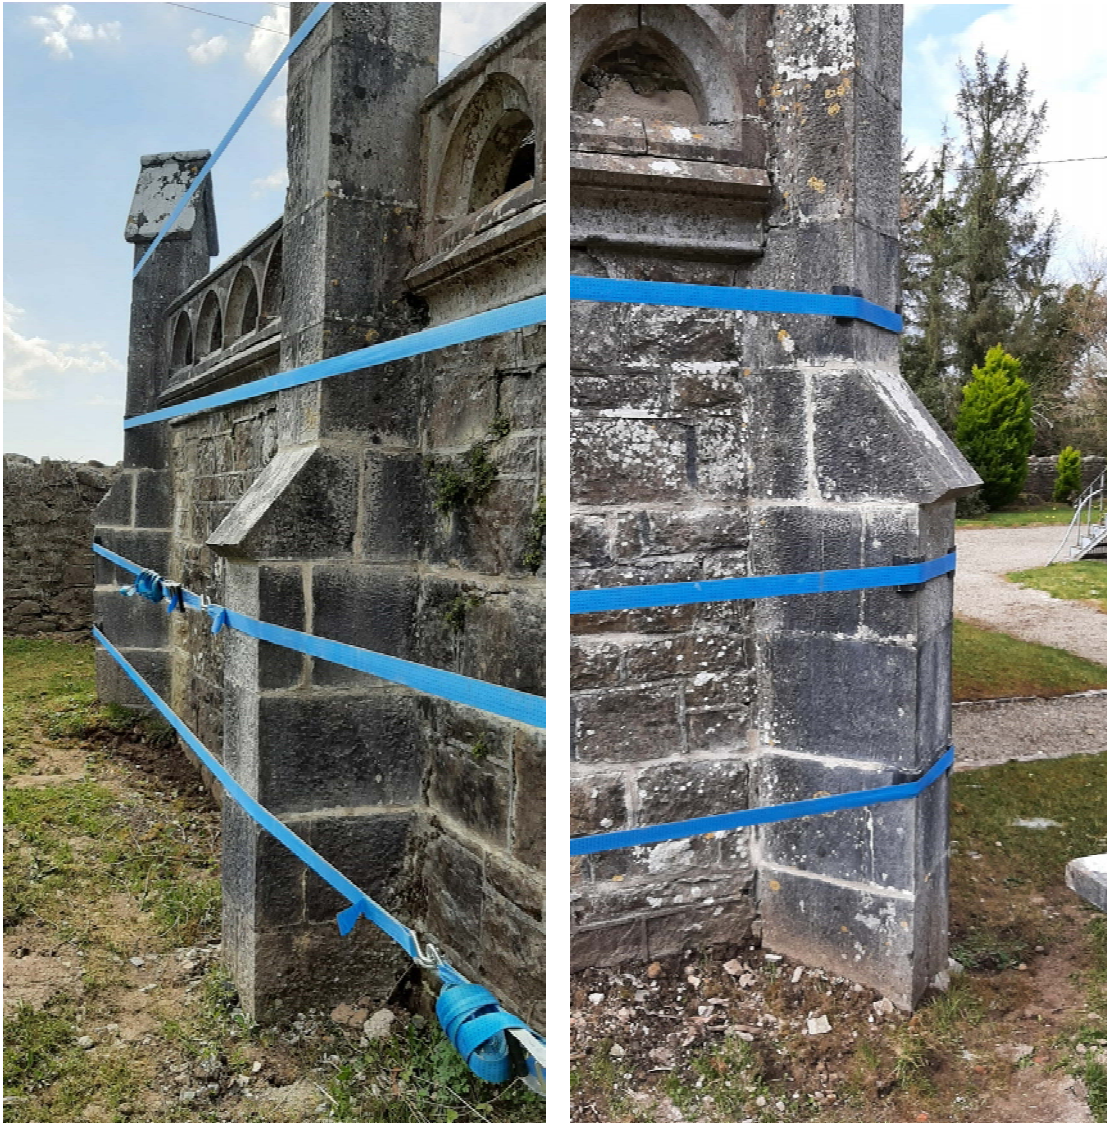
*Kneeler stones returned and surrounding joints repaired with lime mortar*

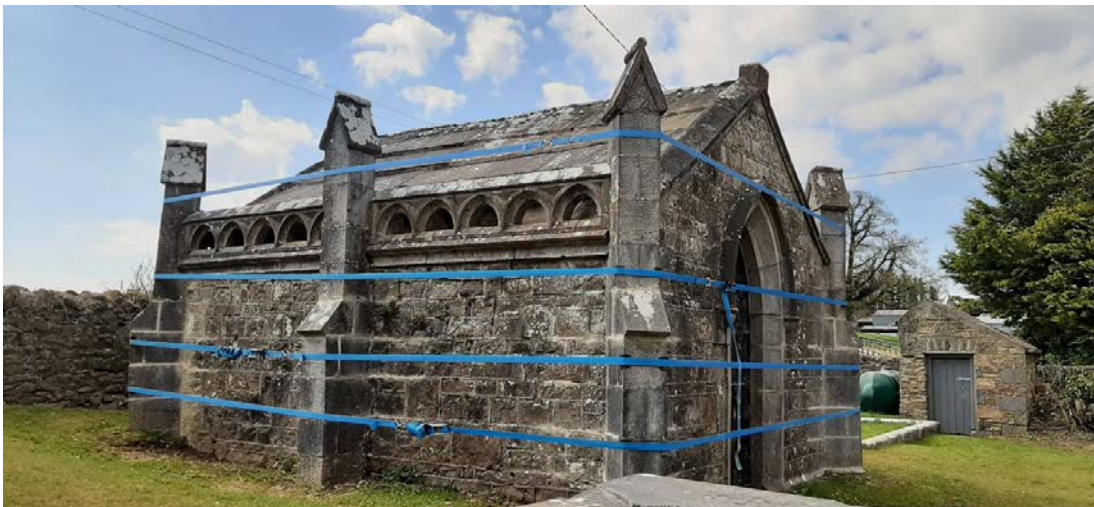
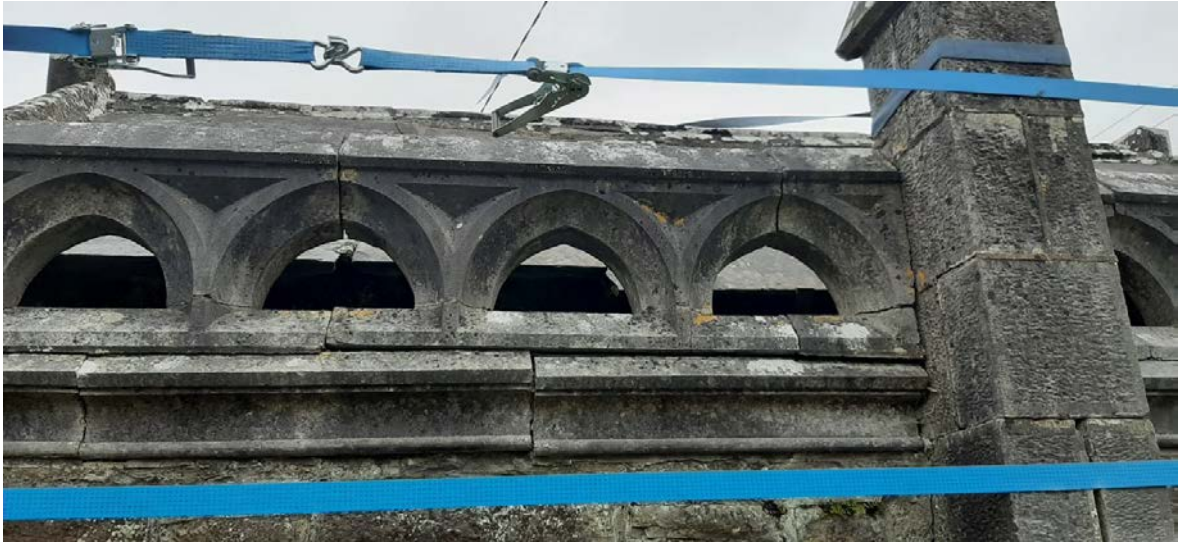
Further works considered to relieve some of the issues around the high-level tracery that was fixed historically with wrought iron cramps. These had corroded causing opening of cracks. Further works to this area will be required in Phase 2.

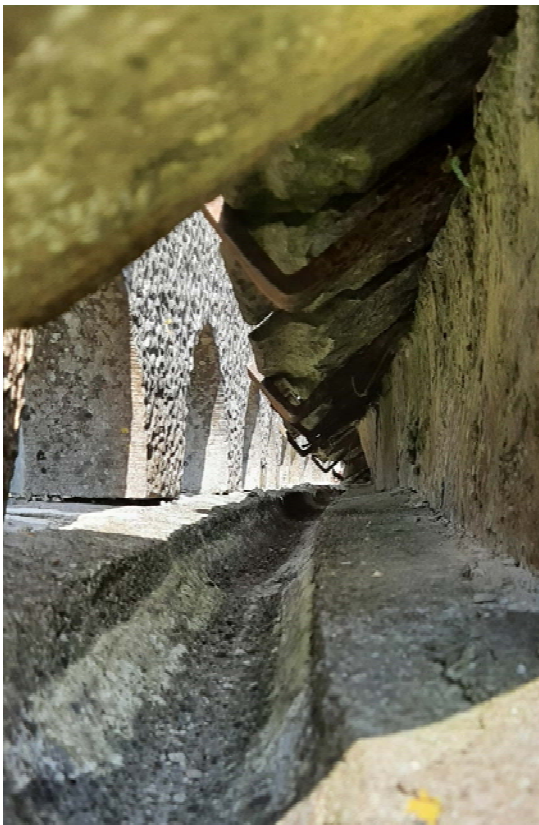
*Large, heavy stone flags cover the roof behind this high-level tracery or apron, and they slope down into an inner gutter. Note the arched stone-work, inner gutter and over sailing stone flags fixed with metal cramps.*

The valleys have been cleared and cleaned of debris, the joints pointed in an NHL 5 and the finished surfaces protected in a Remmers water repellent.

Further works in the next year or further years in a Phase 2 are recommended and should focus on the replacement of iron dowels to the arcade stones on either side of the building and rebedding of these stones on new mortar tied with stainless steel dowels. The end coping stones will need resetting and the upper sections of several of the buttress would require repointing and repair. Overall, this years project has been a successful project and demonstrates a good example of what can be achieved using best practice to stabilise and conserve a structure which was at risk of imminent collapse. This project was partially funded by the Built Heritage Investment scheme, Creative Ireland, The Follies Trust and The Moneygall Development Fund.

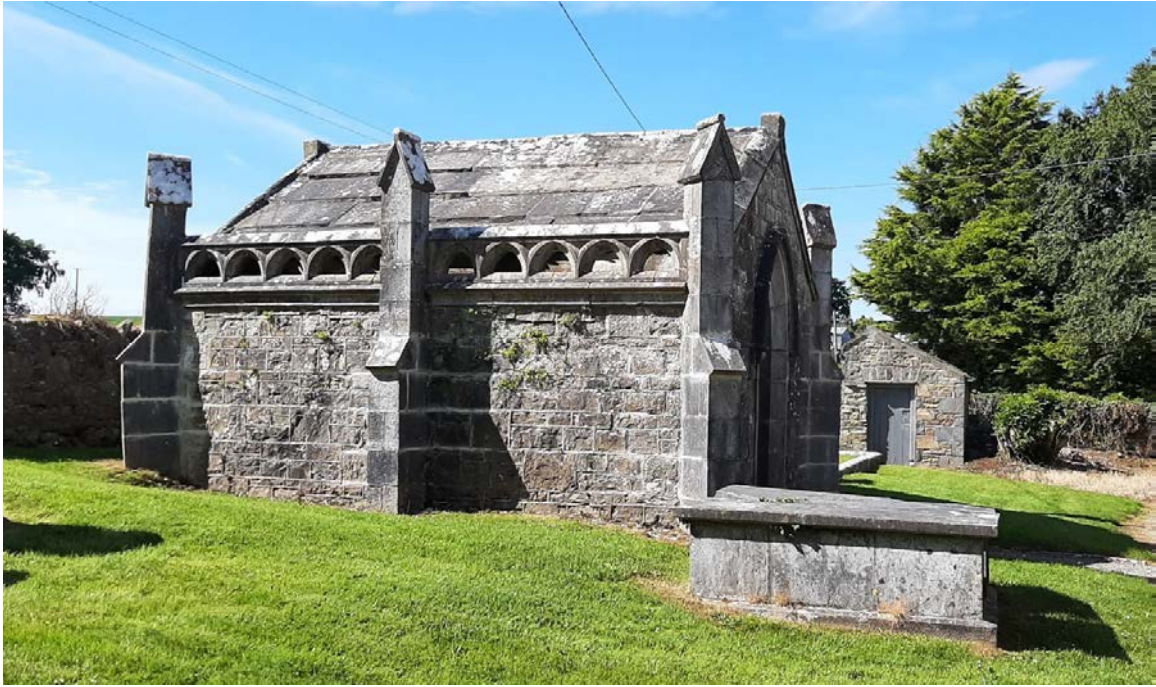
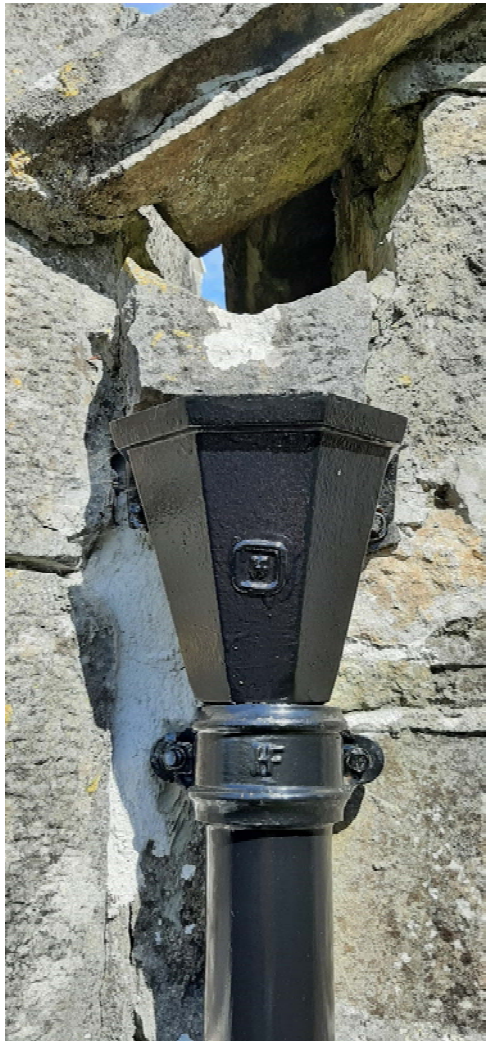
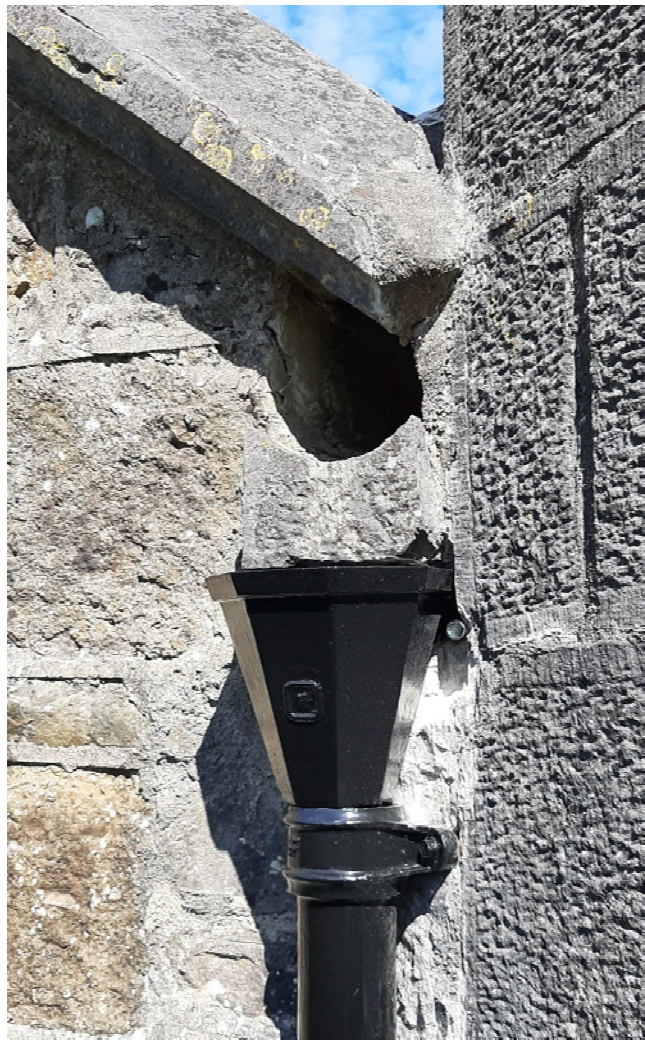
Cast iron rainwater goods

**Extract from Southgate Conservation Engineers, Final Report:** Stabilisation and conservation works have successfully been carried out to the Bloomfield Mausoleum at Borrisnafarney Church. Prior to the project the buttress' were leaning out of position and at a risk of collapse. While the original scope was focused on emergency stabilisation works, it was found additional grouting was required to the buttress' and also the project has managed to secure and stabilise the buttress' and surrounding stonework and also return function rainwater goods and valleys to the building. By using tie plates and rods and helibars the buttress' are now tied into the masonry of the main structure and this along with carefully installed concrete underpin to each buttress has now stabilised the structure and allowed for the unsightly straps to be removed. The conservation works to the valleys and the installation of cast iron hoppers and downpipes has returned functioning rainwater goods to the structure.
