## Creative Ireland Projects 2021 – Follies Project

### **CI Folly Project Kinnitty Suspension Bridge, Kinnitty Demesne, Birr, Co. Offaly €10,000**

Repairs to the existing bridge include replacement timber deck and steel flats, repair of existing cast iron frames and main cables. Repair and minor replacement of wrought iron stays, hangers and latticing. Proposed works a combination of direct labour by Coillte and specialist contractor.

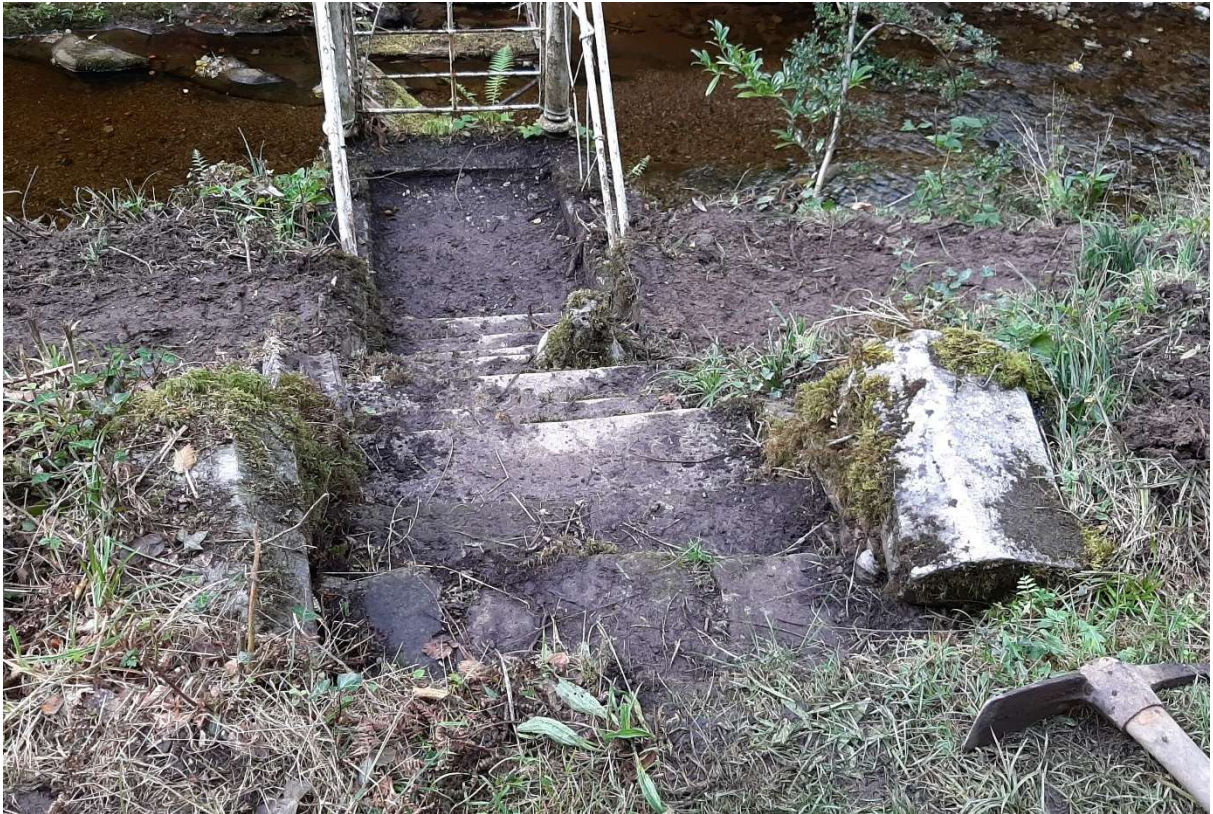
Stone steps and cappings uncovered as part of clearing and site preparation

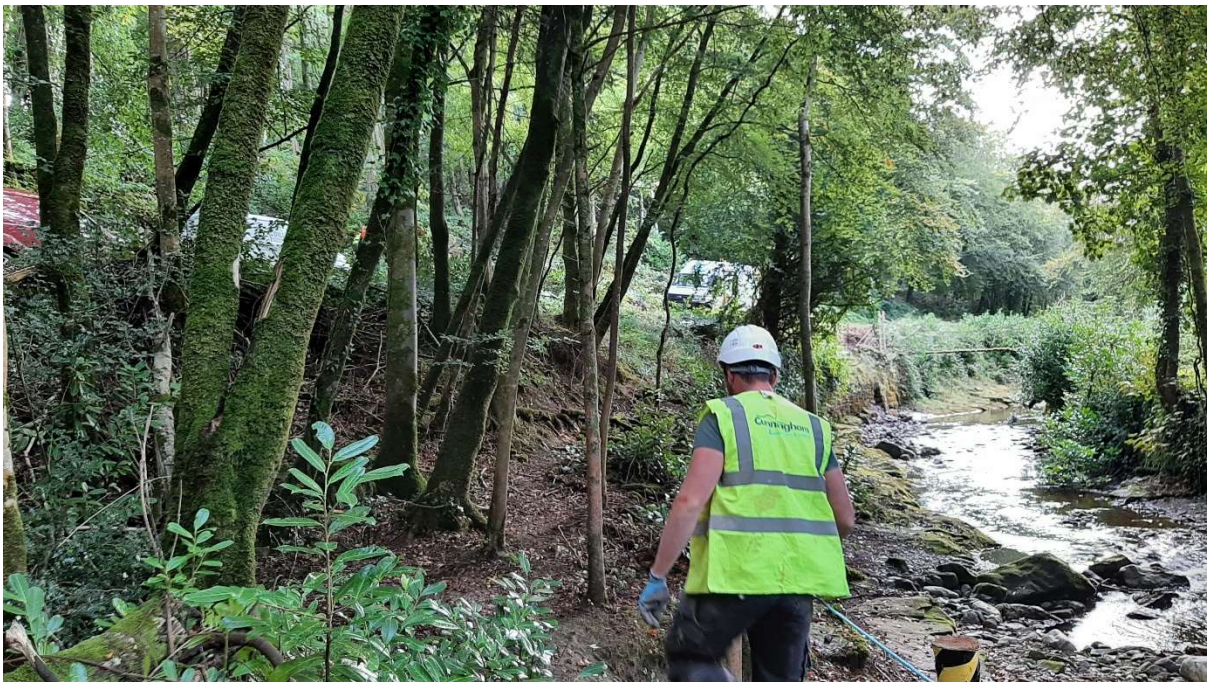
Site clearance and safe passage to river

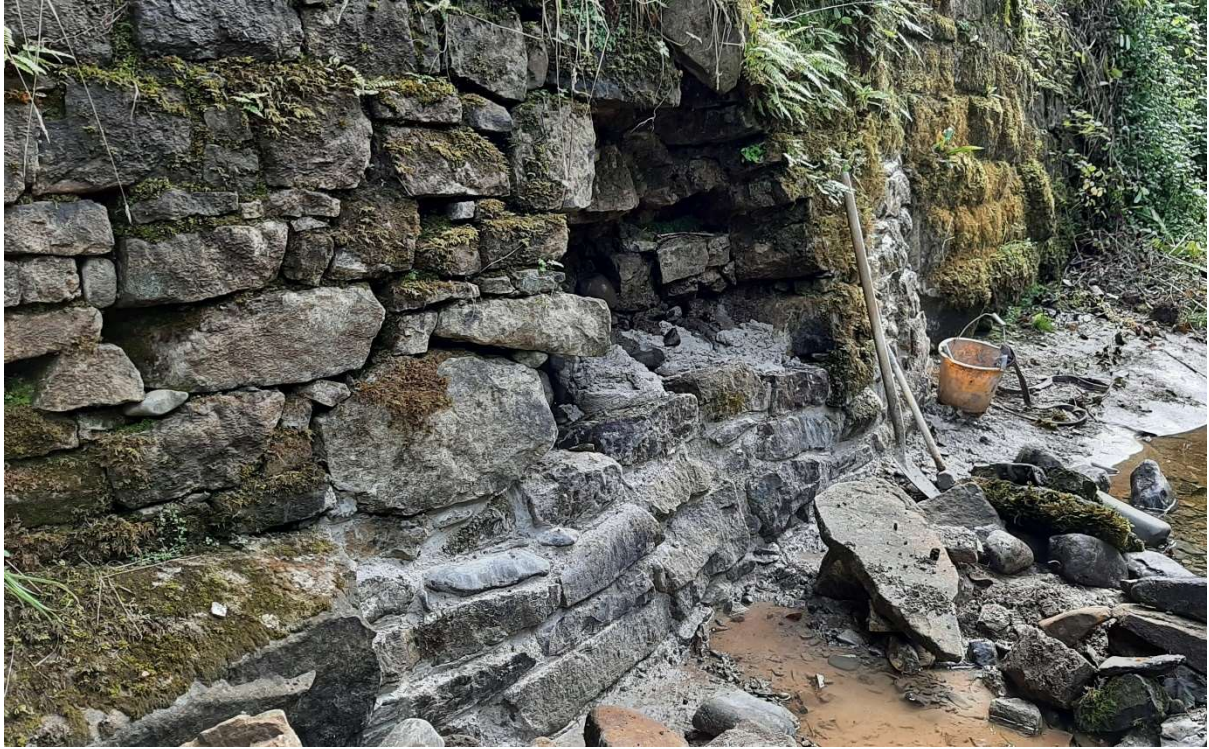
Sections of embankment washed out requiring repair with lime mortar

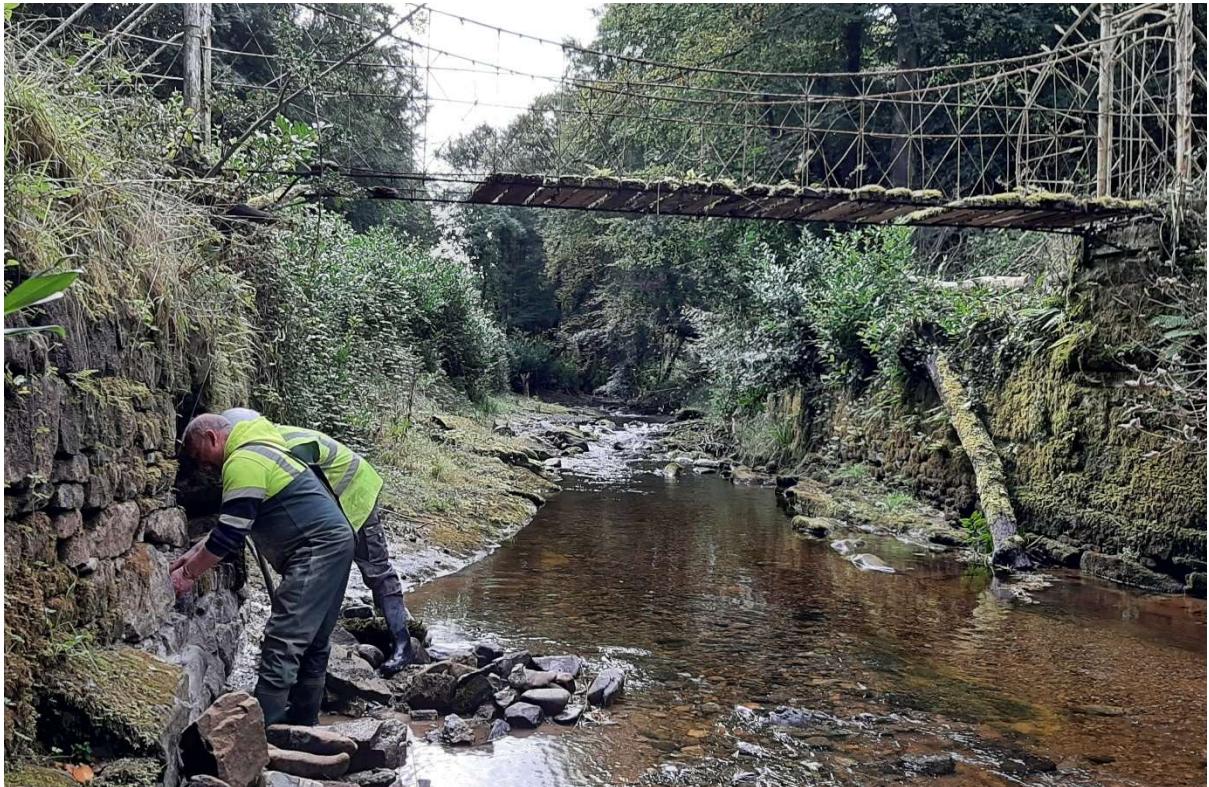
Loose stones washed down river, returned and set in lime mortar

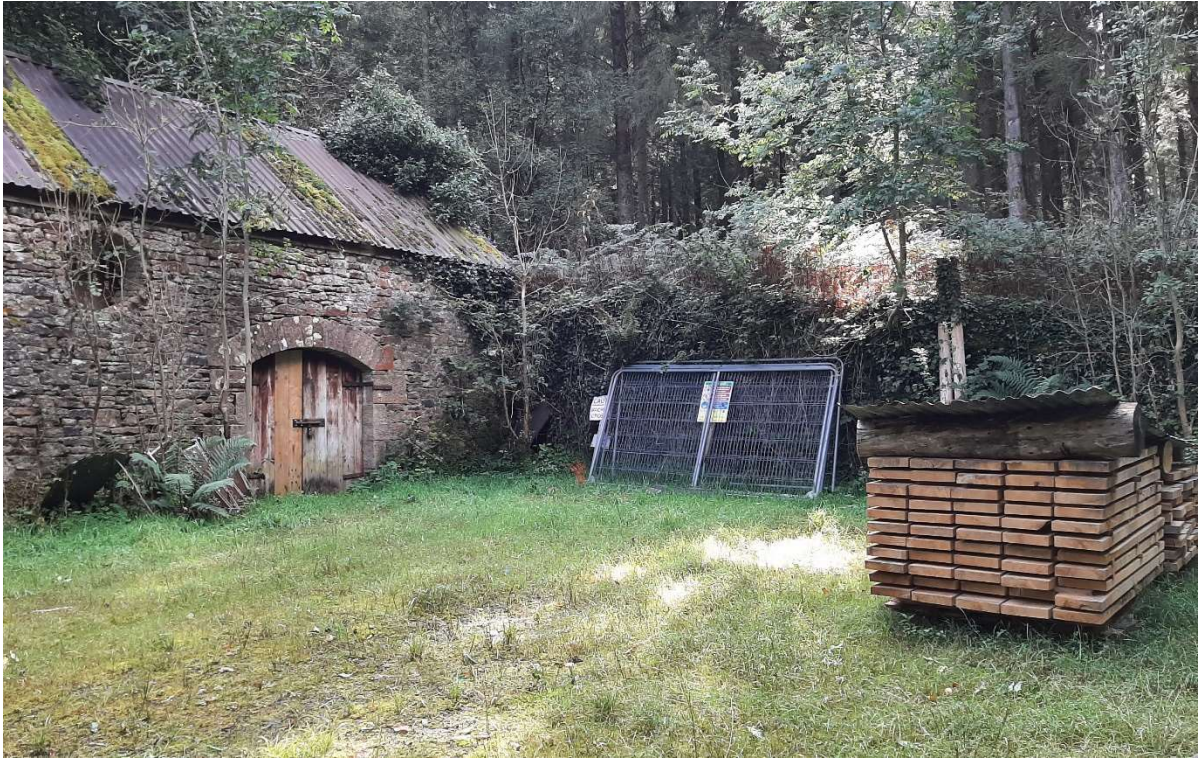
Oak from the site prepared and planked by Coillte for bridge decking

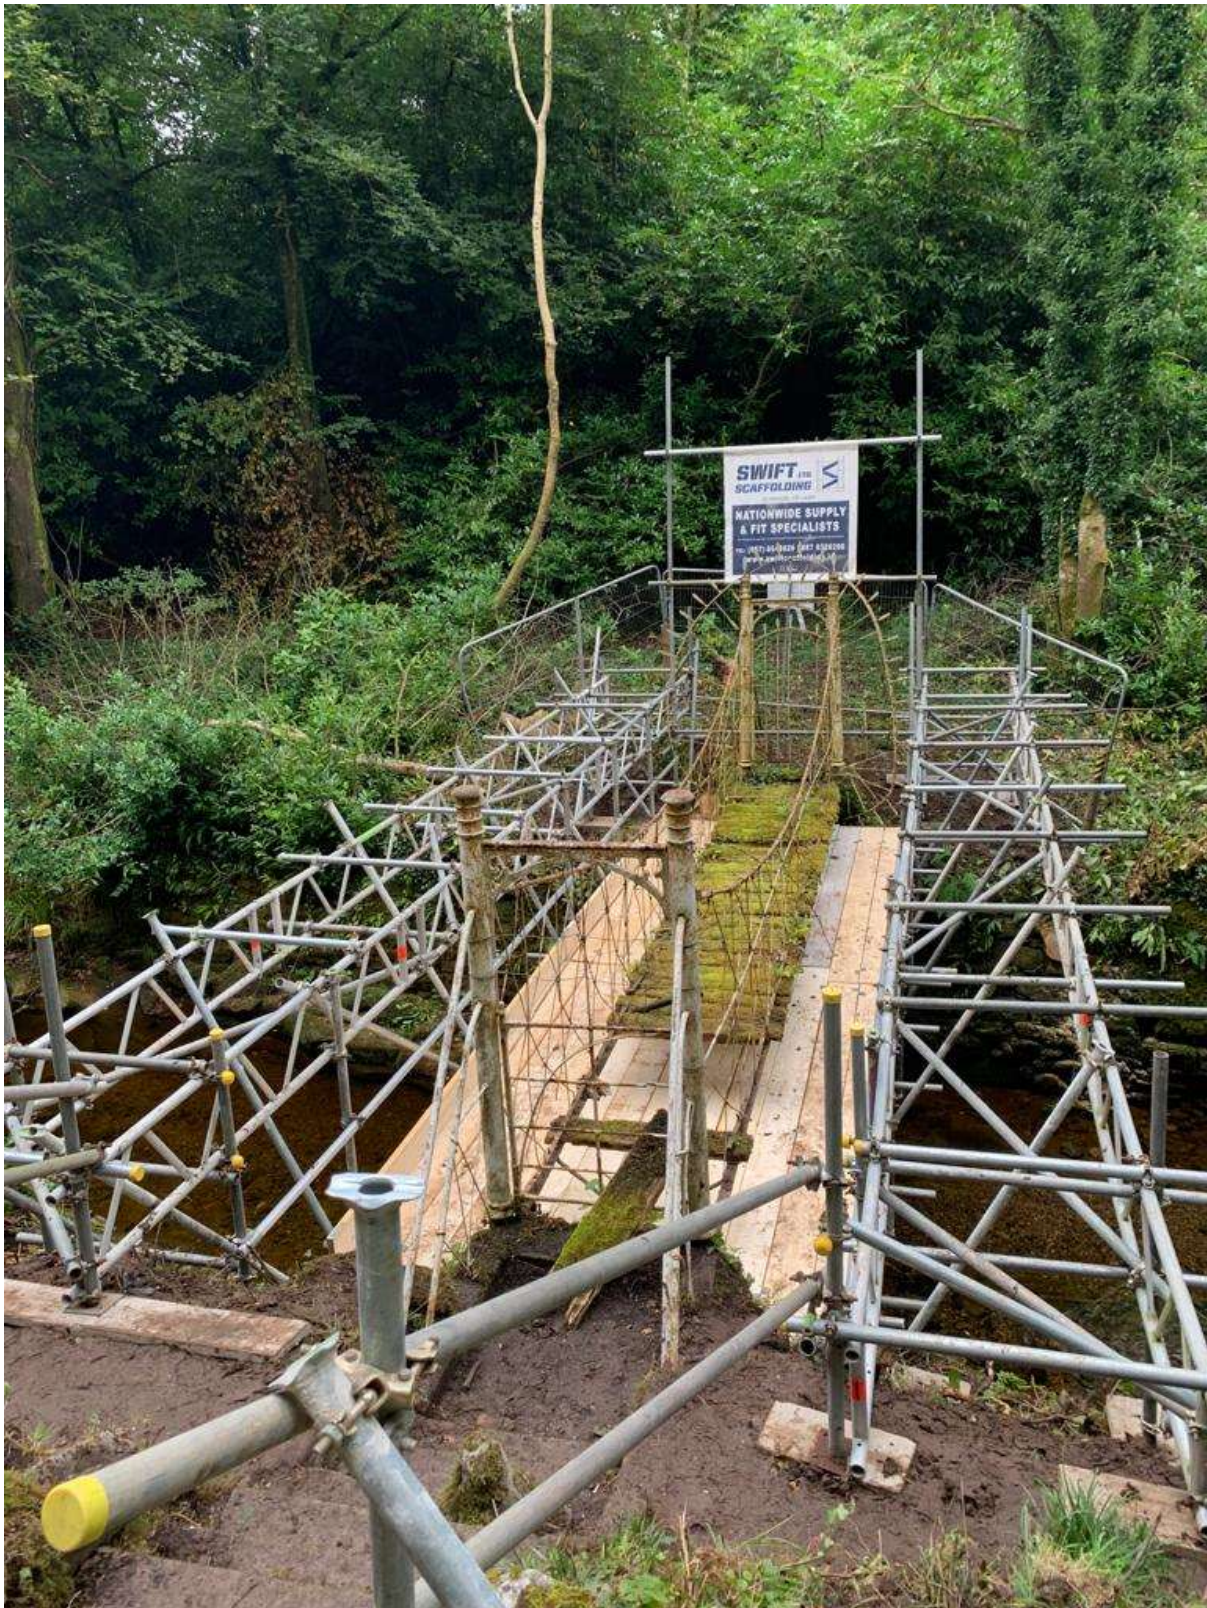
Scaffolding built around bridge with first layer of support below deck

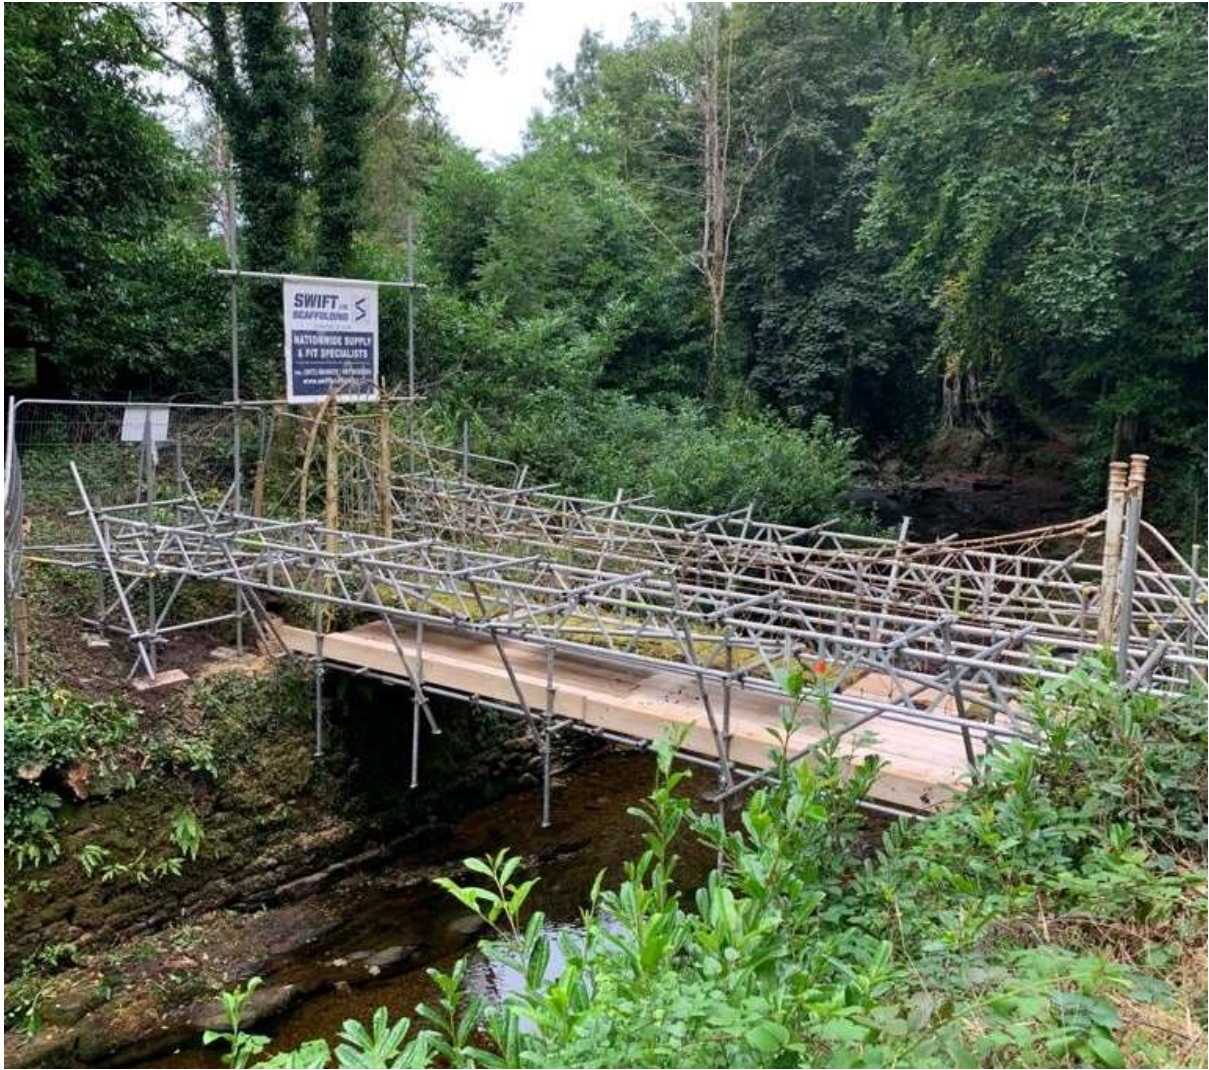
Temporary support below and around the bridge

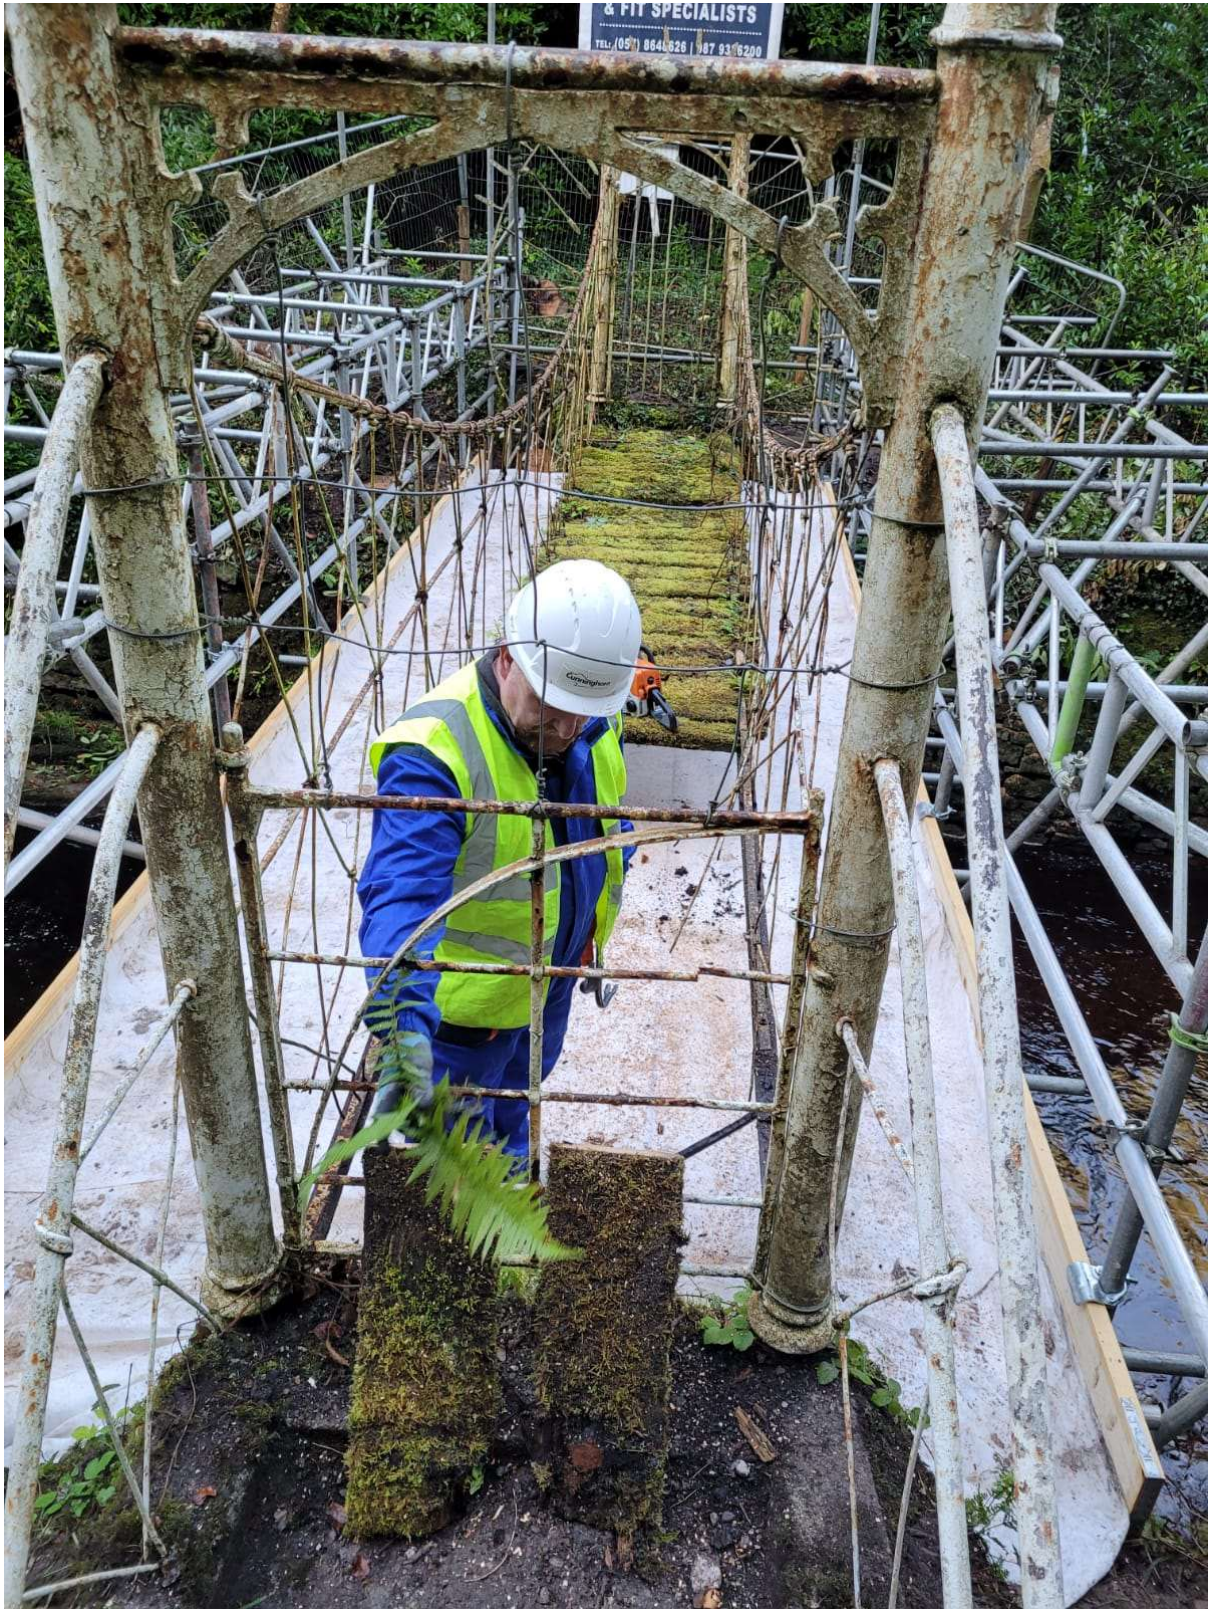
Existing pedestrian swing gate to bridge

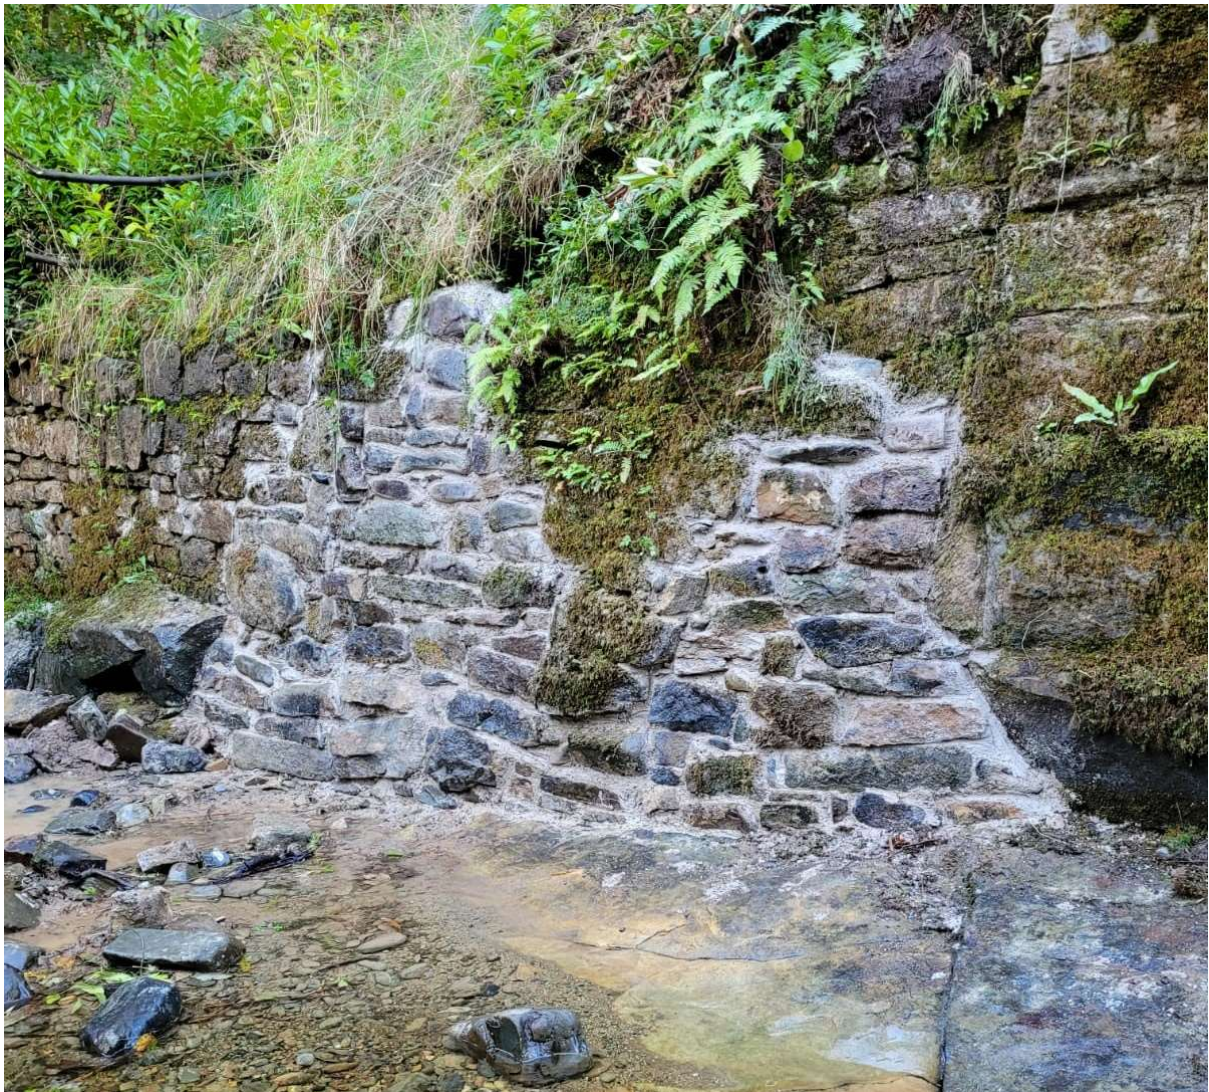
Embankment built up and secured with lime mortar

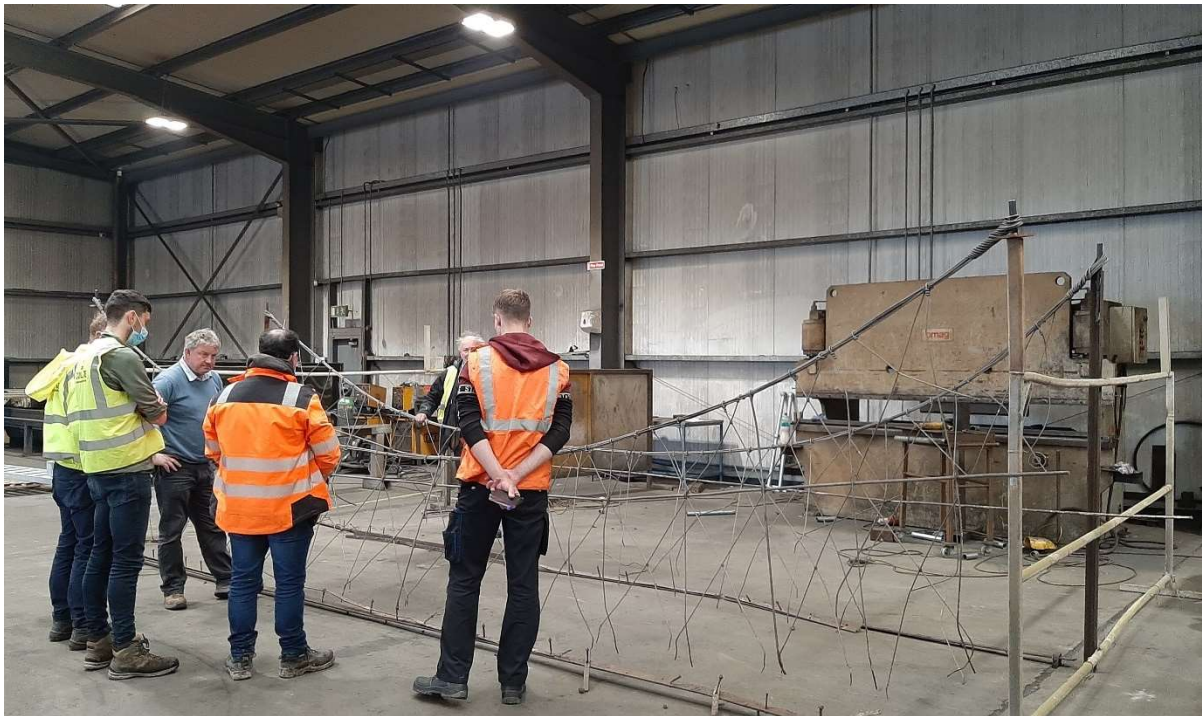
Assessing the side cable structures at the workshop

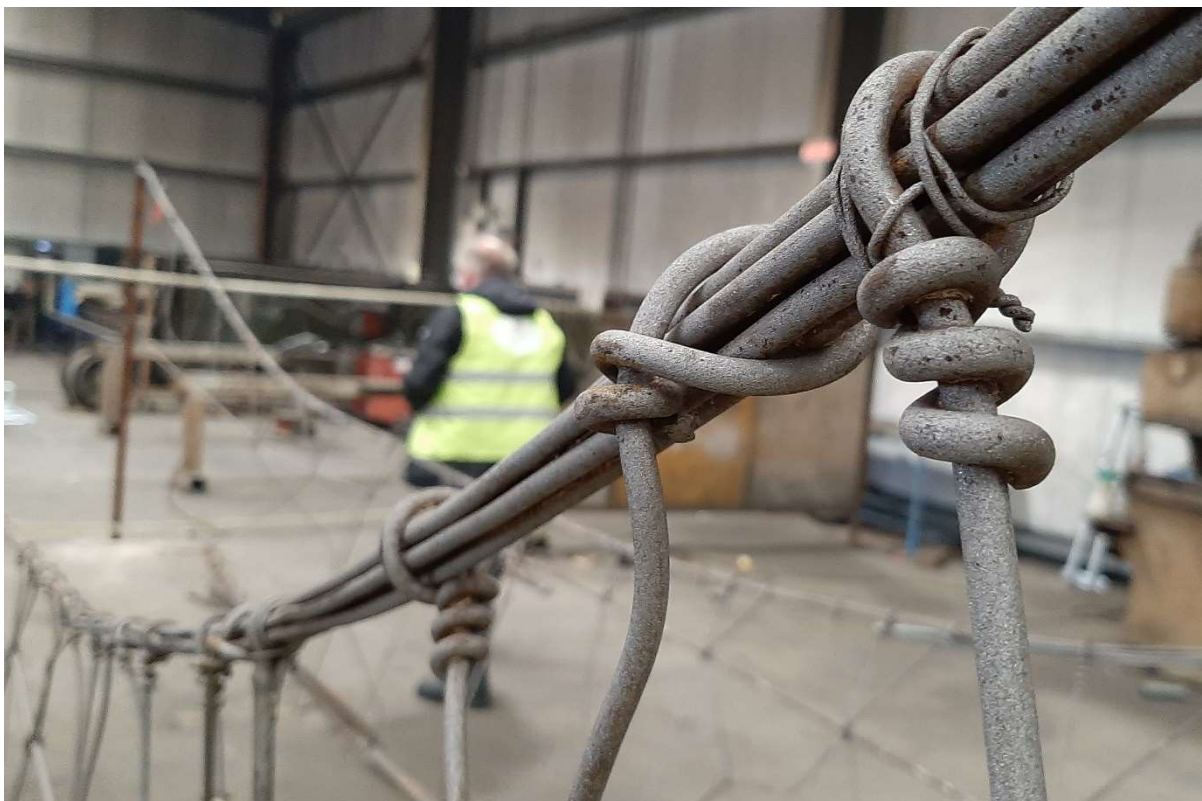
Top chord multi strand in good condition. Requires filler between top chord strands for corrosion protection (CS)

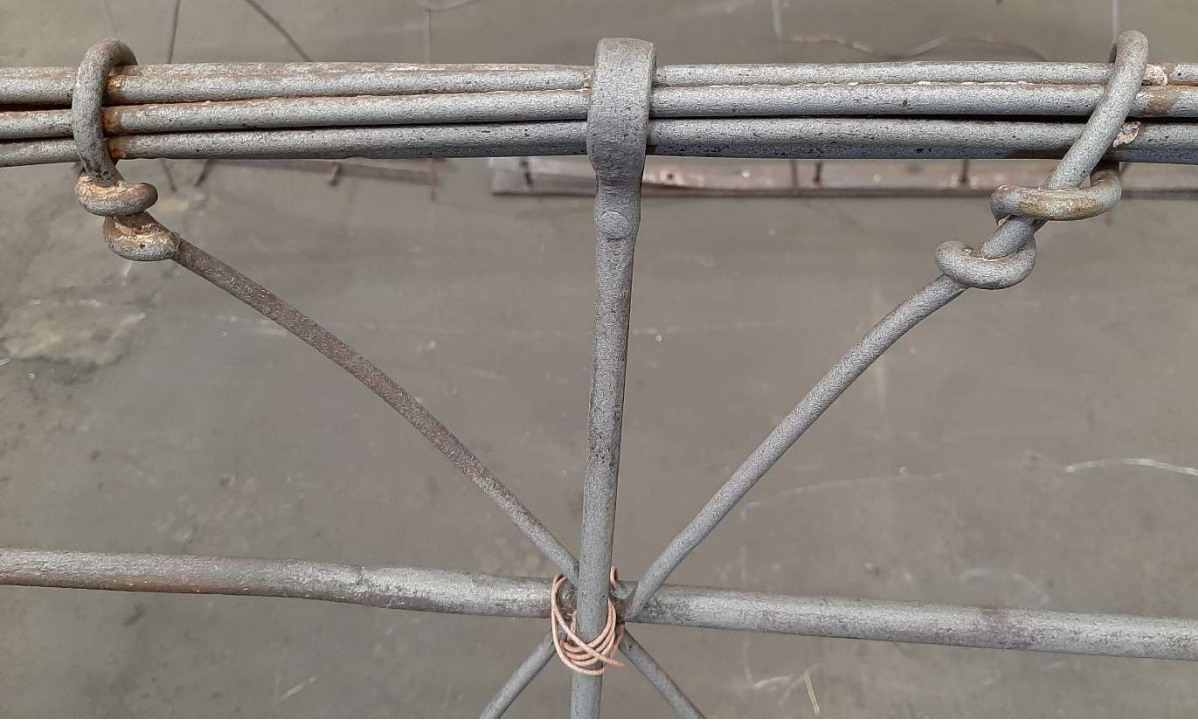
3 No 10mm uprights each side to be extended with M10 couplers (CS)

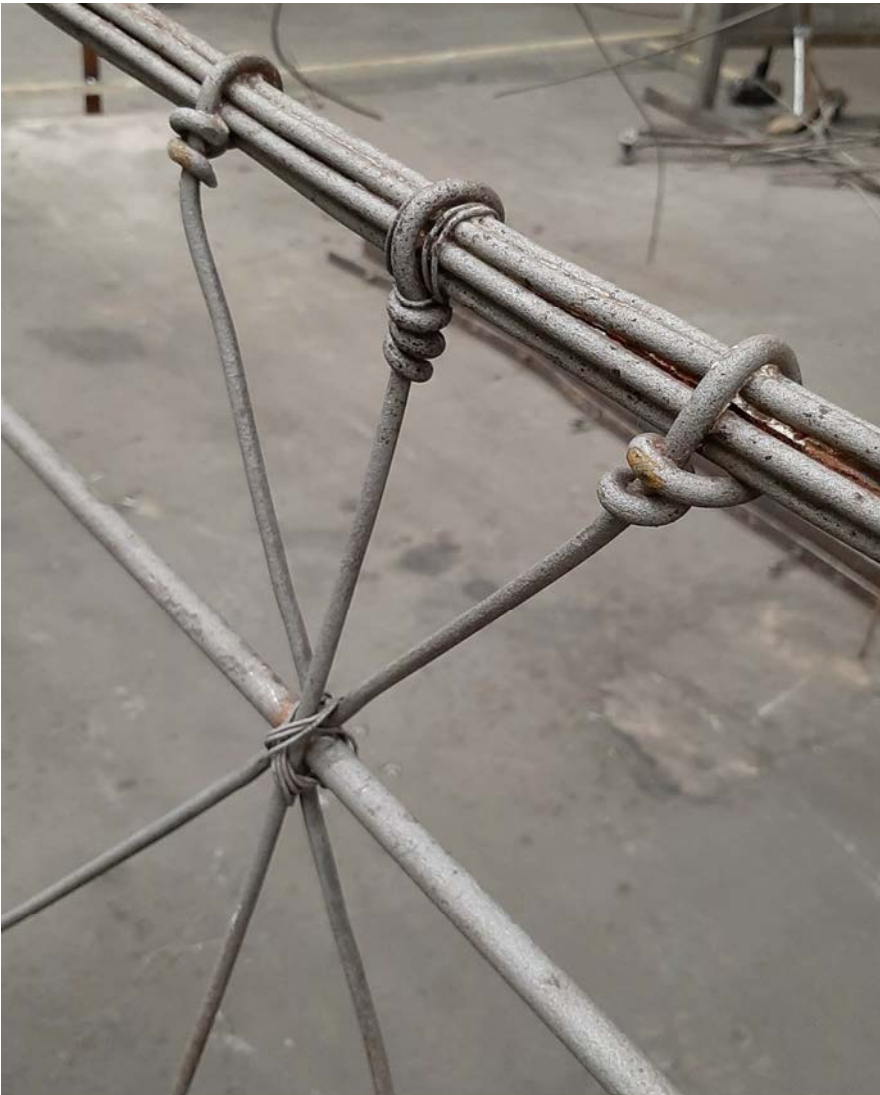
11 No 6mm uprights to be extended with couplers (CS)

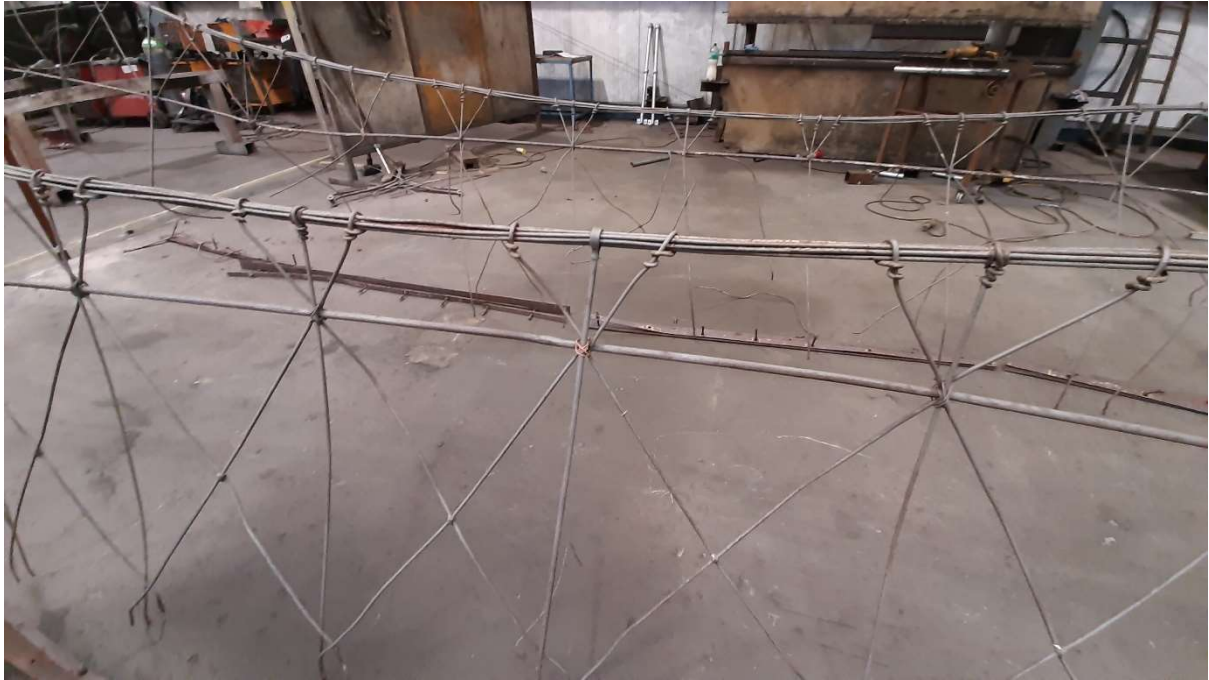
Diagonal bracing (lower) to be extended by TIG welding. All original components to be retained (CS)

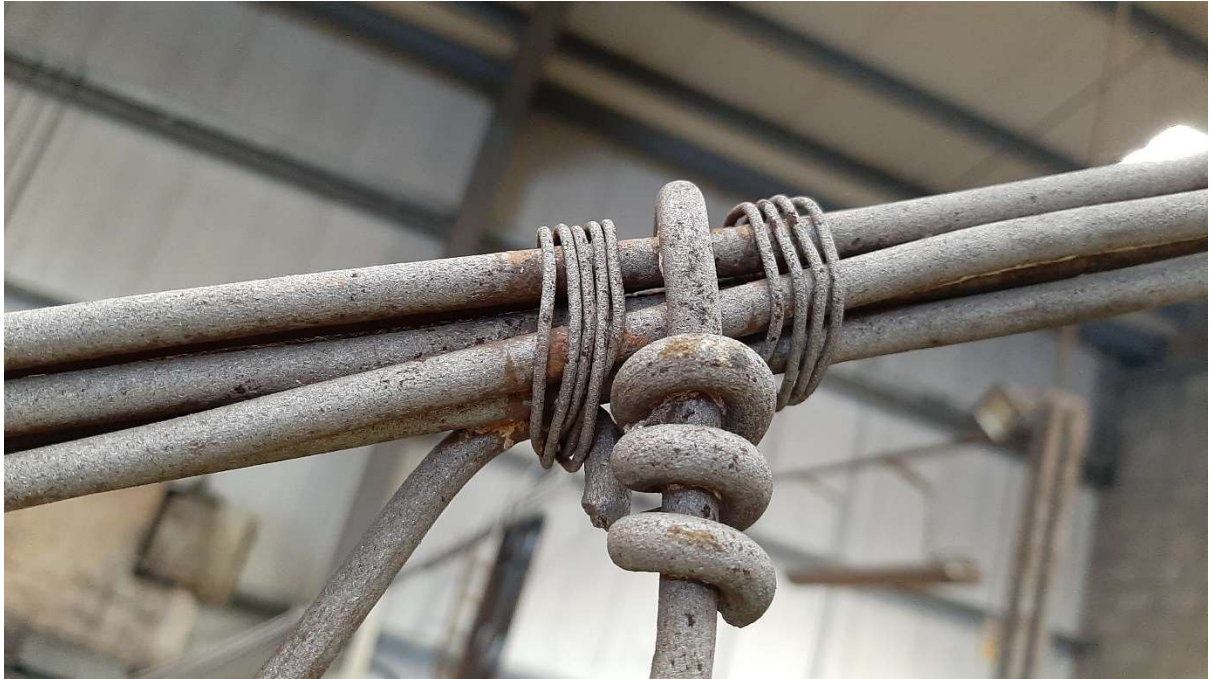
Connection details

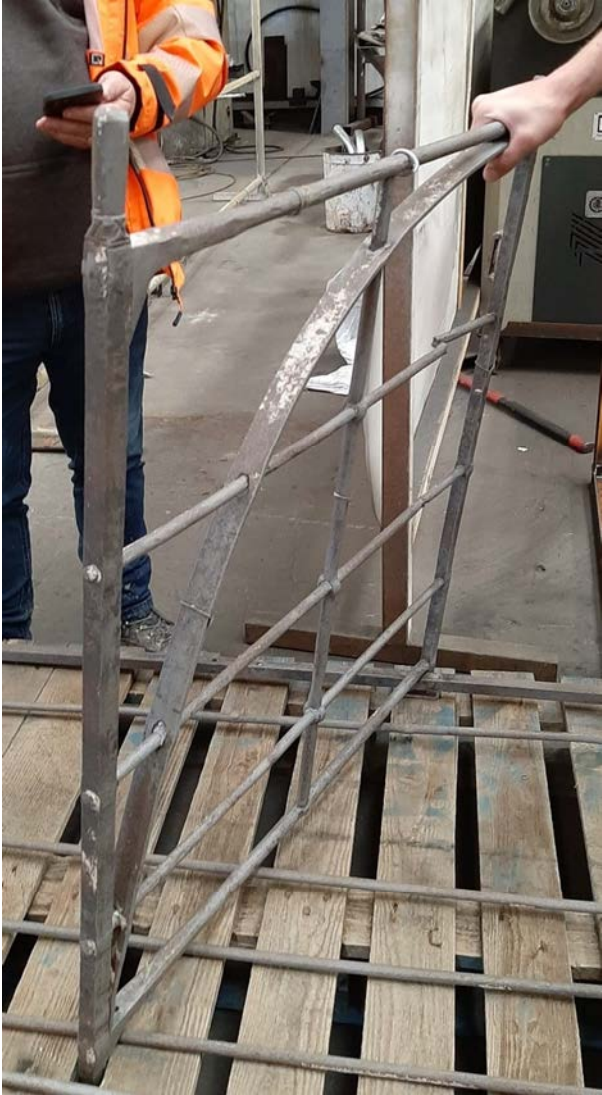
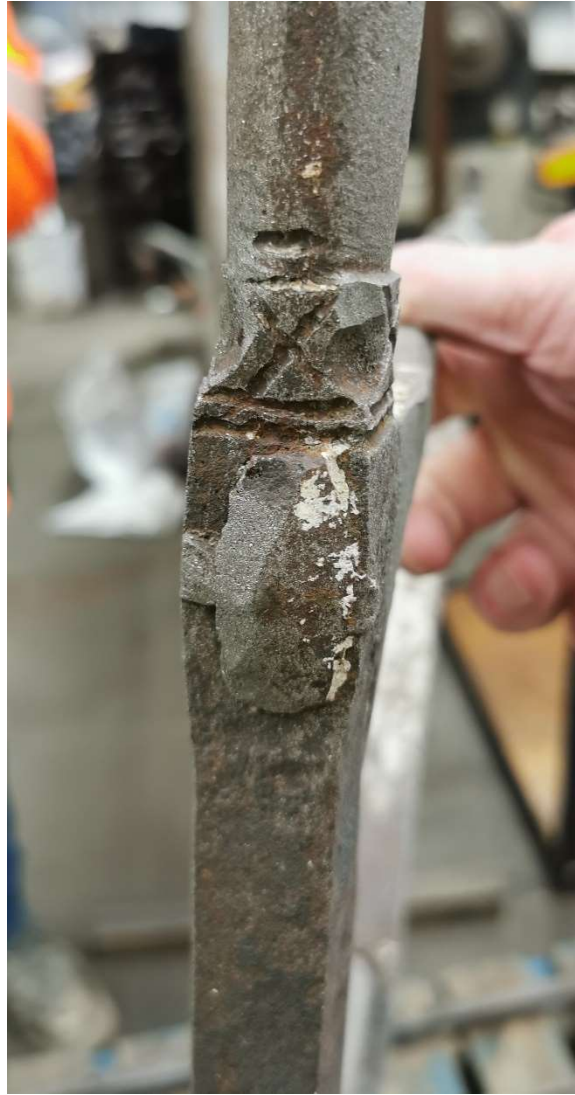
Pedestrian gate (Coillte side) with blacksmith mark

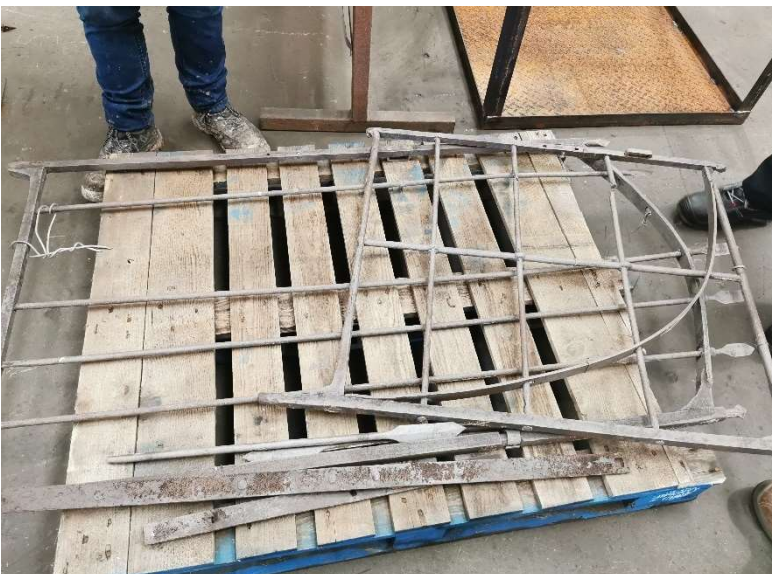
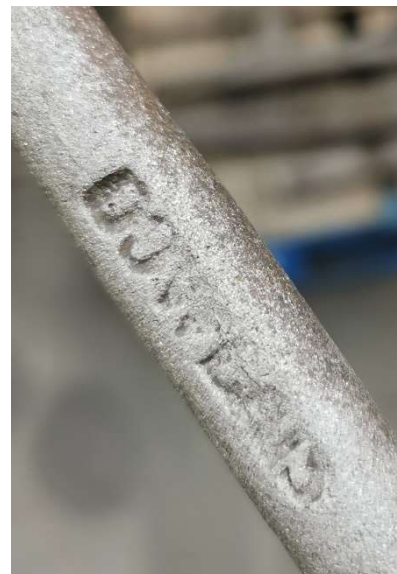
Taller pedestrian gate (Castle side) with spear finials, DOWLAIS Foundry stamp

Note also: Upright on site with T & D Roberts, Mountmellick Foundry. At the workshop we spotted another stamp which appears to be DOWLAIS. See [https://en.wikipedia.org/wiki/Dowlais\\_Ironworks](https://en.wikipedia.org/wiki/Dowlais_Ironworks)

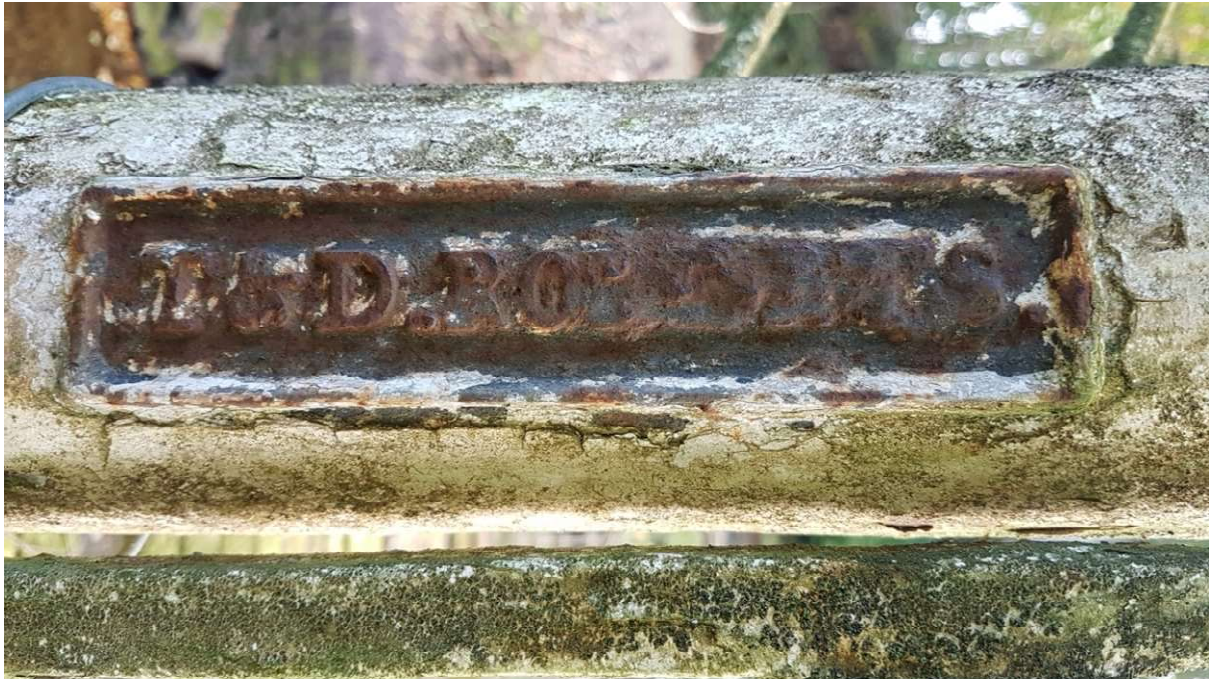
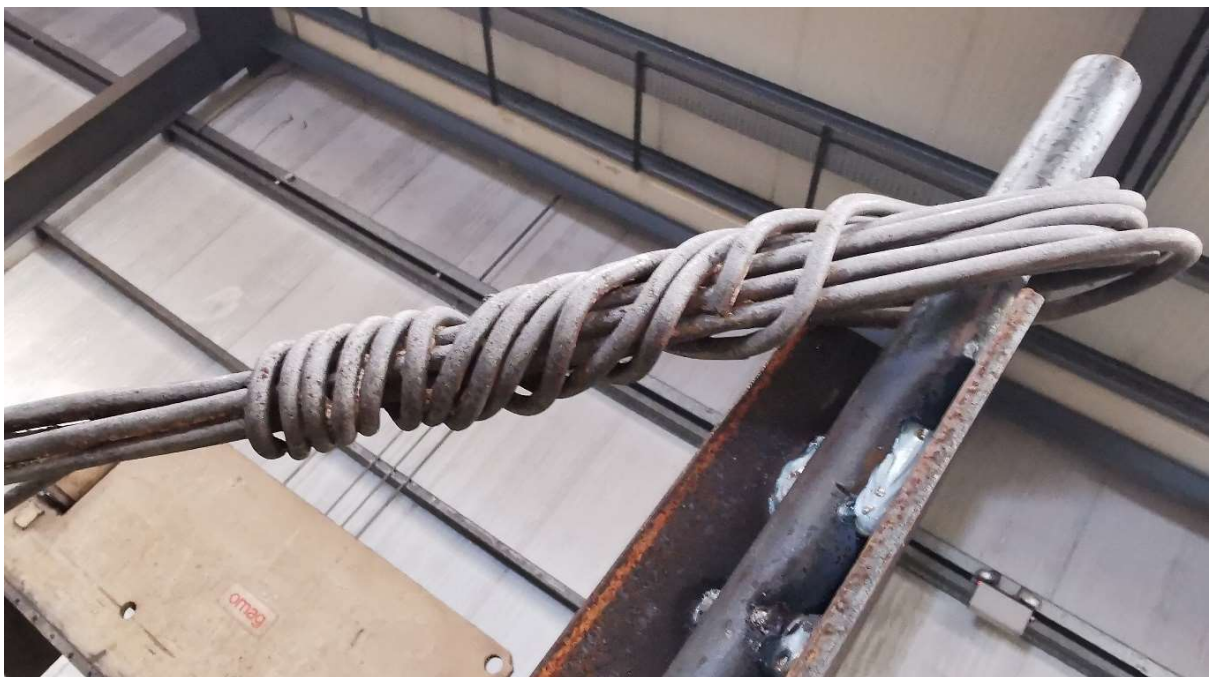
Top chord fixing detail to uprights (viewed at an angle)

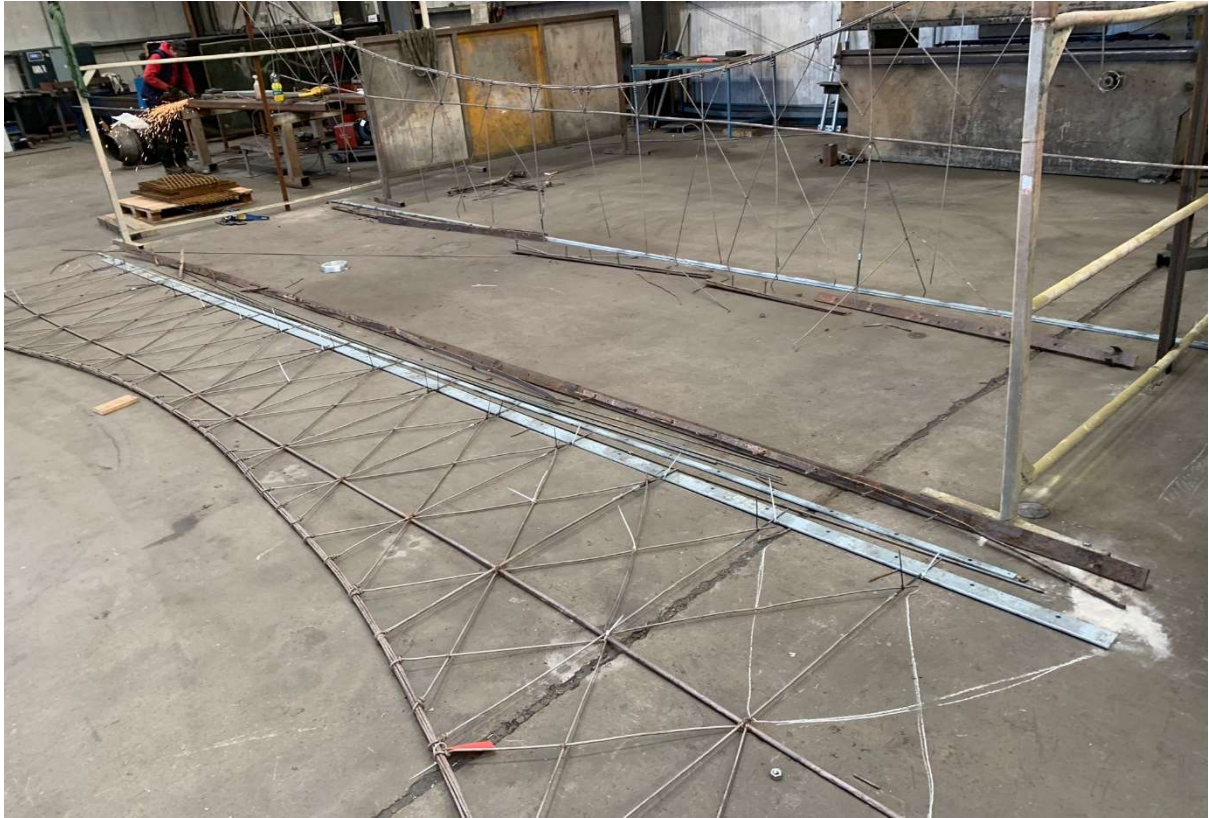
**Workshop images: 2021\_1022** New bottom rail prepared to take existing supports

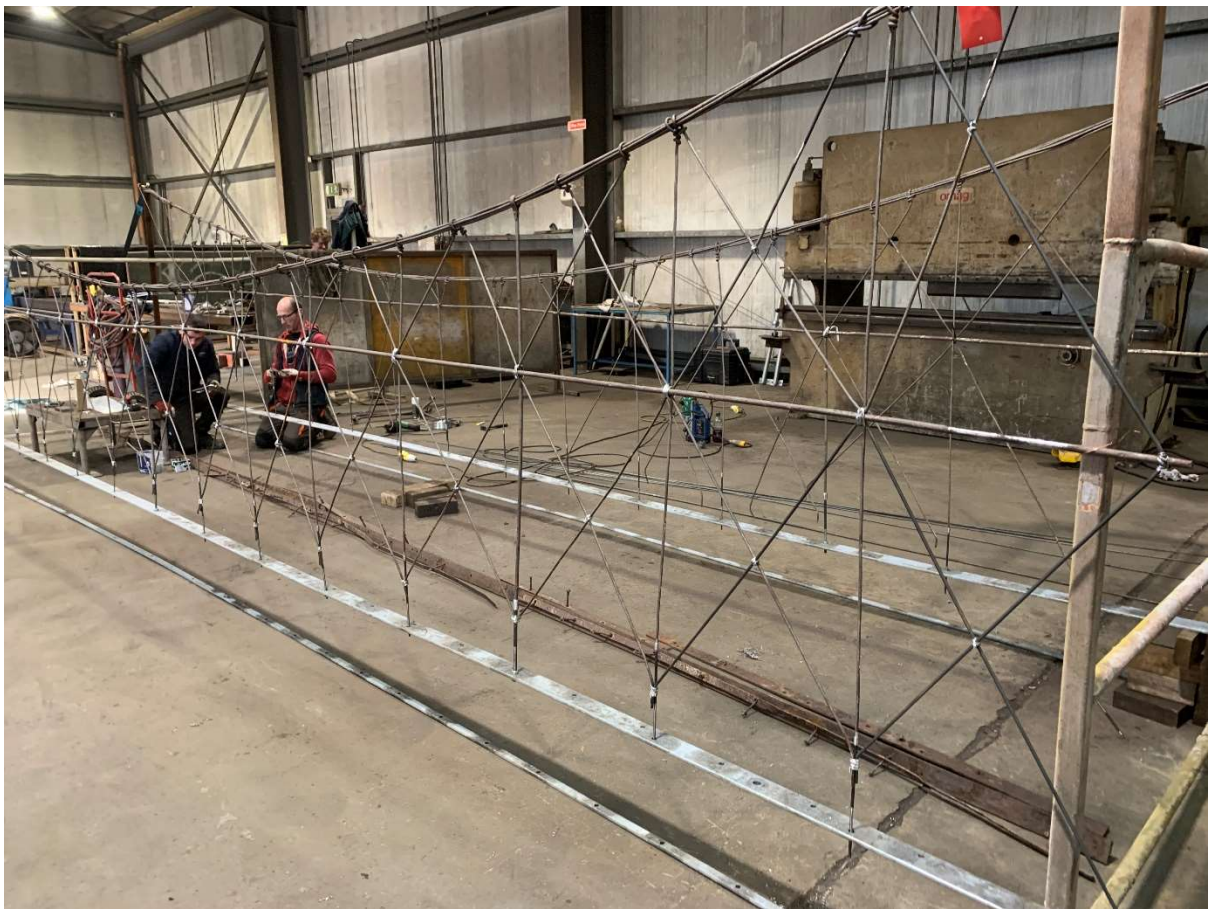
**Workshop images: 2021\_1102** Supports with couplers added to fix to bottom rail

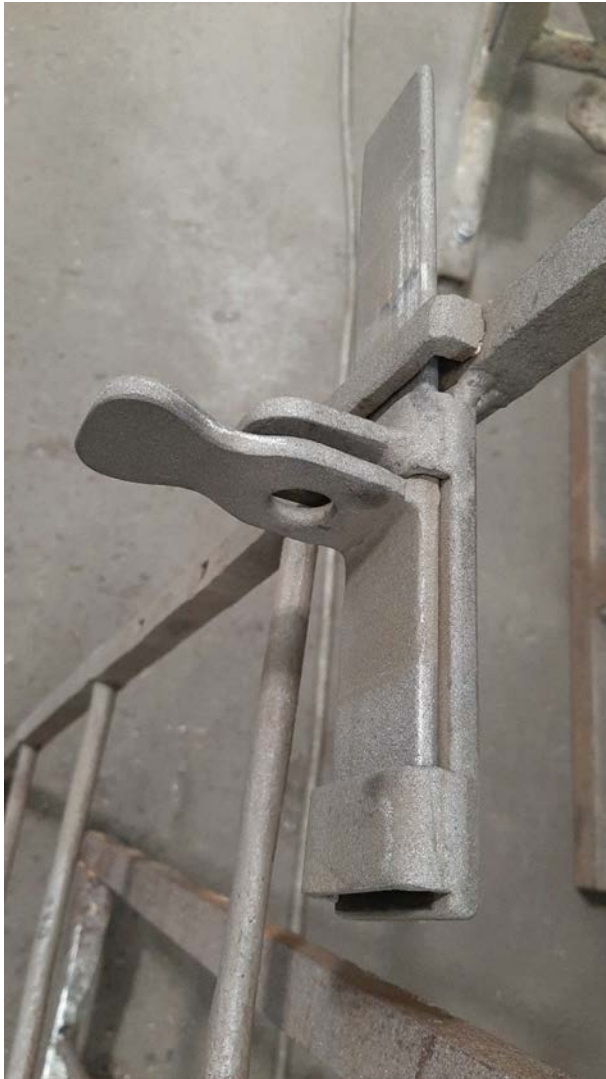
Pedestrian Gate – Existing drawbar
