## Creative Ireland Projects 2021 – Follies Project

### **CI Folly Project Kinnitty Suspension Bridge, Kinnitty Demesne, Birr, Co. Offaly €10,000**

Repairs to the existing bridge include replacement timber deck and steel flats, repair of existing cast iron frames and main cables. Repair and minor replacement of wrought iron stays, hangers and latticing. Proposed works a combination of direct labour by Coillte and specialist contractor.

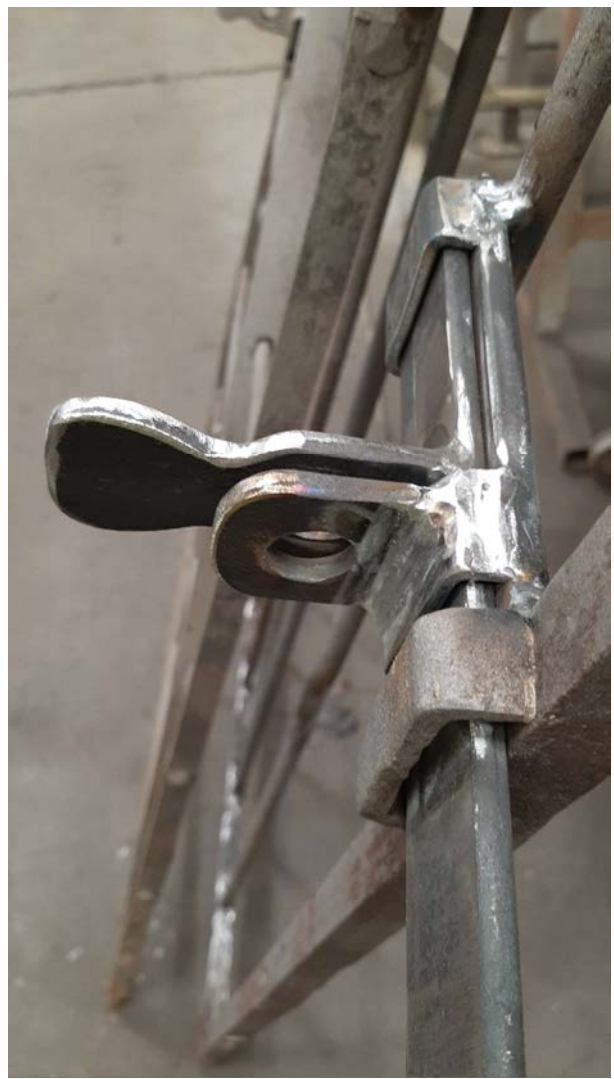
New matching drawbar

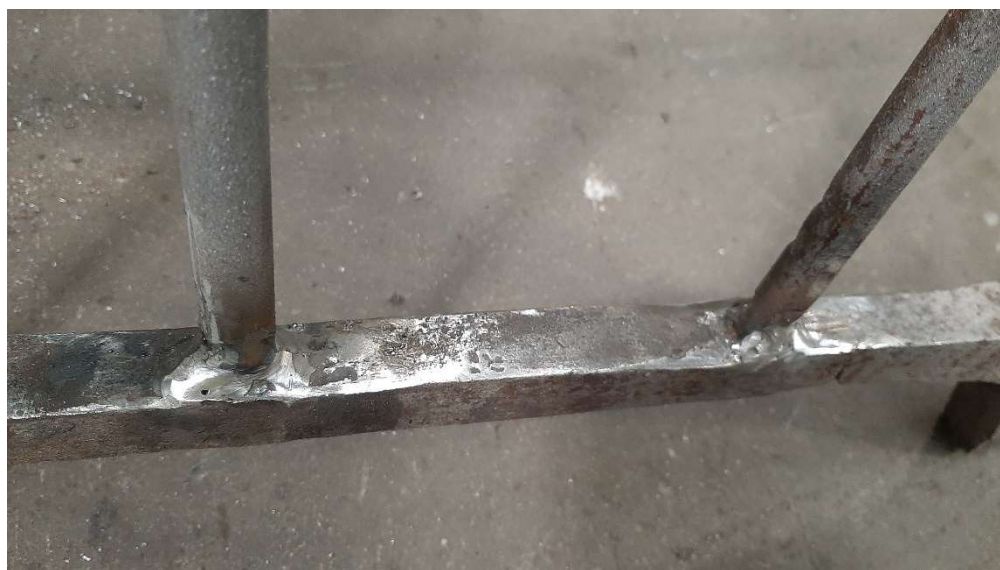
Repairs to bottom rail of gate – retaining original material

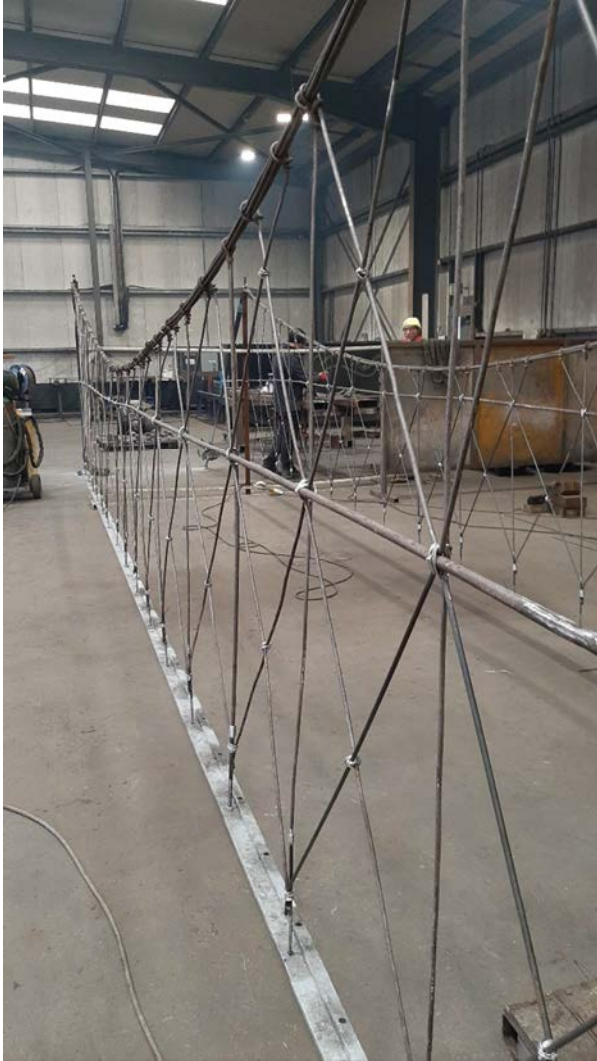
Bridge repairs underway

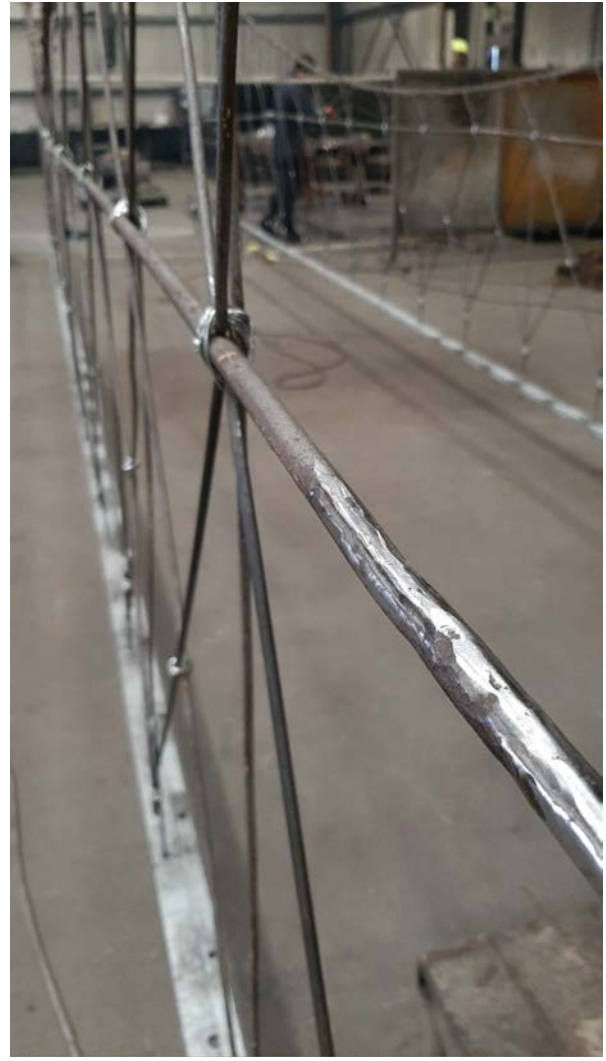
Welding new sections where required to horizontal rail

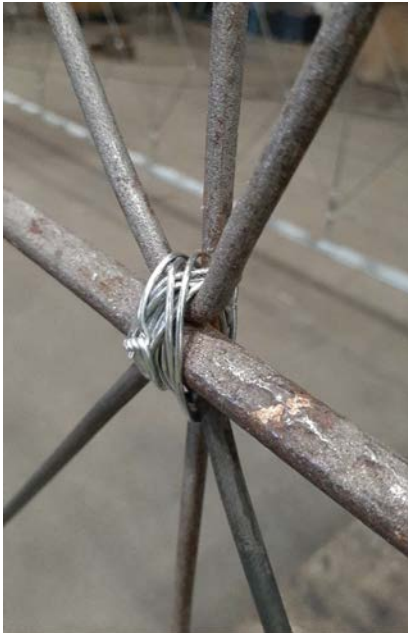
New wire binding

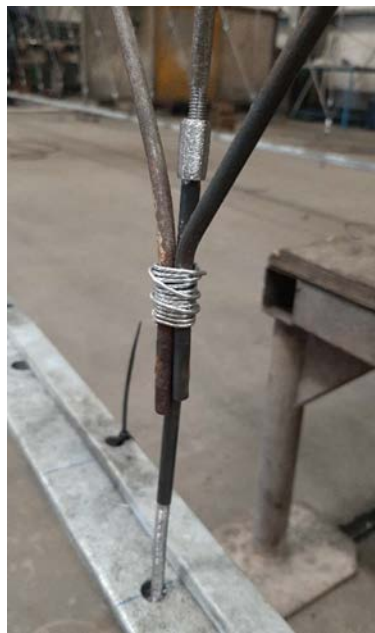
End detail reading for timber deck

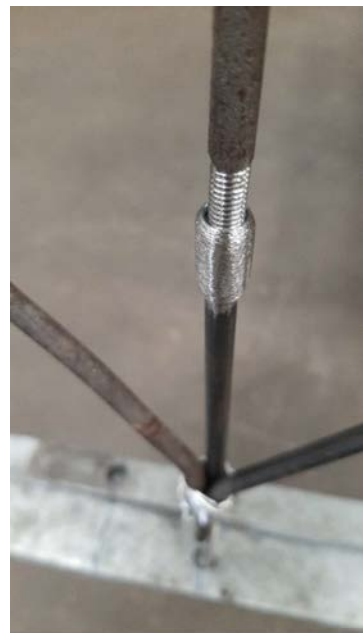
Threaded fixing to coupler

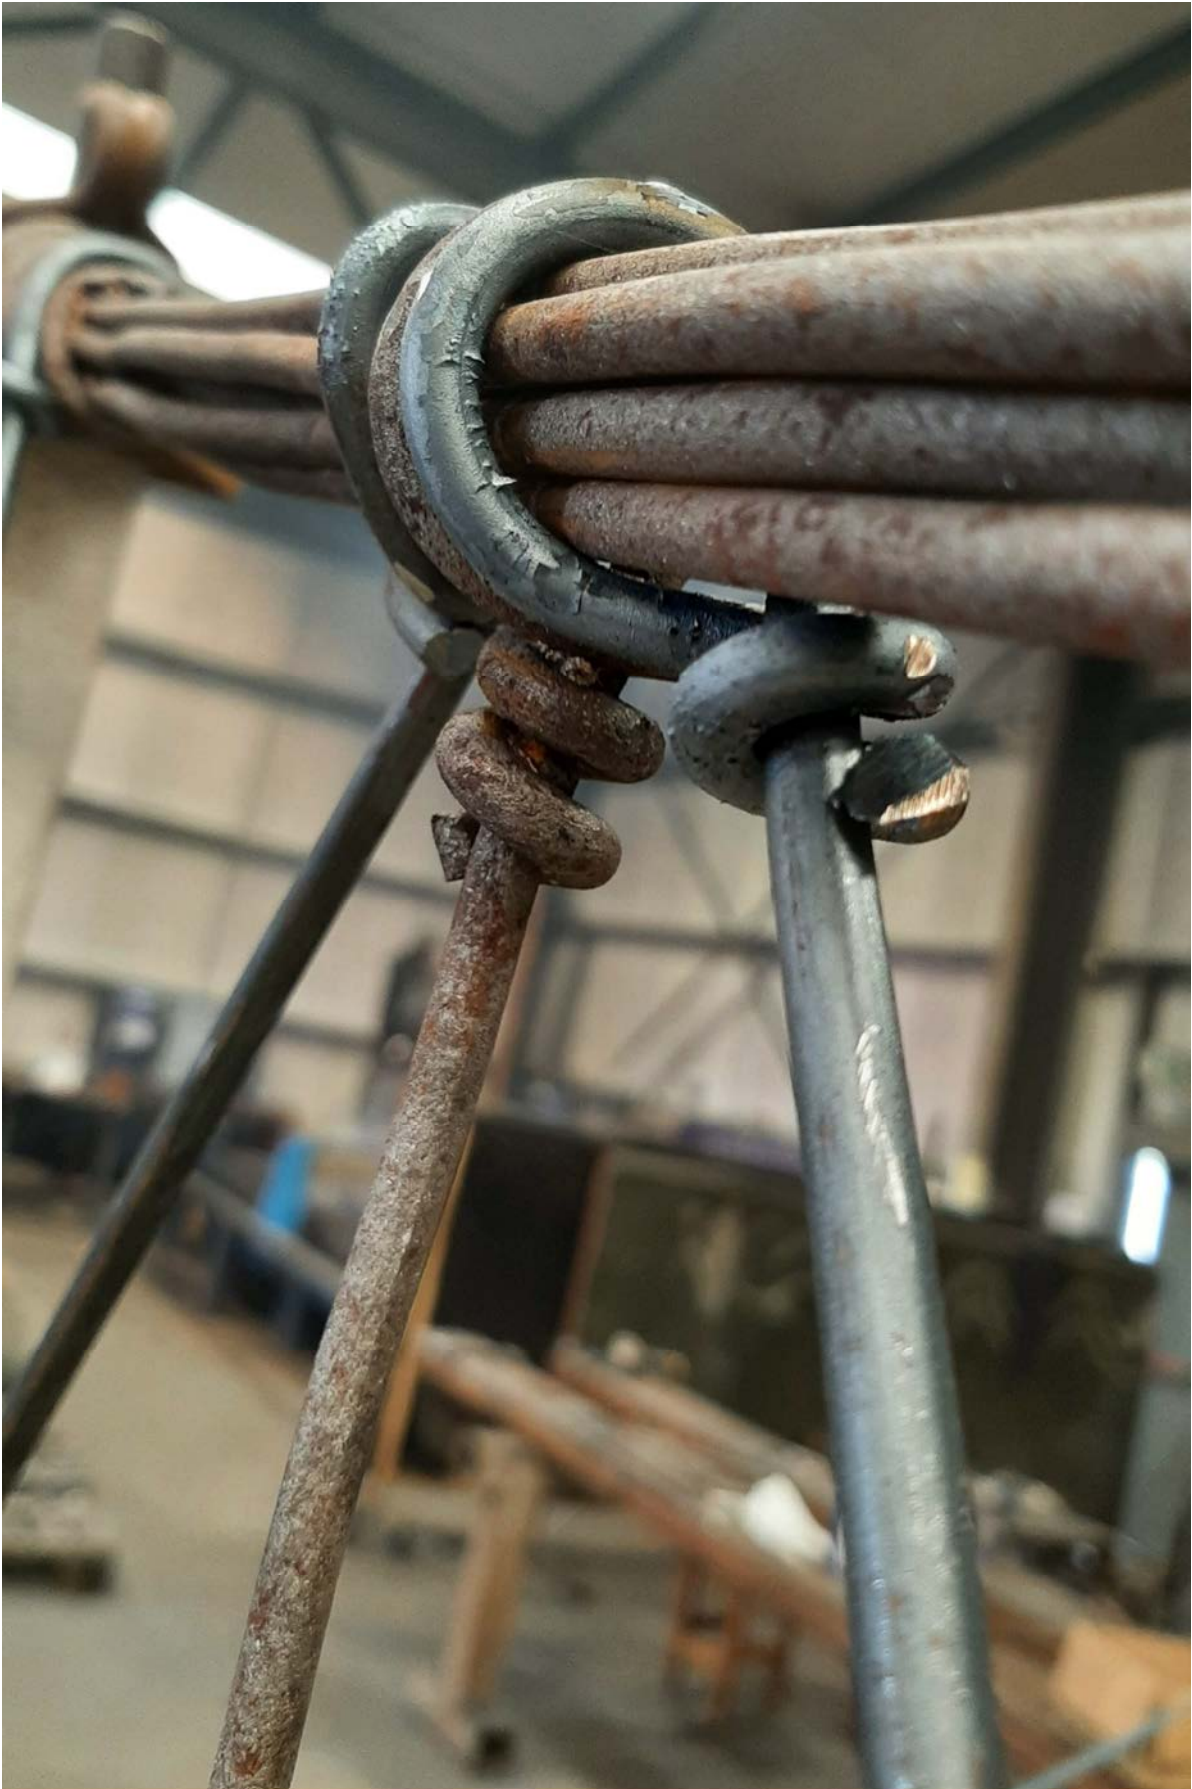
Original and new diagonal support with graceful twist detail to match

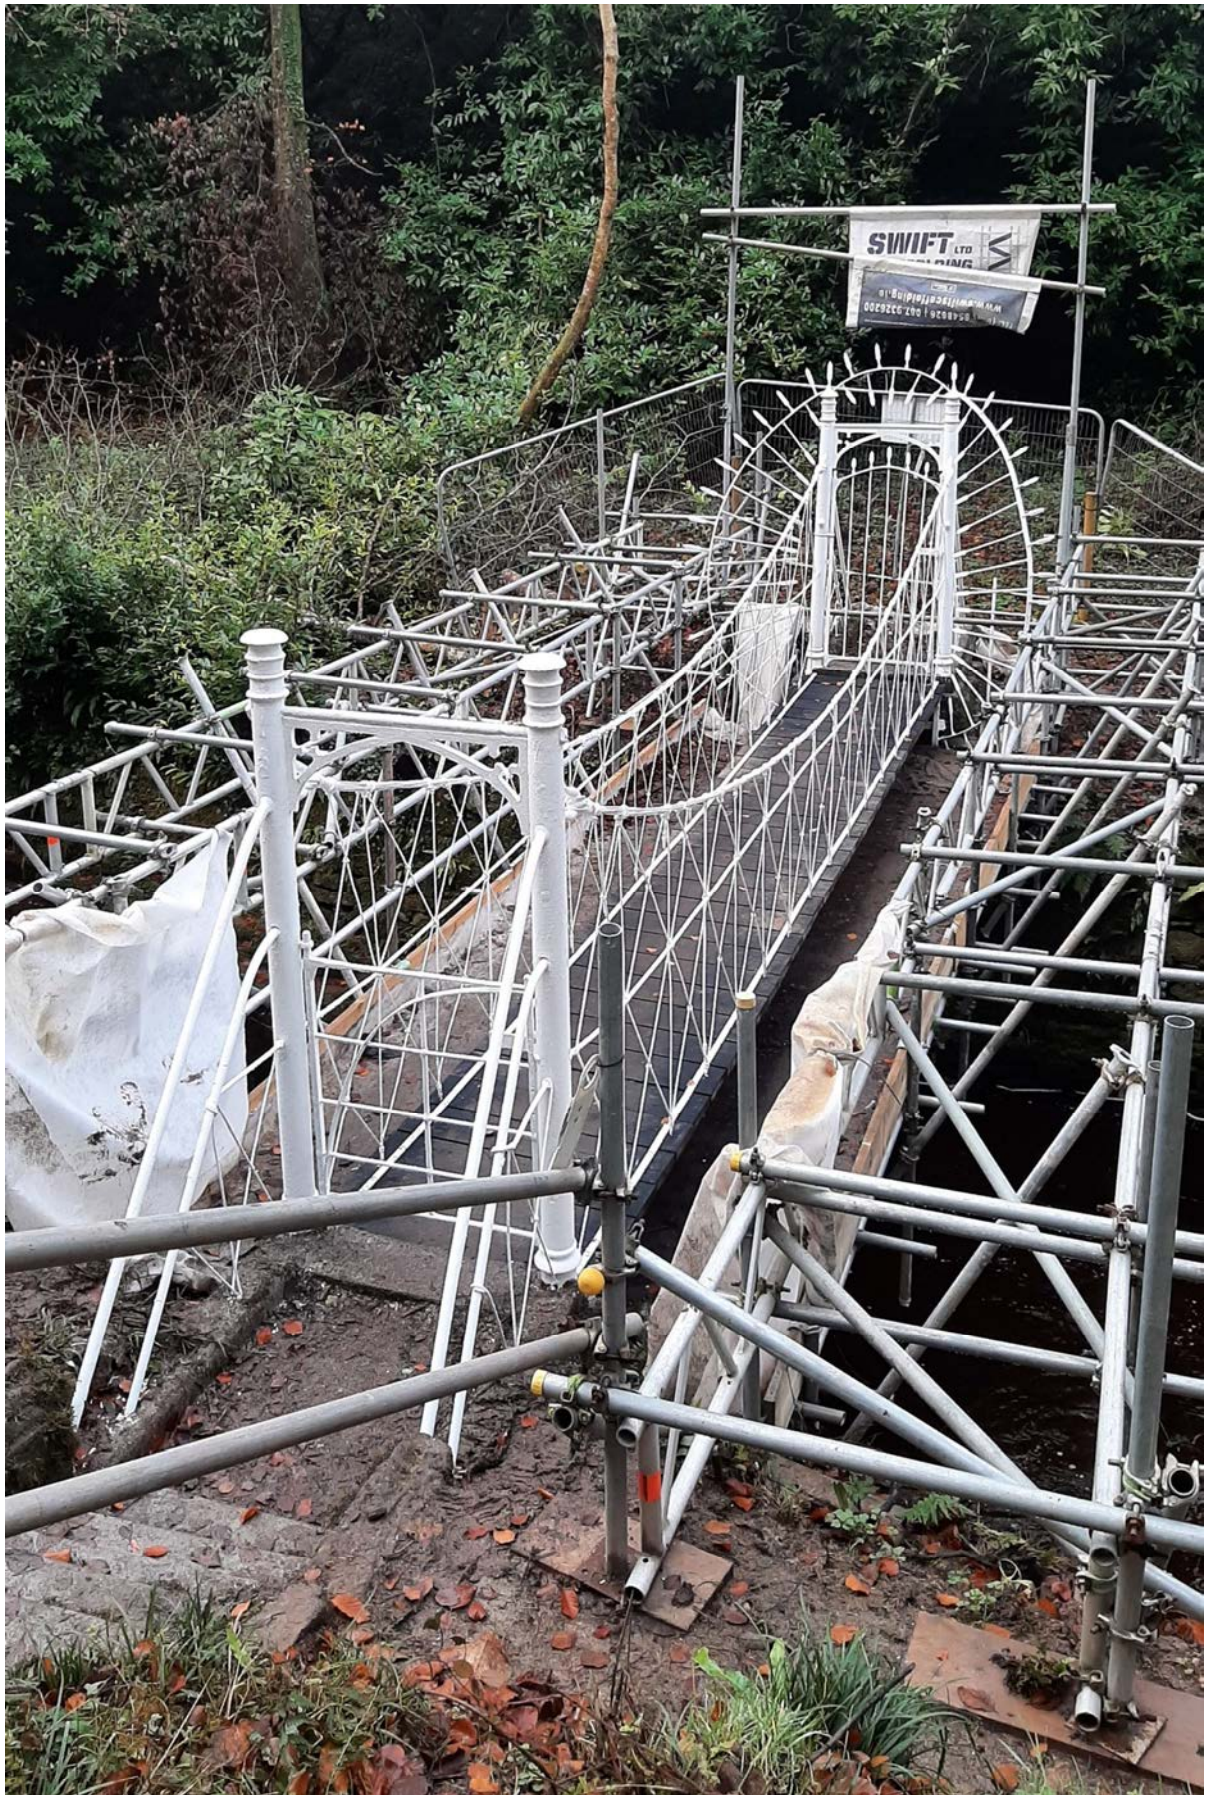
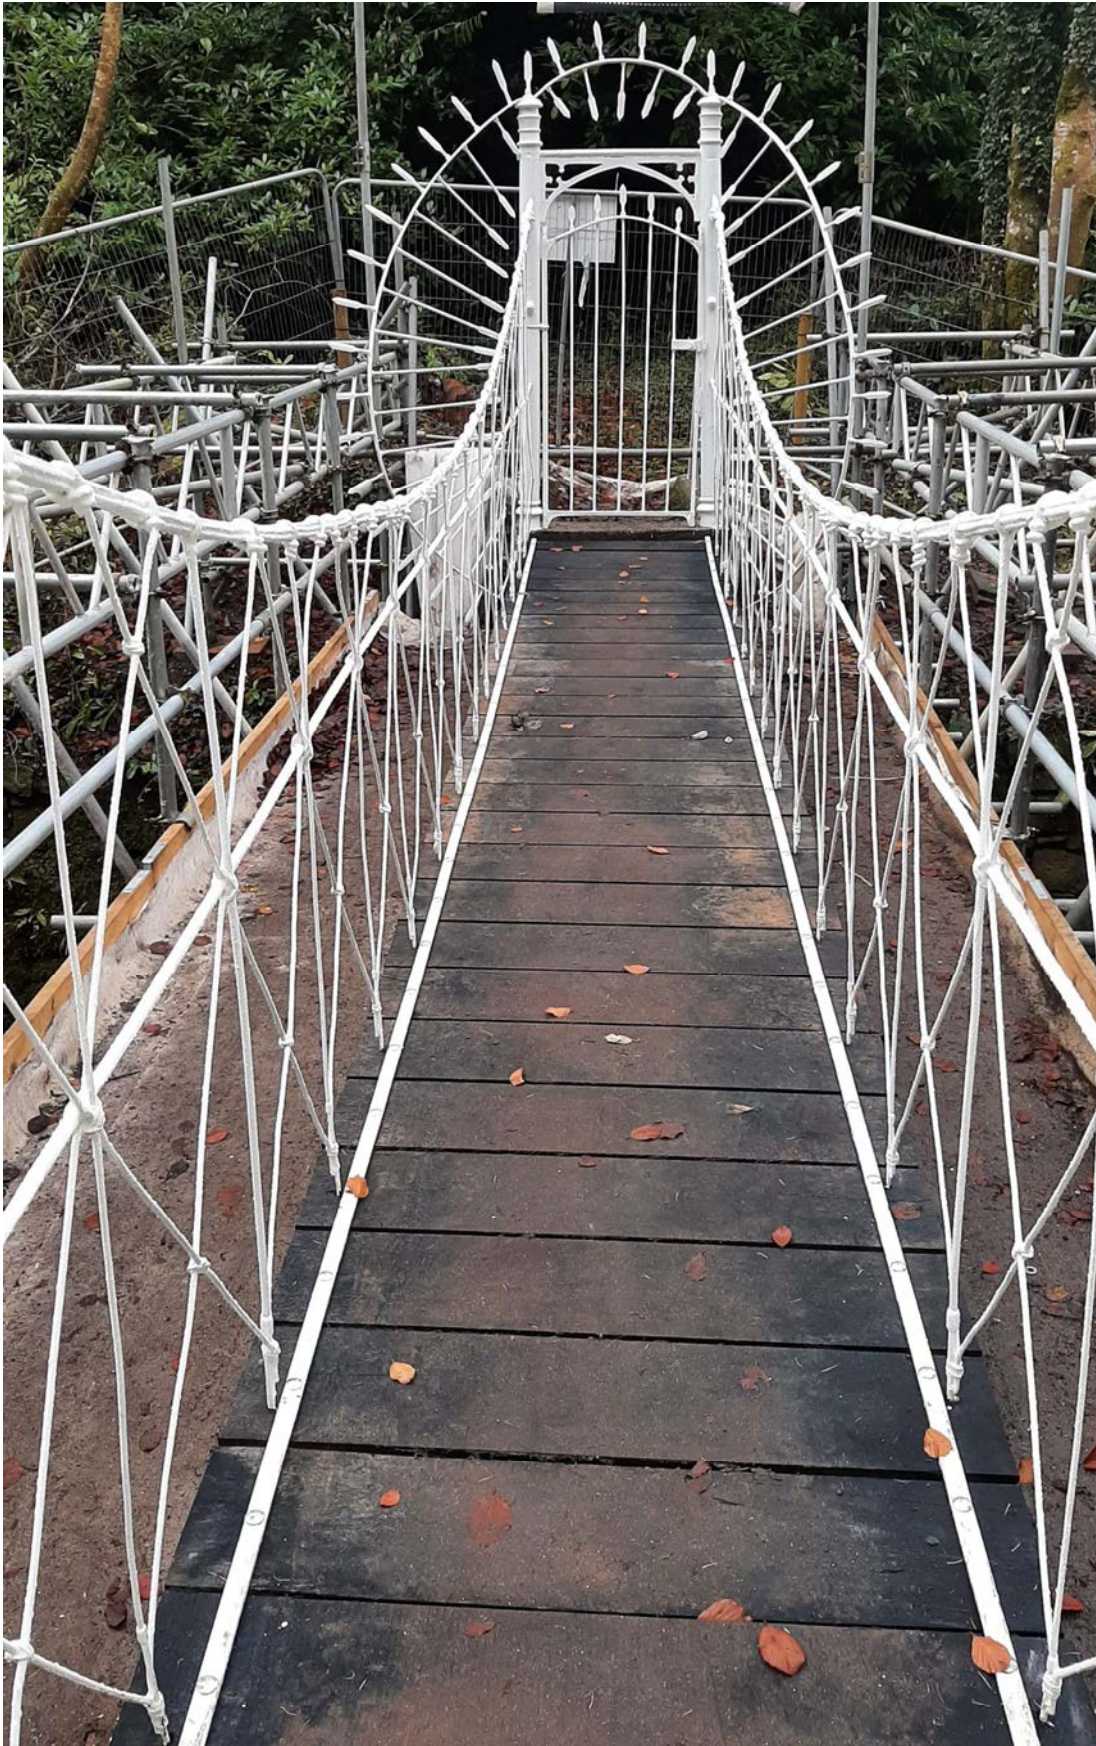
New timber deck with Oak from the estate by Coillte, diagonal supports and the delicate connection through new decking to horizontal bar below as per original detailing

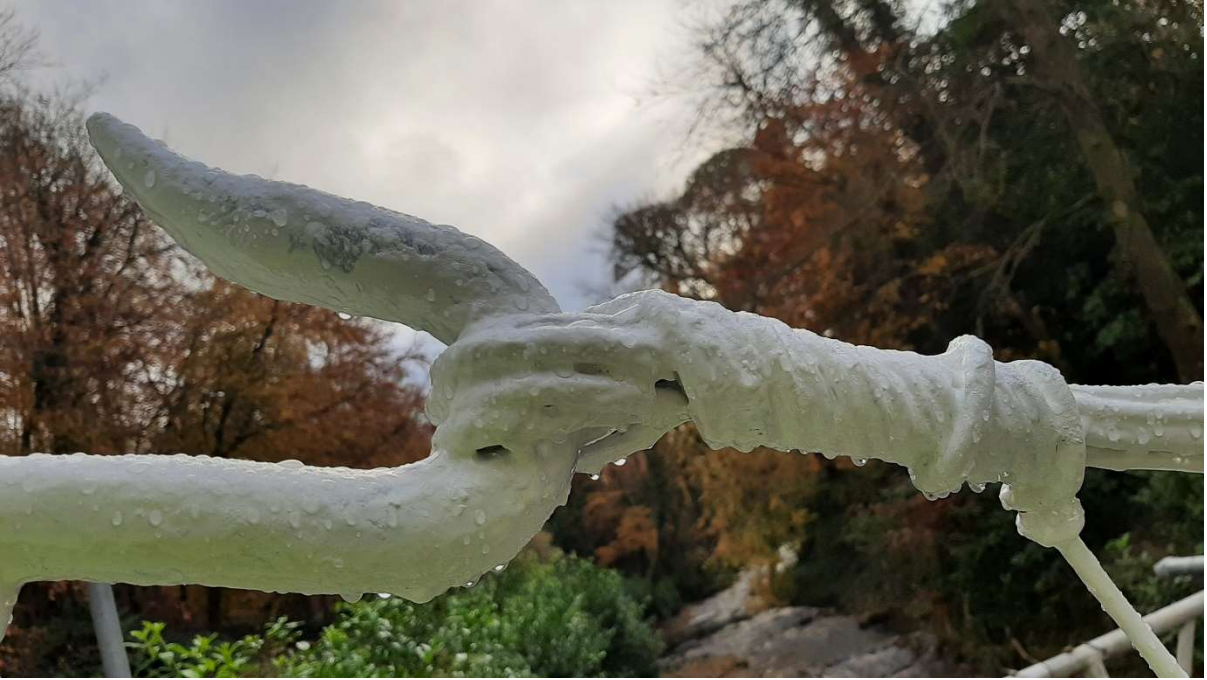
Top chord fixing detail to uprights

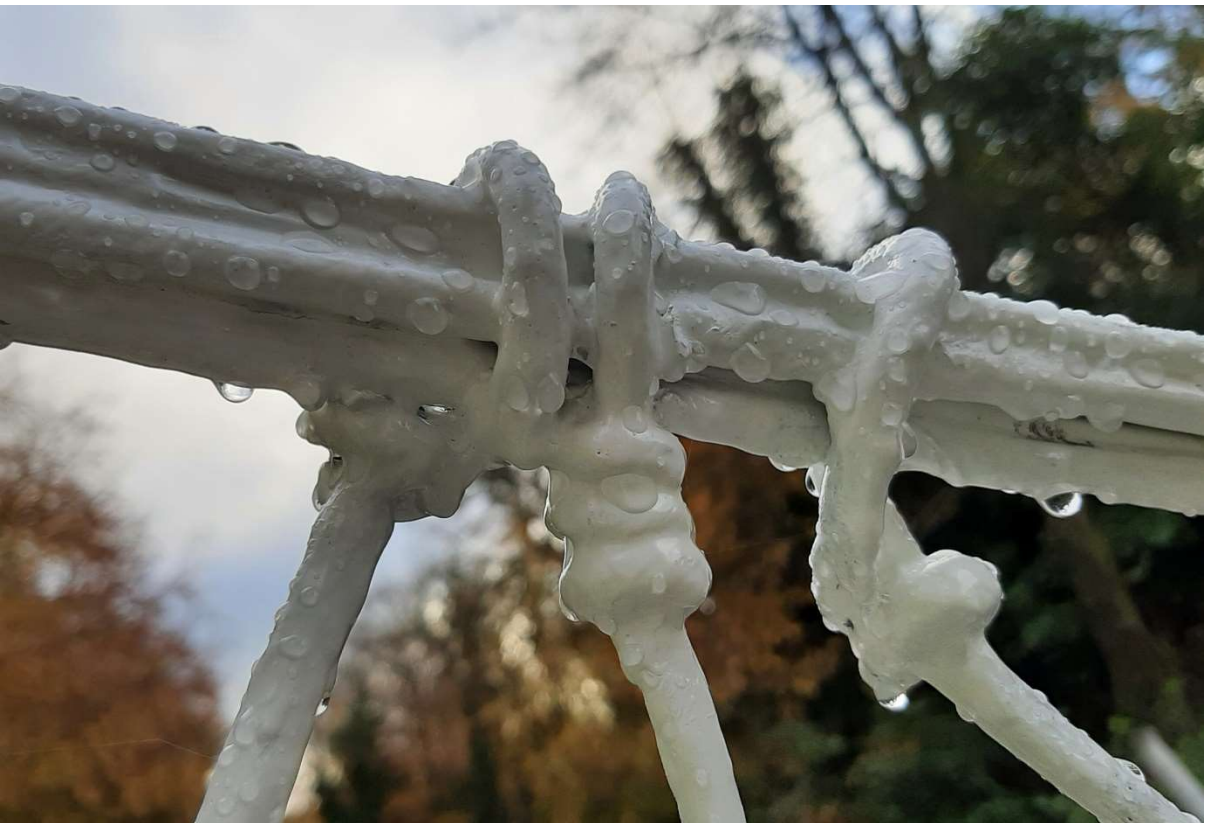
Freshly painted diagonal and horizontal connections to top chord

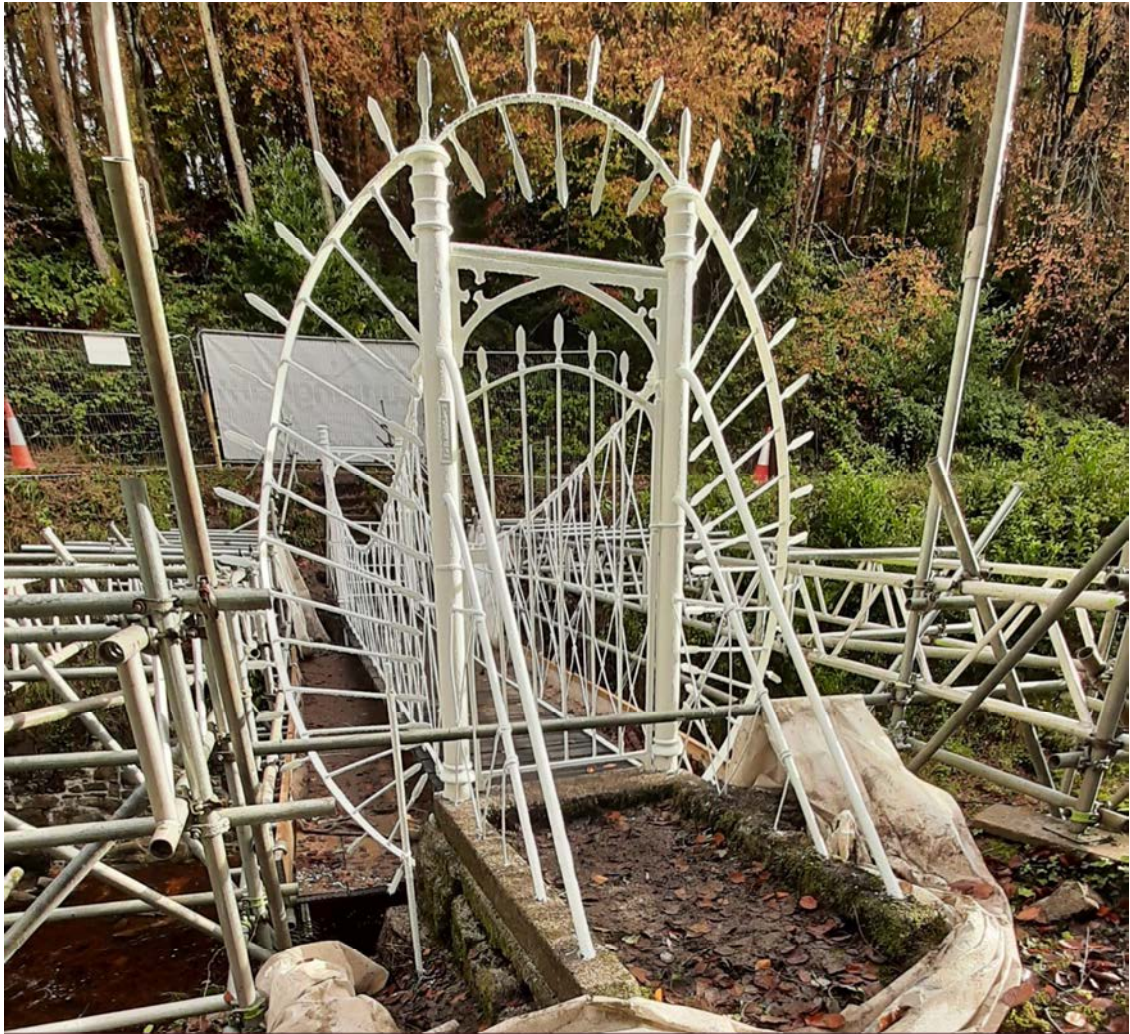
Castle side with full height gate and spear finials in place

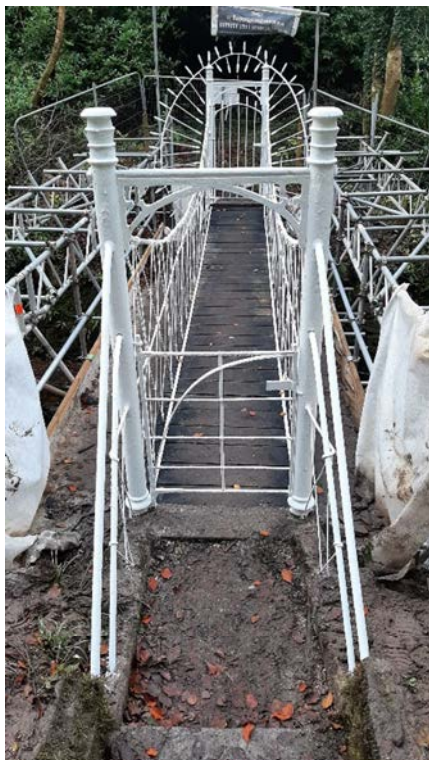
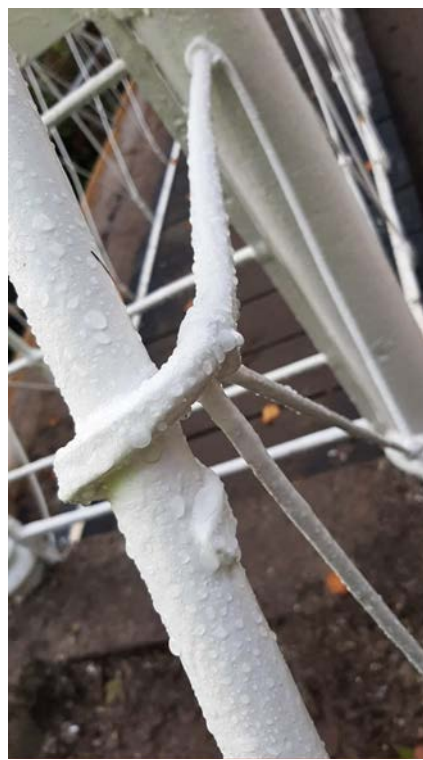
Coillte side gate in place and elegant side connection details

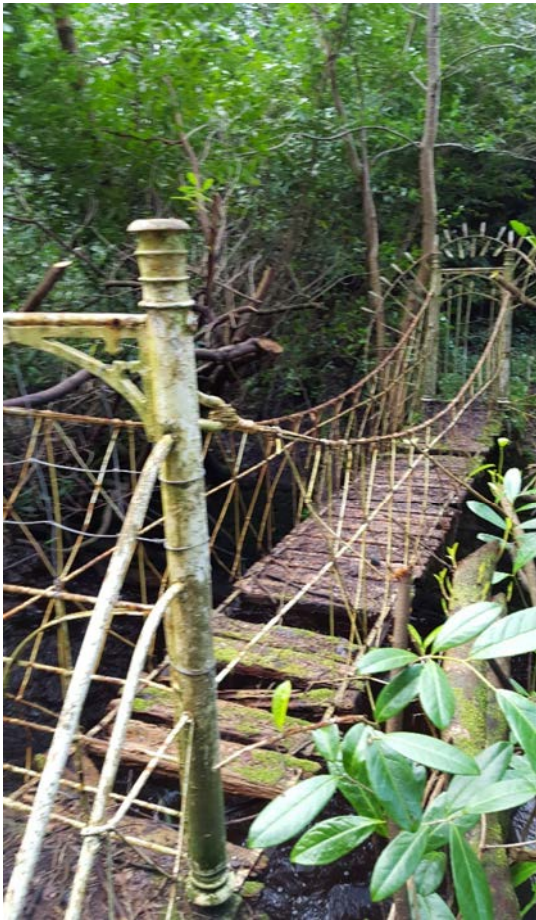
Prior to works, missing sections

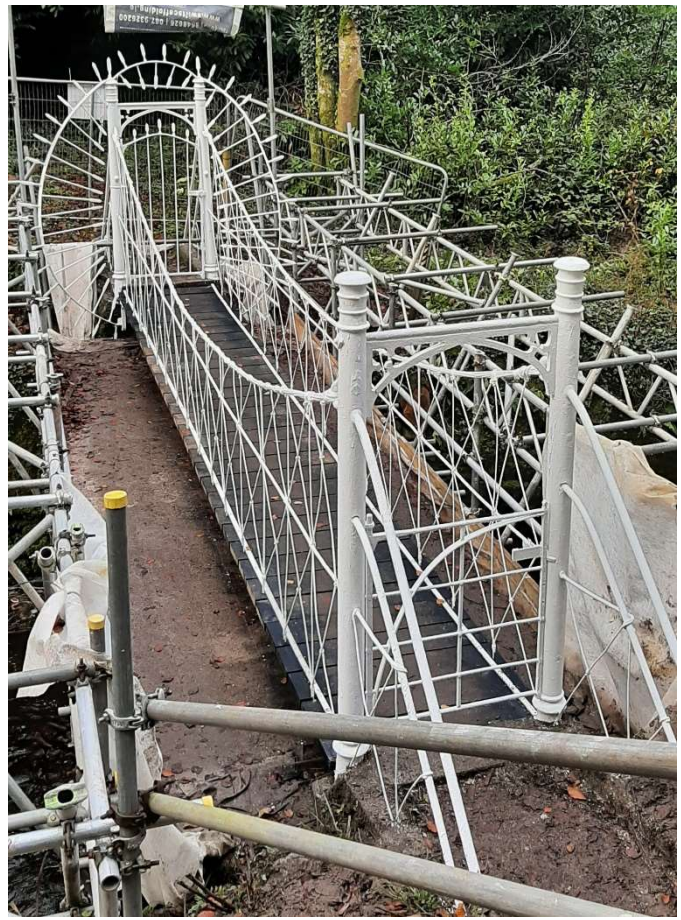
Back in place, repaired and conserved

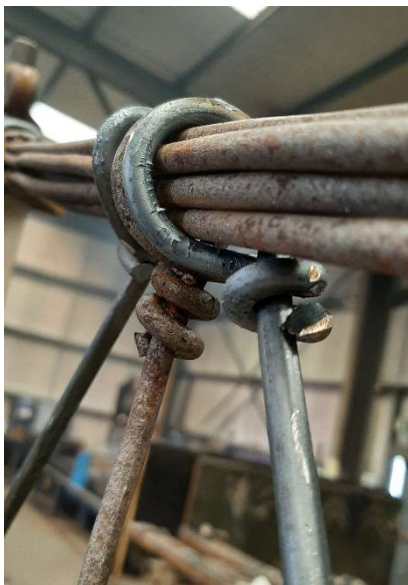
Replacement and original sections

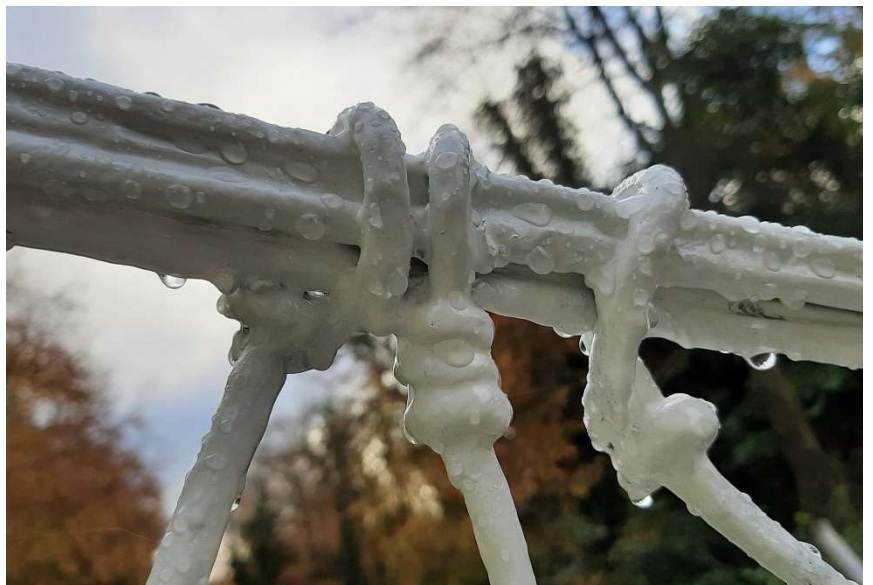
Painted and back on site
