# DURROW ABBEY, CO. OFFALY

## CONSERVATION PLAN

September 2005

HOWLEY HARRINGTON ARCHITECTS

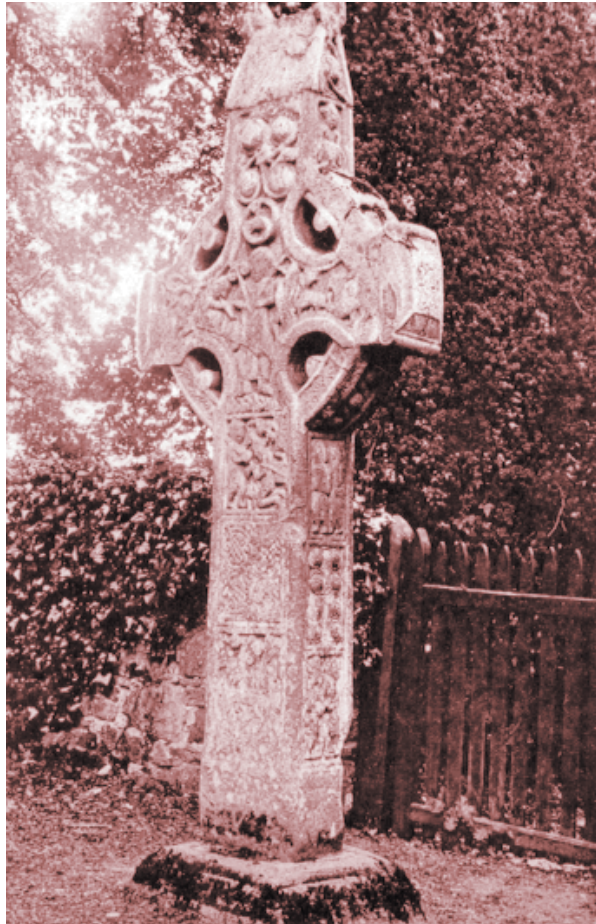
Durrow High Cross, east face

in the nave of the St. Columba's Church. The head, arms and shaft of the cross, measuring over three meters tall, are carved from a single block of sandstone. The cross is carved with a number of biblical themes and geometric motifs. The base of the cross bears a number of plain panels. An inscription on the north face of the cross has been tentatively interpreted as mentioning Máelsechnaill, the Uí Néill high-king of Ireland, who succeeded to the kingship of Tara in about 846. In addition to the principal high cross, there are three stone fragments representing the remains of a number of other crosses. One of these, the head of a small sandstone cross, was re-used as a finial on St. Columba's Church, and has since been removed to the National Museum of Ireland. Another fragment, a cross base known as the 'Headache Stone' on the

The high cross (OF009:00510) formerly stood immediately within the opening at the west end of the graveyard but has recently been relocated to the interior of the church. It is currently covered in protective timber shuttering while repair works are ongoing at the church. The head, arms and shaft are carved with biblical scenes and geometric motifs and the shaft is surmounted by a cap in the shape of a church or house-shaped shrine. A number of panels on the base of the cross are plain.

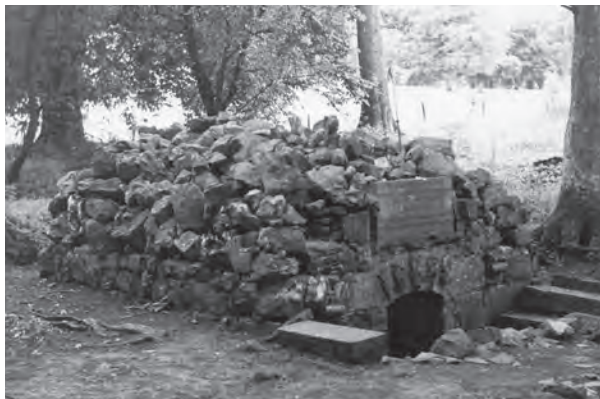
and stream and on the south, southeast and southwest sides by a very low bank and stream. A holy well dedicated to St. Columcille is located in the centre of the island. The small spring, which is accessed by stone steps, is covered by a barrel vault of small boulders. Despite its relatively modern appearance it is possible that the well was a place of devotion from the early medieval period. The well is venerated every year on the pattern day, June ninth. The first record of the pattern was in 1463, when an archery contest took place between the O'Catharnachs of Durrow and the McGeoghigans of Westmeath<sup>14</sup>.

St Columcille's Well

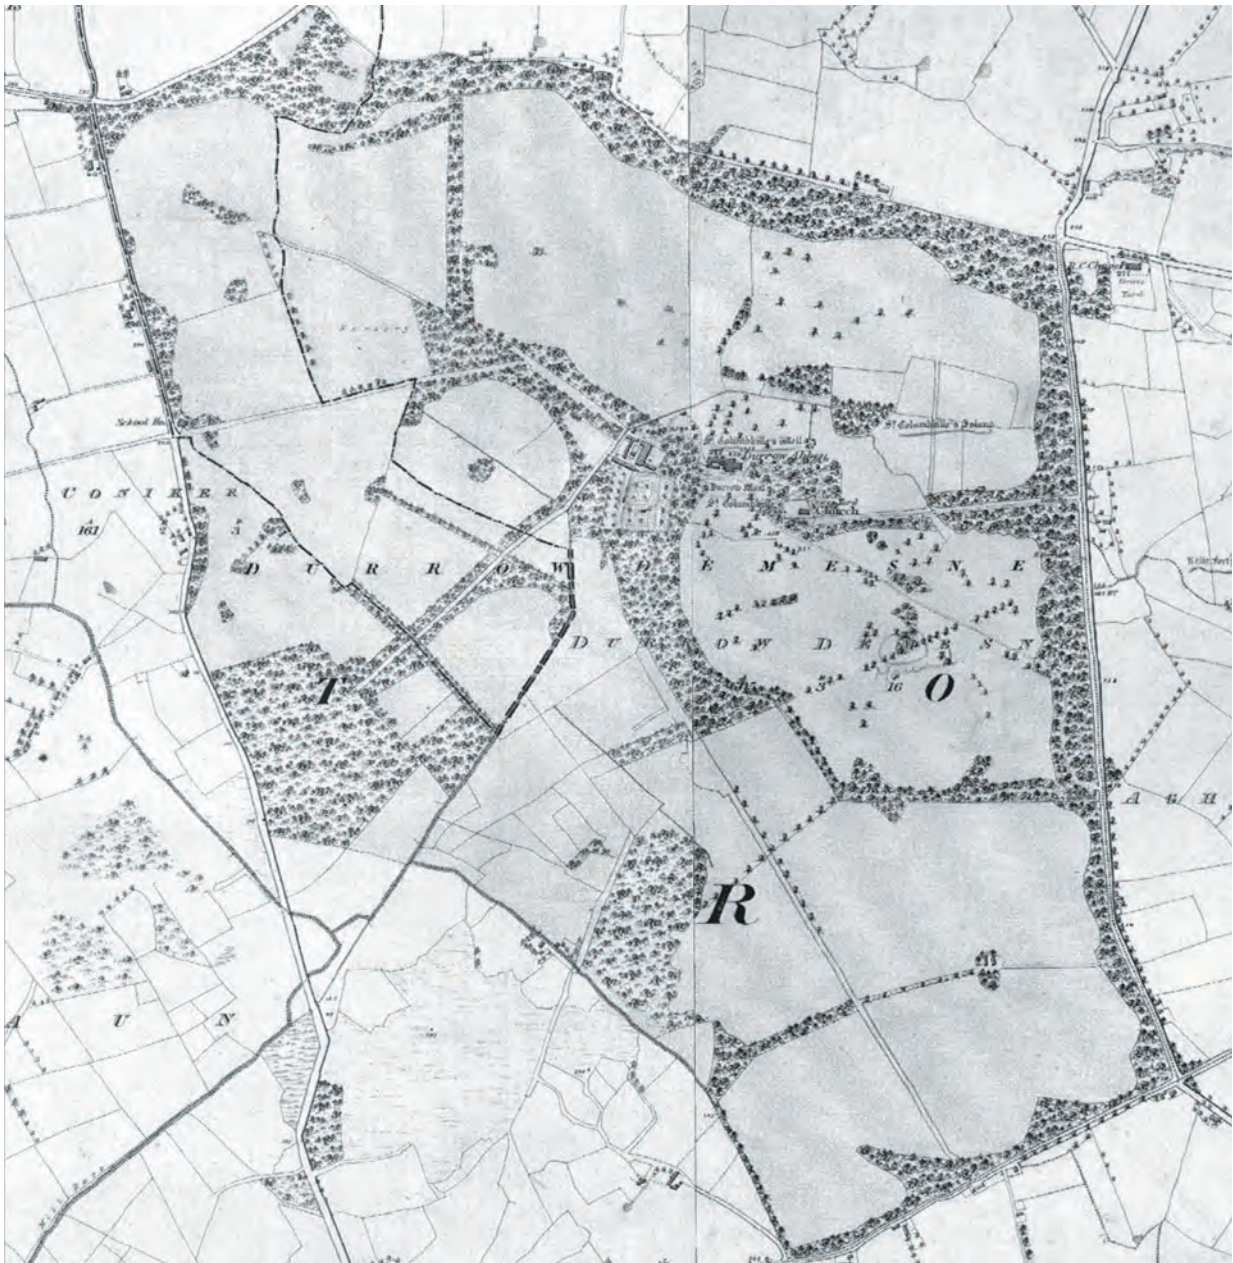
1837-8 Ordnance Survey map of Durrow Demense

The first edition Ordnance Survey map of 1837-8 shows a mature and well planted demesne at Durrow Abbey. Throughout the nineteenth century additional buildings and features were incorporated into the demesne design. These included gate lodges, cottages and an interesting octagonal ended structure in the walled garden. On top of the motte a rusticated stone structure was built using grotesque river worn limestone.

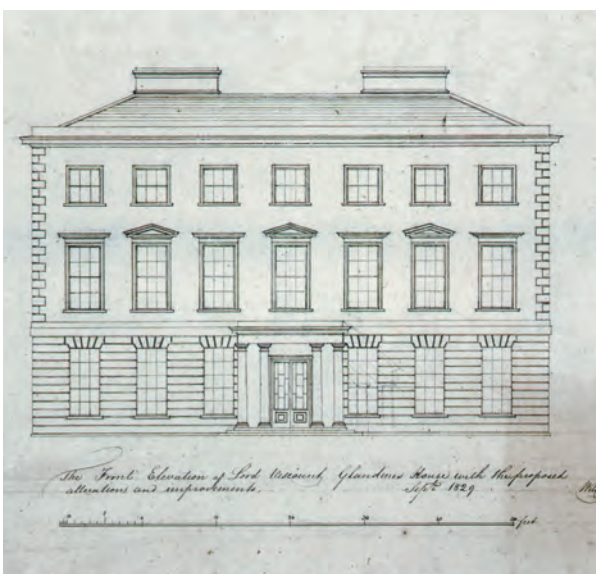
William Murray proposal drawing for Durrow Abbey, 1829

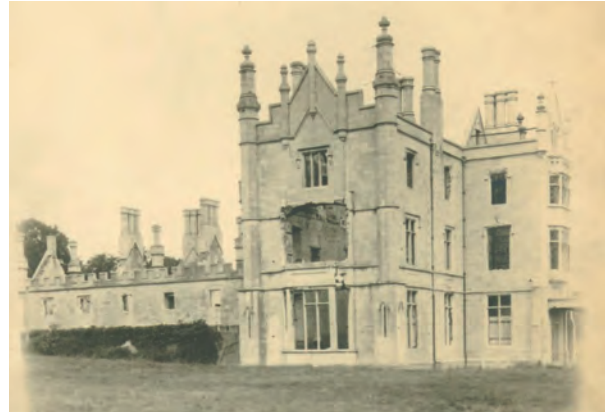
Durrow Abbey following fire of 1923

Durrow Abbey House was gutted by fire during the Civil War in 1923. Ralph Byrne of William H Byrne and Son, the Dublin based architects, was employed to oversee the repair and reconstruction of Durrow Abbey House for Ottoway Graham Toler in 1926.

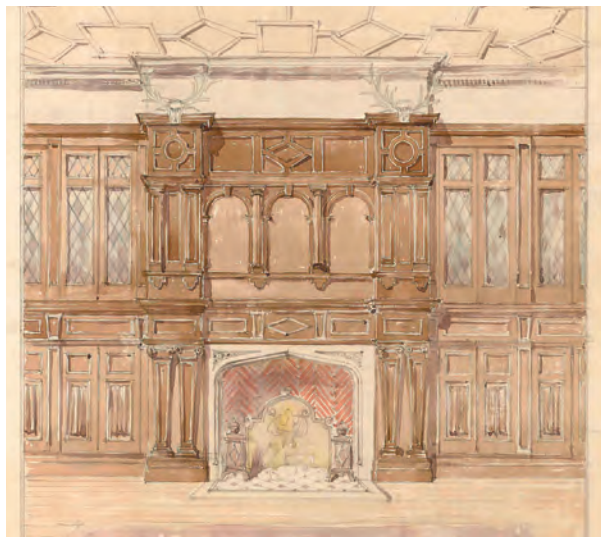
William H. Byrne, proposal drawing for library

The main block was also to be extended westwards by an additional bay providing a drawing room and morning room at ground floor and bedroom and dressing room at first floor level. A sketch for the entrance hall shows a double height Arts and Crafts

style panelled room with inglenook built around the existing fireplace and gallery above. The main staircase was relocated to the south with a panelled library beyond. The library is depicted in a sketch with a moulded plaster ceiling and timber dado paneling with glass fronted bookshelves above. The dining room was relocated to the north of the entrance hall with kitchen in the west range.

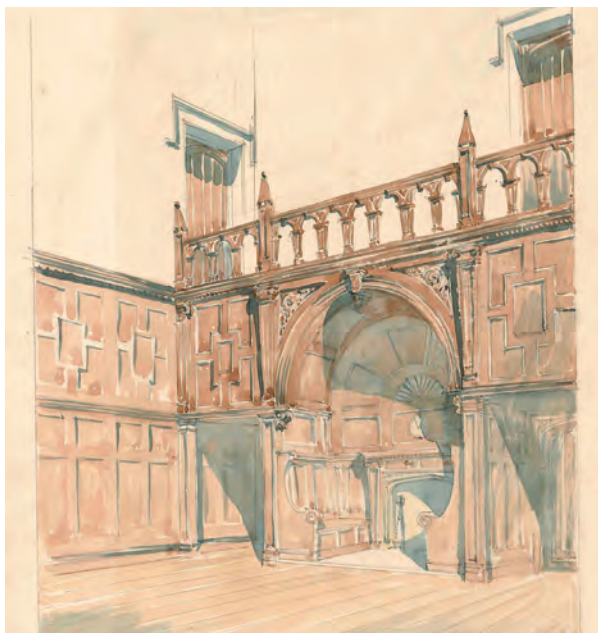
William H. Byrne, proposal drawing for entrance hall

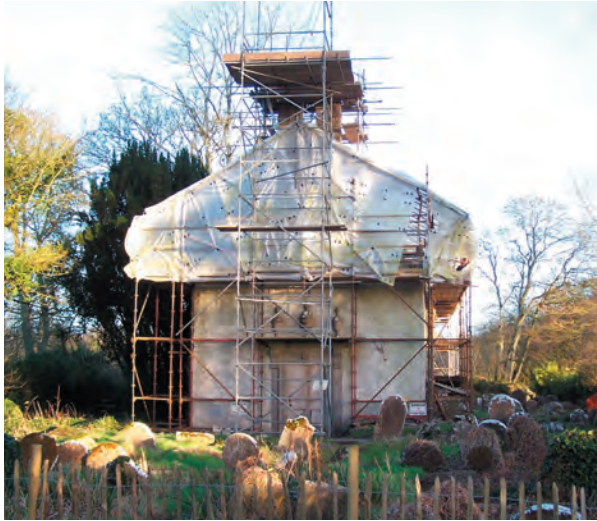
St Columba's Church, from west

Features of archaeological interest within the church include a graveslab commemorating Francis de Renzi of Tinnycross (1665). Detailed investigation of the fabric of the church could not be undertaken due to ongoing repair and conservation works being undertaken by the Office of Public Works.

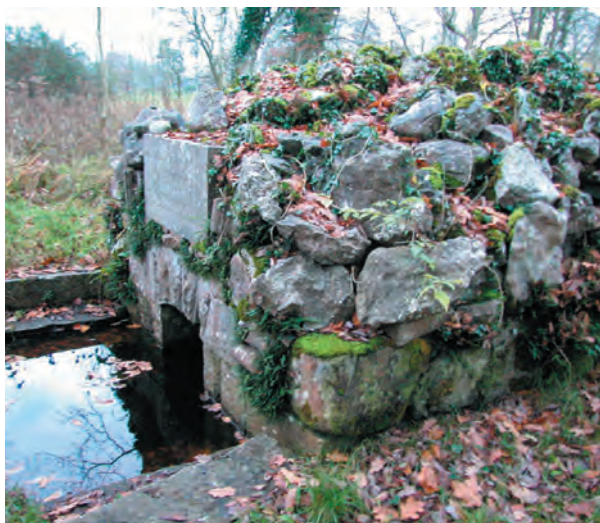
St Columcille's Well

St. Columcille's Well (OF009:00505) is located at the centre of the island. The well is covered by small boulders of granite and limestone and measures 4.3m long, 1.6m wide and 3m high. A number of pieces of carved masonry are visible within the covering of the well. During dry weather the water is accessed by stone steps at the front of the well above which is a stone plaque inscribed with the following words:

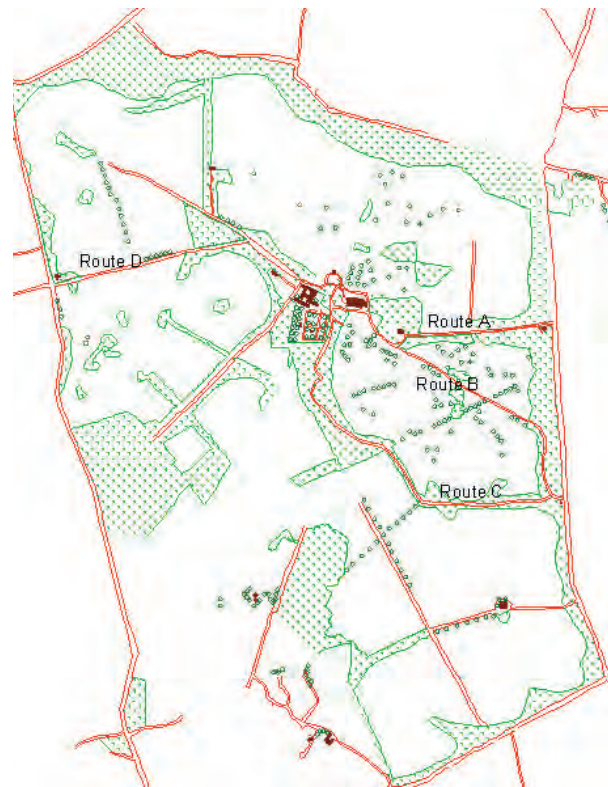
Access roads to Durrow 1837-8

A stretch of road shown on the historic maps leading from the southern demesne boundary (but cut off by the belt of enclosing woodland) is conspicuous. Its extension would lead to the apparent avenue of trees approaching the farm buildings (west of Pheasant Wood and the walled garden) from the south. This may indicate a pre nineteenth-century demesne entrance to a pre nineteenth-century demesne house.

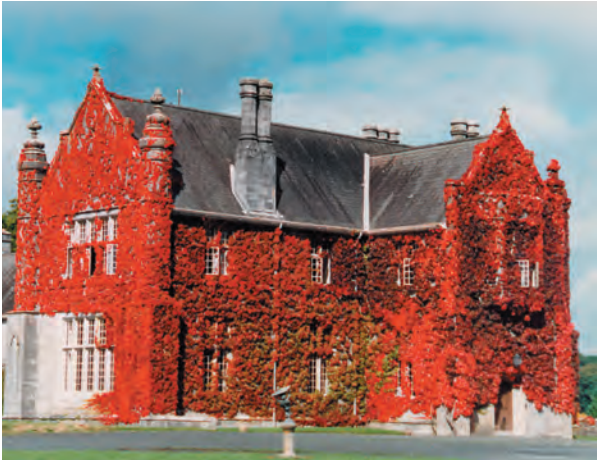
Boston ivy covering east facade of Durrow Abbey House

Boston ivy (*parthenocissus tricuspidata*) was planted beside the house in the twentieth century and now covers large expanses of the walls. However, the

tight and sound. A very old growth of boston ivy (*parthenocissus tricuspidata*) has been allowed to cover the south, east and north walls to the house, the long-term effects of this growth are likely to be destructive to the fabric of the building and removal should be considered. All of the pinnacles and stone enrichments should be inspected at close quarters to identify open mortar joints or rusting iron bars.

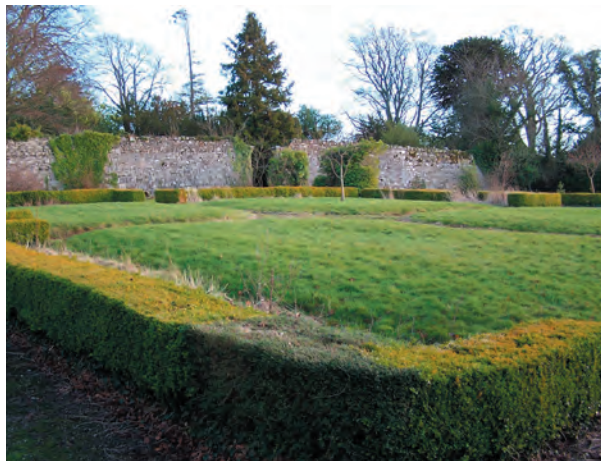
Maintained eastern portion of walled garden

The garden appears to be in a state of relative neglect. The path layout remains in place, as do the walls. The north-eastern portion is maintained as a formal garden, characterised by low box hedges, lawn and rhus typhina specimens. Flower beds are also maintained, containing hybrid tea roses and lawns<sup>36</sup>. The larger western portion has been used in the twentieth century for sheep grazing and more recently as a nursery. Large numbers of nursery beech and sitka spruce trees remain in the western and southern areas of the garden, surrounding remnants of an apple orchard which still produces substantial quantities of fruit. There are remains of several structures (possibly potting sheds and glass houses)<sup>37</sup> in the centre of the garden on the site of buildings depicted on the historic maps, and also against the north wall.

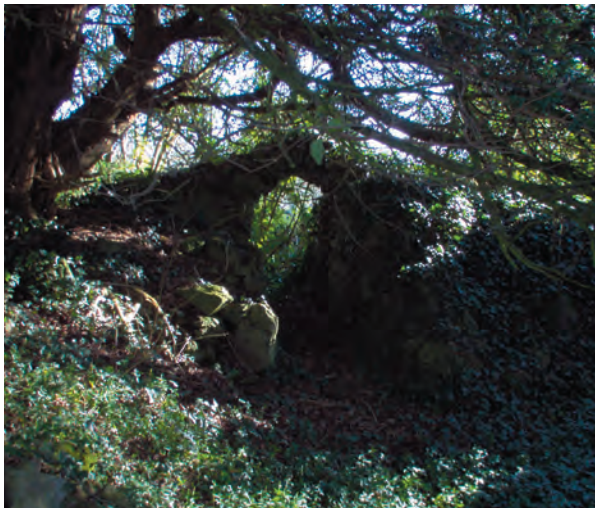
Stone archway at summit of Motte

Stone steps and a rough 'banister' probably from the early twentieth century, lead up the southern slope to an entrance feature comprising two sets of steps leading to the left and right onto the summit. A stone archway also exists on the summit, appearing to form an entrance to a basin or depression, possibly the site of the structure.

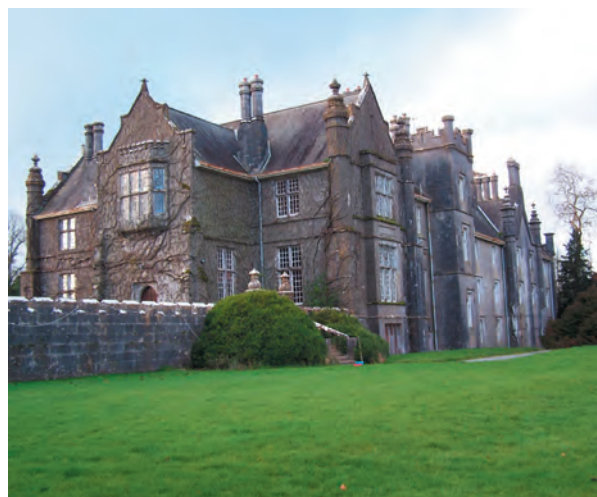
Durrow Abbey House, from north-east

The roof of the house is covered with Welsh slate which generally appears to be sound. Some flat roofs are lined with a torch-on roofing membrane. There are a number of significant leaks at the bases of chimney stacks to the north facade, that require early attention.

Cast iron gutters and downpipes were installed in the 1920s, most of which are now badly rusted and in need of attention. Some have been replaced with uPVC alternatives.

The massive stone chimney stacks and corner turrets survive from the nineteenth-century house although reset at lower heights after the reduction in height of the building. These elements appear to

be generally plumb and sound, however a structural engineer experienced in the care and repair of historic buildings should carry out a more detailed inspection.

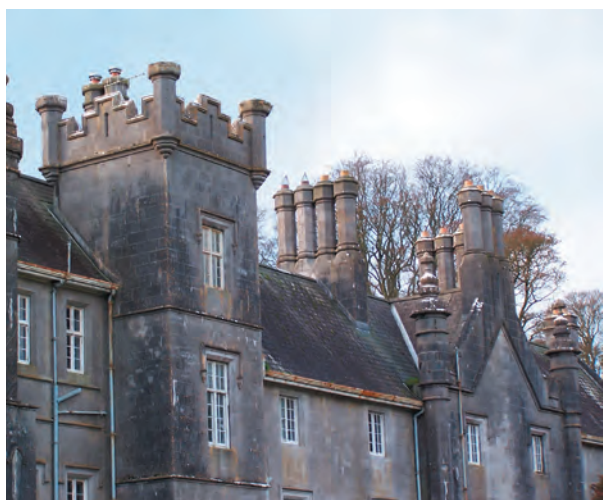
Roof detail, from north-east

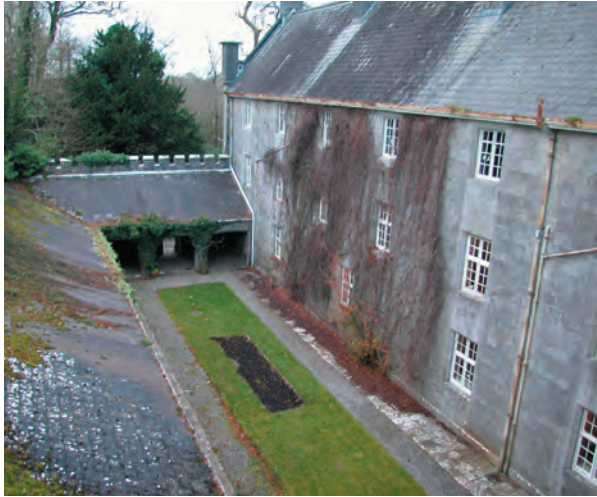
Courtyard, from south-east

storey ranges. Several doors lead from the basement of the house and service range directly into the courtyard from which a gate leads to the farmyard. The south and west sides of the court are mostly arcaded. The west and south ranges are set within high crenellated stone walls that act as retaining walls. The single-pitch roofs are covered with slates, many of which have begun to slip and require attention. The floors to the arcaded ranges are paved with smooth stone flags.

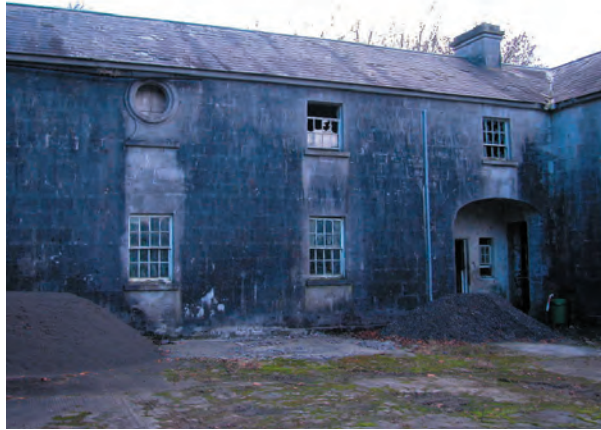
The ranges were built in a plain, astylar fashion. The external walls were faced with finely jointed limestone ashlar blocks. Exceptional workmanship is particularly evident in the arched door surrounds, with their finely carved voussoirs. Timber windows survive in many of the openings, probably dating from the 1830s. Internally, a fine stable room remains with boarded stalls, patterned brick paving, and good quality plaster cornices.

The masonry shell of the east yard appears to be stable and in reasonable condition. The failure of the slate roofing has led to widespread decay to the timber roof and floor framing. Many of the windows survive reasonably intact, however, some of the lights have been broken by vandals.

East yard, south range

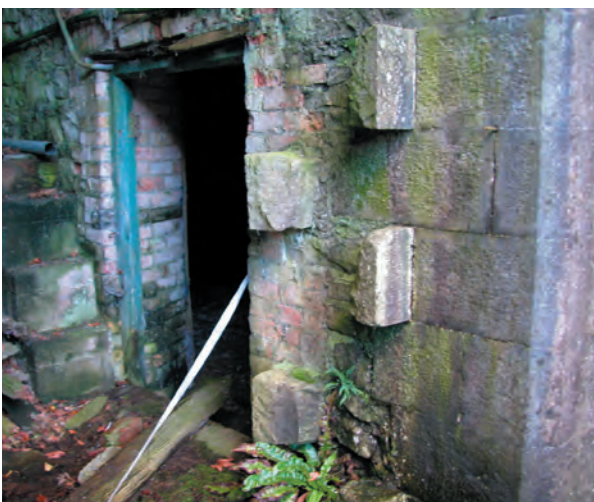
An inscribed date of 1833 on the centre of the south range shows that the east yard pre-dates the work to the house. A close examination of the two-storey yard suggests that it was originally intended to include east, south and west ranges. The east range was never built, however the limestone ashlar stones were left projecting from the wall of the south range, in preparation for the construction of the missing range.

South range, limestone projections to east

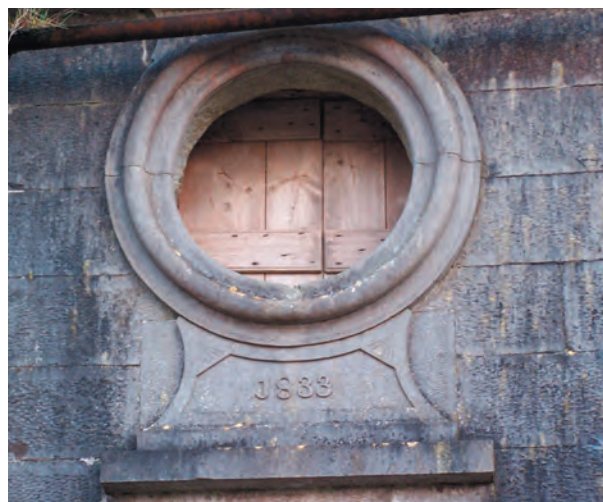
South range, date stone of 1833

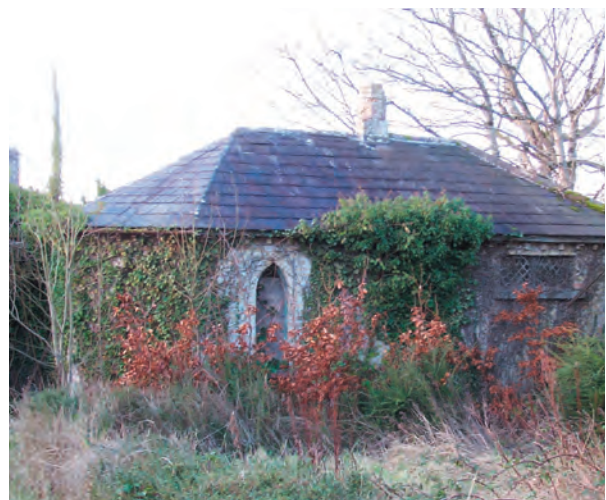
A small cottage was built into the wall at the north-west corner of the walled garden. Faced in pale yellow brick, with a slated hipped roof, the asymmetrical cottage was designed in a vernacular Tudor Revival style. A simple stone cornice is supported by simple brick frets. At the apex of the roof is a small octagonal chimney stack. Internally the structure has two small rooms. The room to

Octagonal Gardener's Cottage, from south-east

the south is a later intervention which creates a delightful octagonal space with lancet windows. The ceiling is coved and decorated with plaster mouldings. The north room contains a small domestic fireplace and has a door on its south side leading to the grounds outside of the walled garden. It is unclear what this structure was originally used for, a dairy is one possibility, however, it has more recently been used as an apple store.

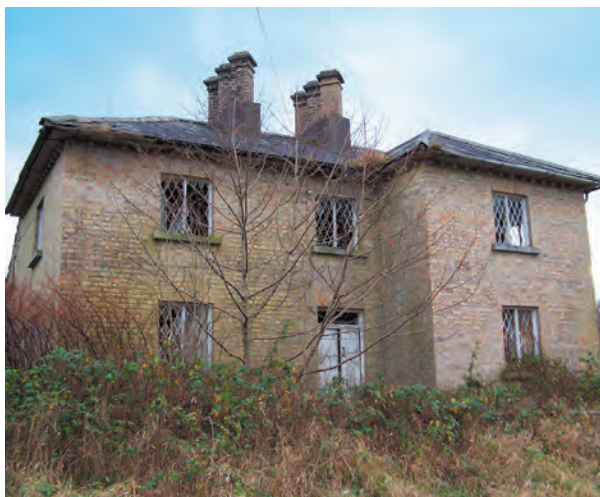
Two-storey gardener's cottage, from west

Standing to the west of the walled garden, is a gardener's cottage of similar style to the octagonal structure in the walled garden. The two-storey house contains a central stair hall and three rooms to each floor. A small kitchen was located in a small shed-roofed east return.

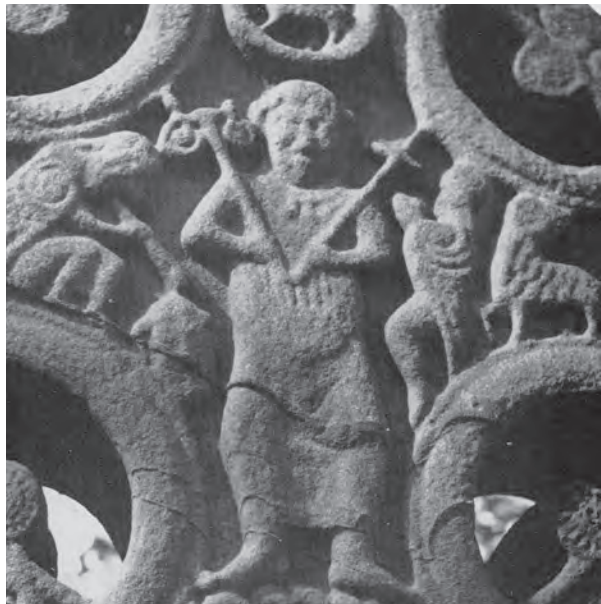
Durrow High Cross is a fine example of a ninth-century High Cross surviving in good condition.

Durrow High Cross, detail of east face

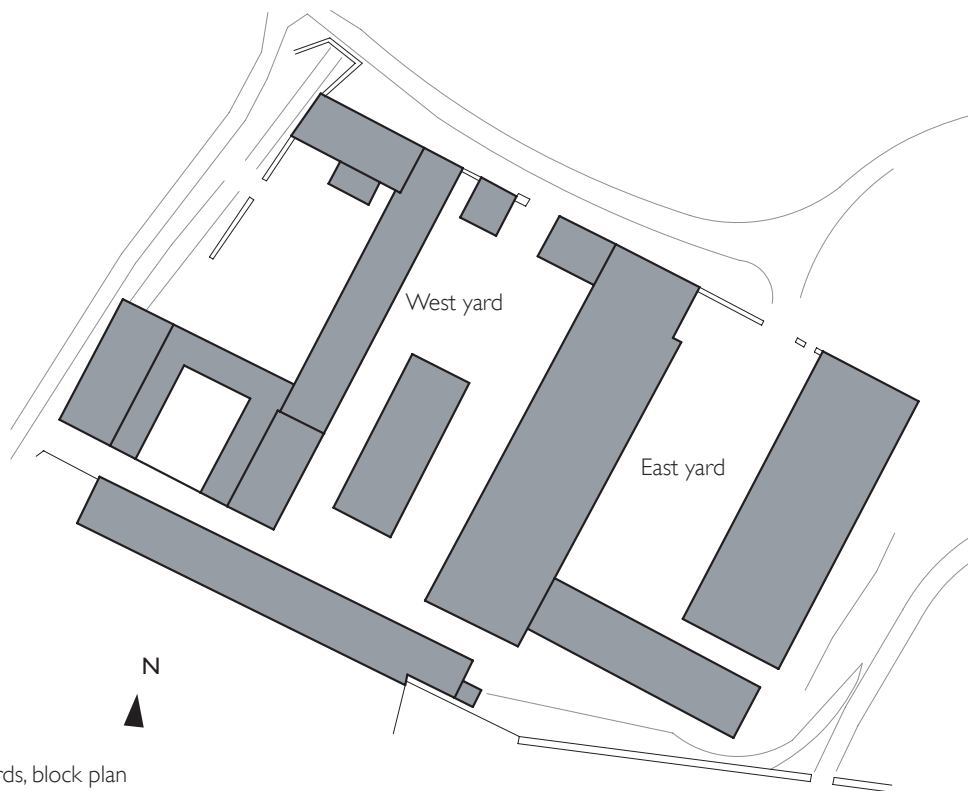
Service yards, block plan
