Conservation of Dowry chest: Treatment report:

Client	Karen Gray/Offaly CoCo
Date:	23rd July 2022
Reference:	OC60122

Early twentieth century painted dowry chest from Co. Offaly.

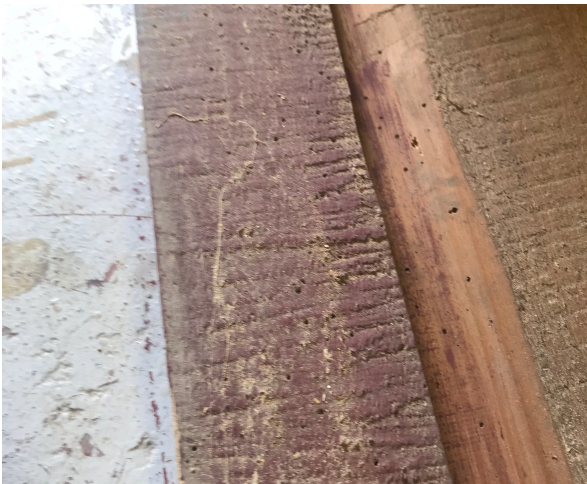
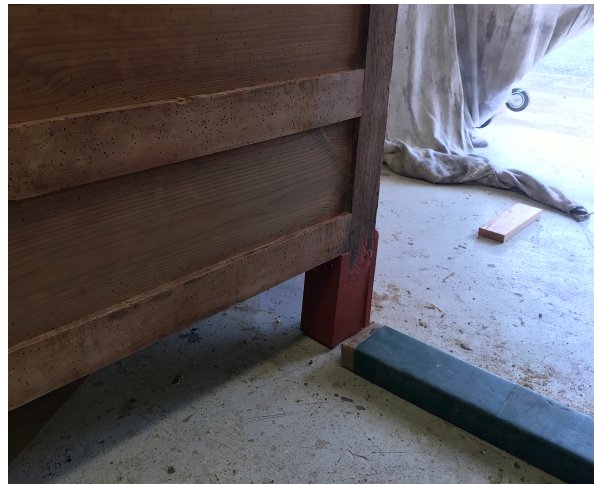
Pitsaw/machine markings

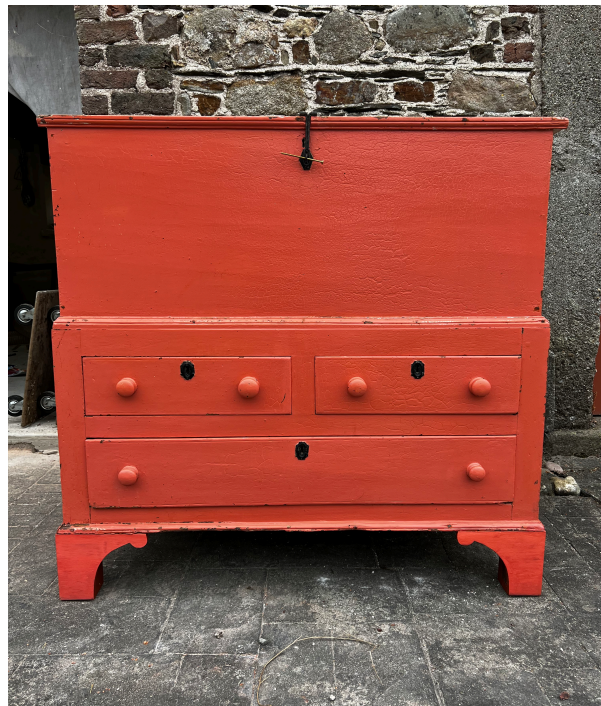
Completed.

7:Wax polish whole with micro crystalline wax:

All surfaces internal and external, painted and bare, were given a coat of micro crystalline wax and buffed to a mid level sheen.
