**Condition Assessment,
Recommendations and Method Statement**

**Bloomfield Mausoleum,
Borrisnafarney Church of Ireland,
Ballycormick,
Monegal,
Co.Offaly**

*Southgate Associates
December 2021*

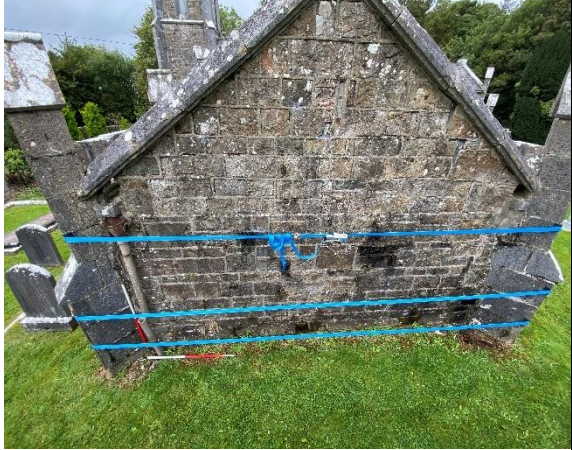
<p>3. Rear south east facing gable. Note down pipes running from eave level stone valleys.</p>	<p>4. South facing side of structure. Strapping is keeping buttresses in place currently and has aided in some cases to pull the subsiding stones back into correct alignment.</p>
