Stained Glass Windows

Six Roman Catholic Churches

County Offaly November 2010

Technical report

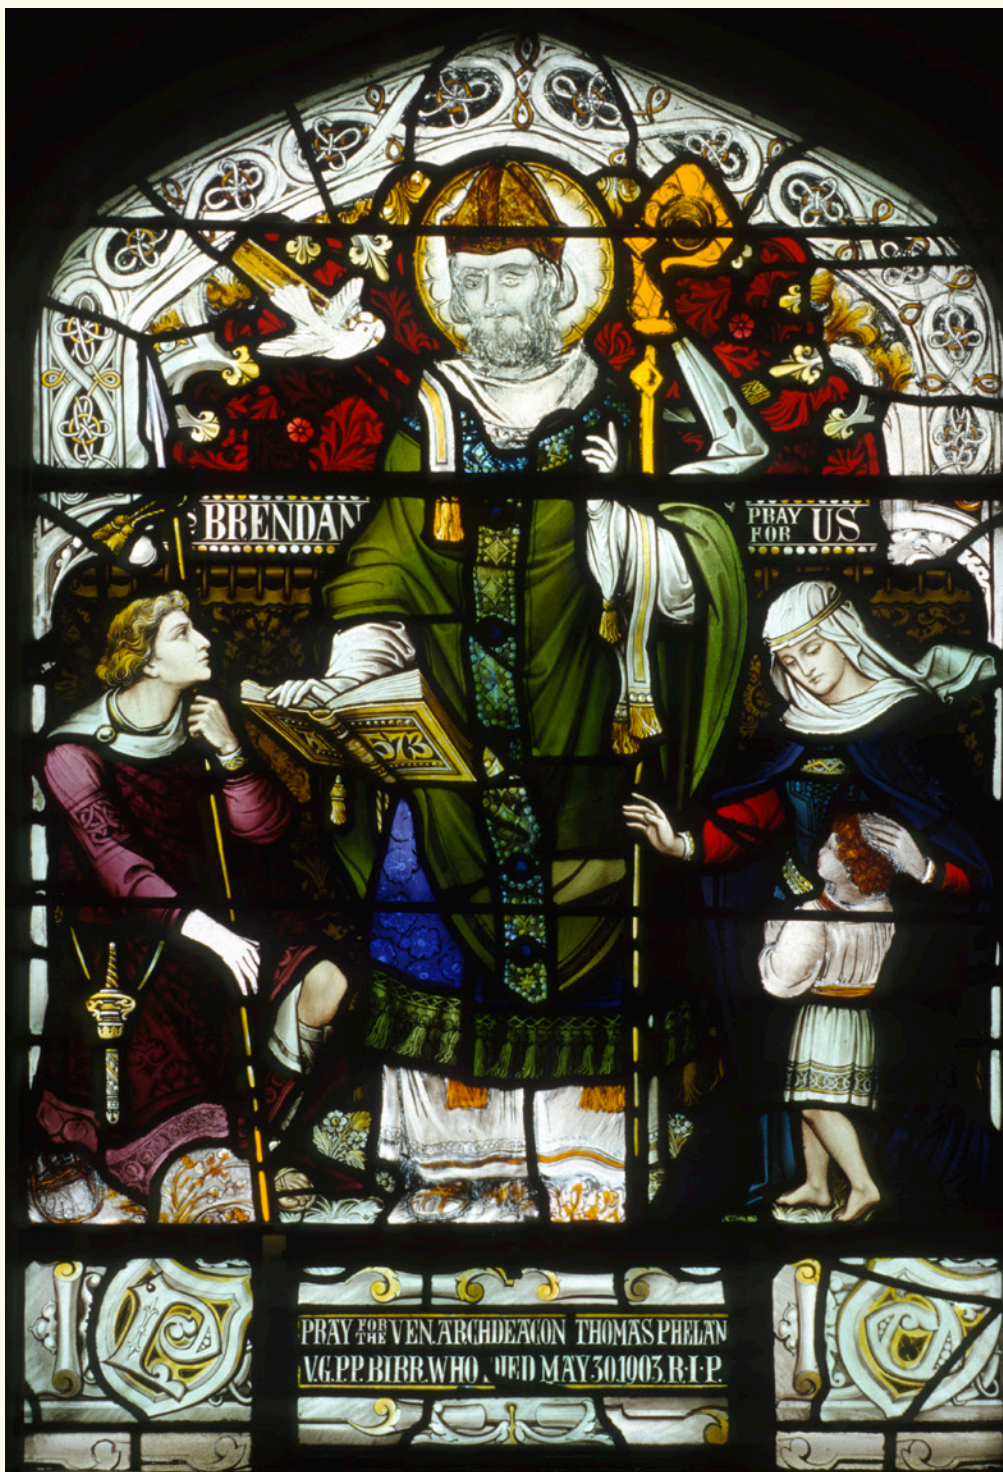
W10

Contains numerous sub-standard intrusions.

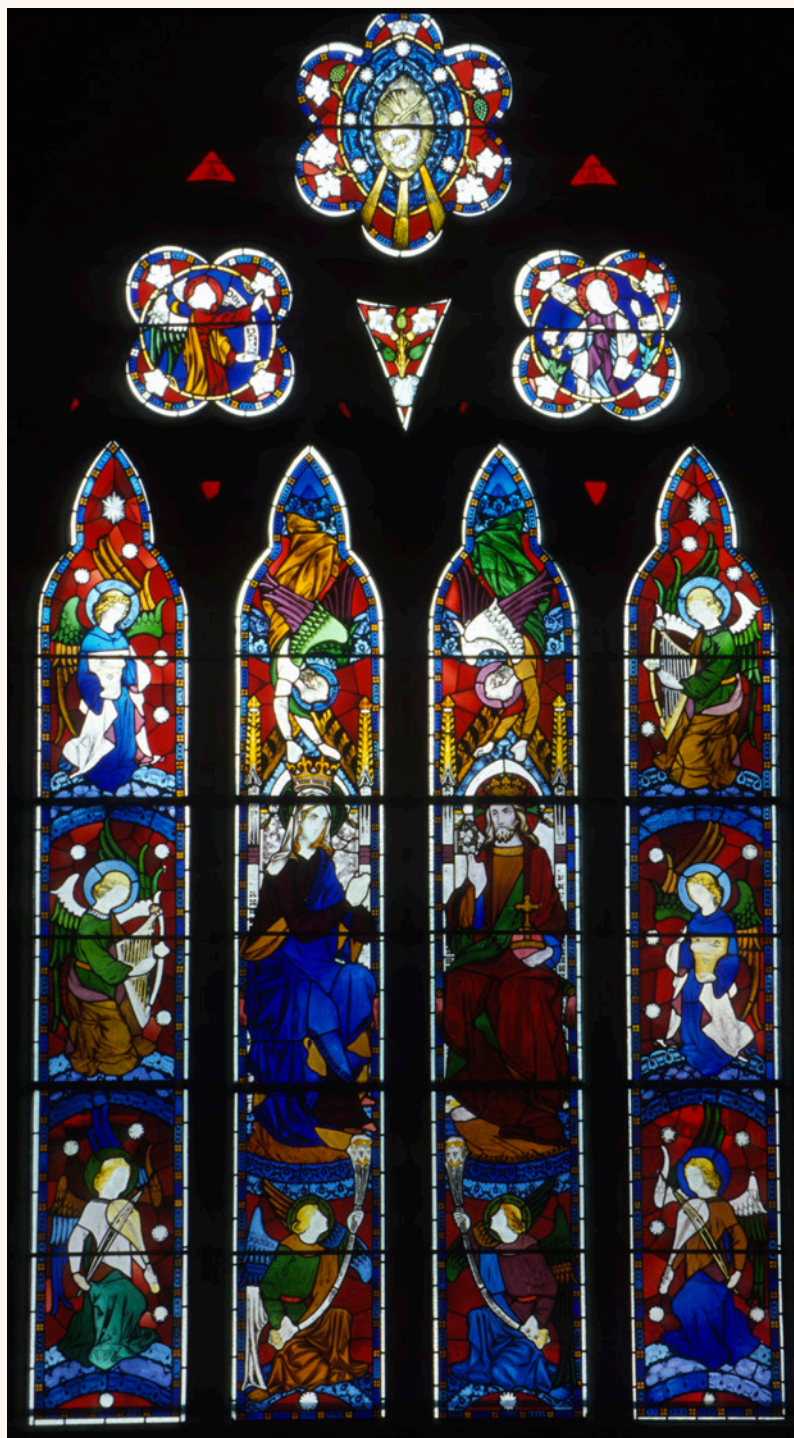
W01 Chancel; east

Extensive loss of painted detail.

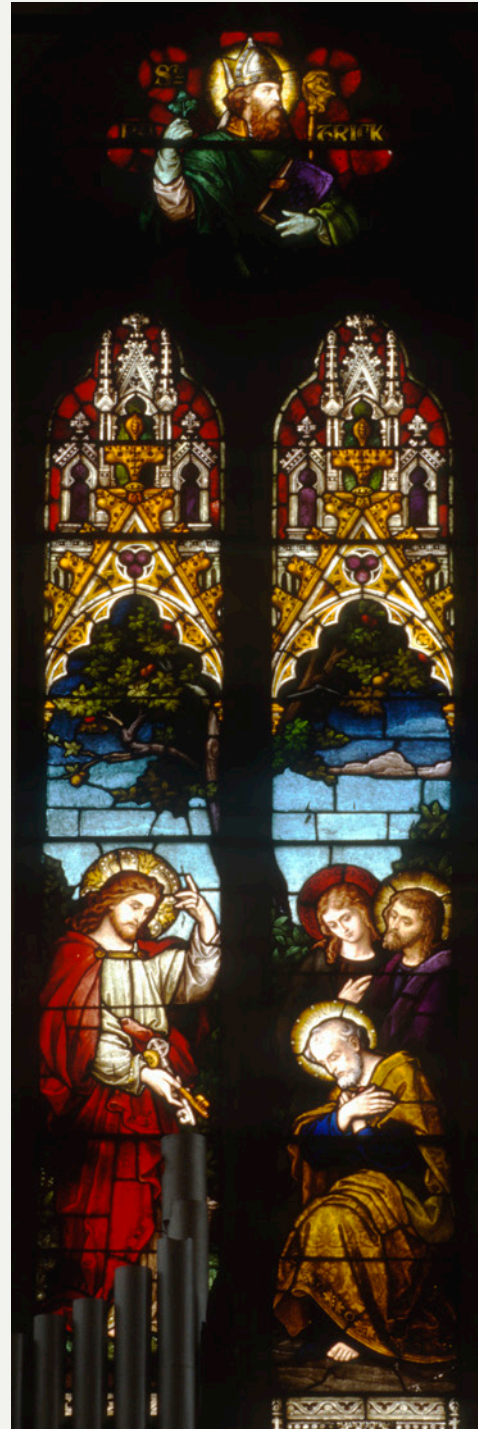
W12 Nave; west; south-most

- one piece (text) cracked;
- three pieces (architectural) multi-cracked;
- two pieces (brown, foreground) cracked.
- There are splashes of paint or mortar on the surface of the glass.

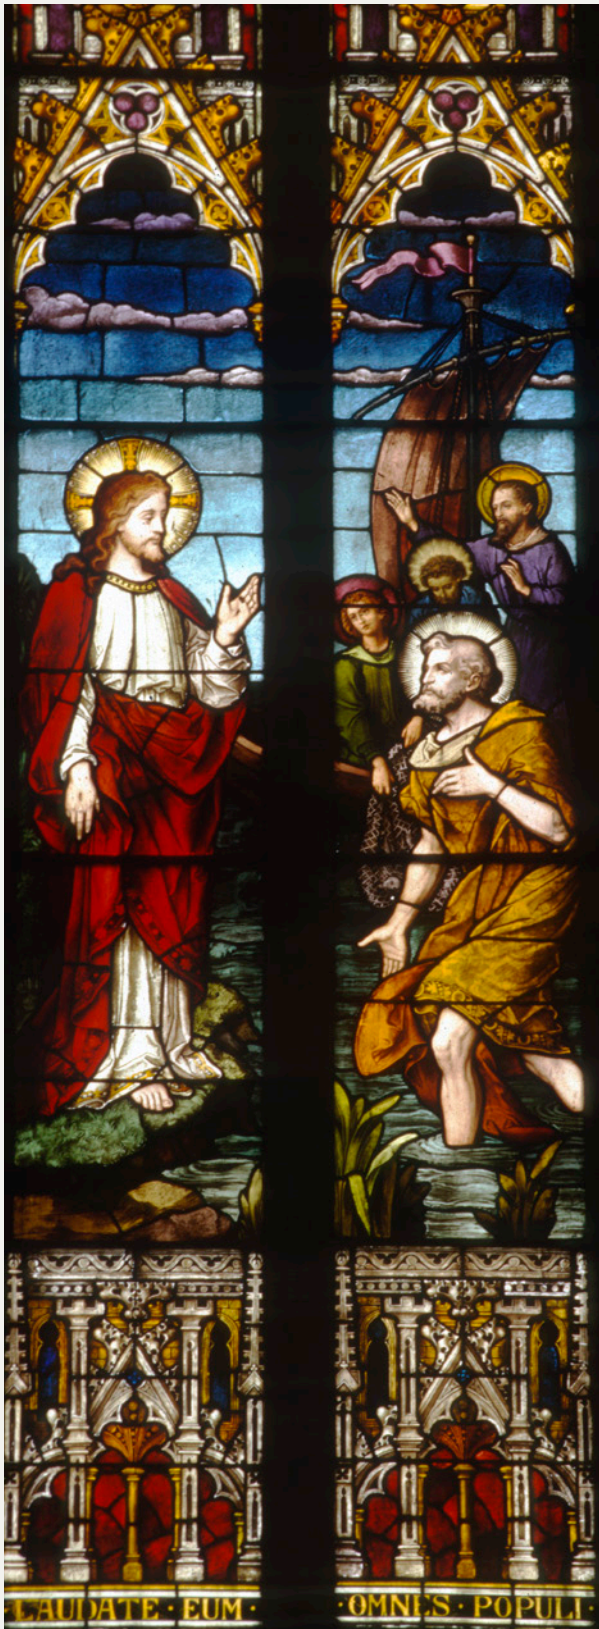
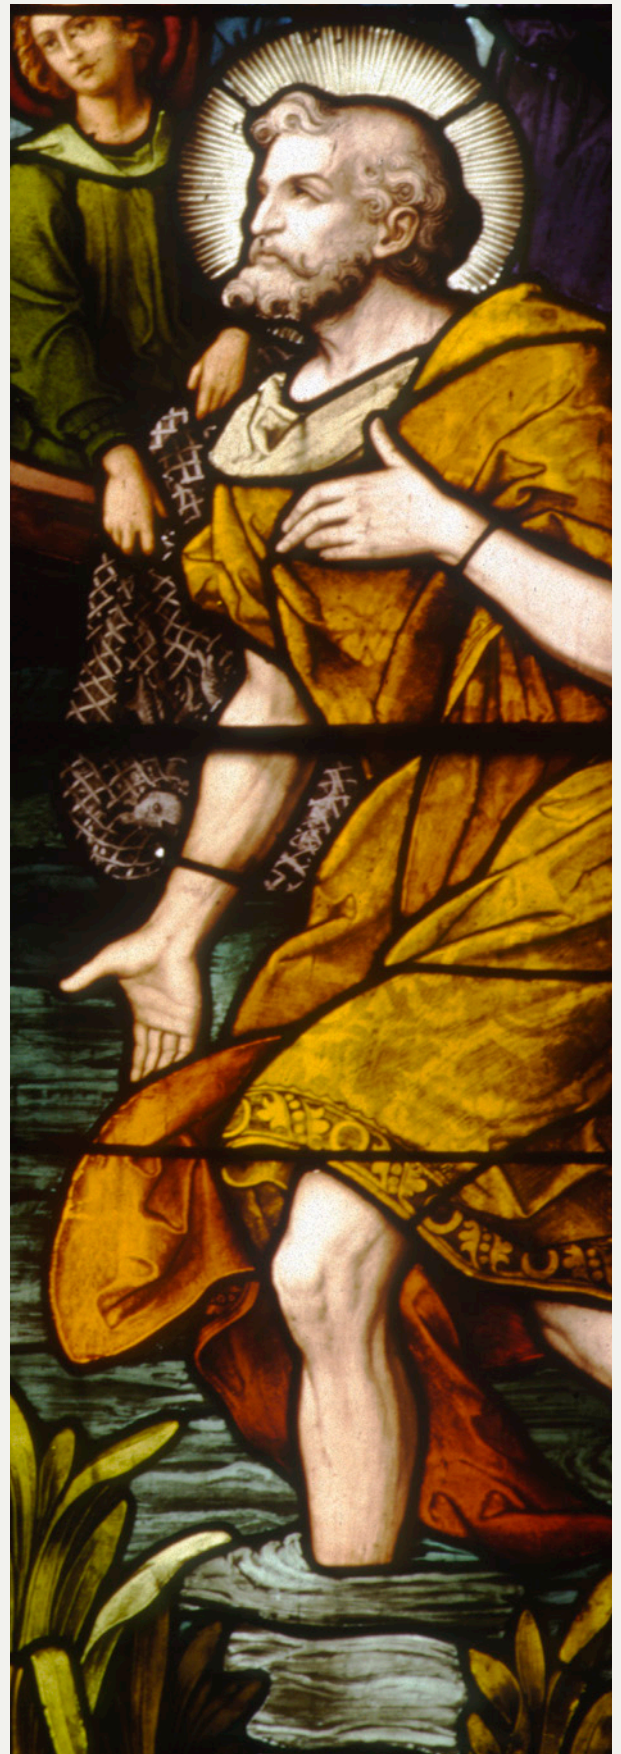
W13 Nave; west; north-most
def studio Mayer & Co.; Munich
Calling of St Peter
Two lancets and one 8-foil.

- one piece (text) cracked;
- one piece (fishing net) hole.
- There are splashes of paint or mortar on the surface of the glass.

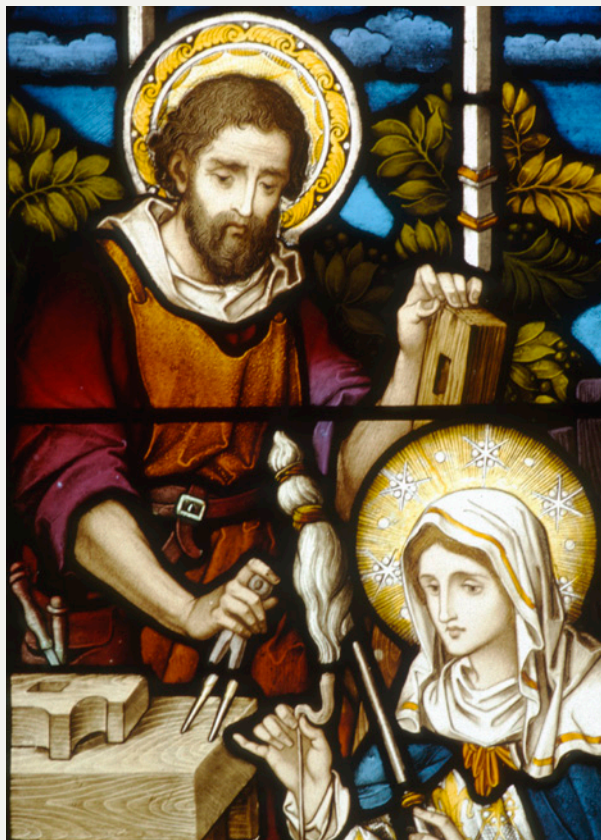
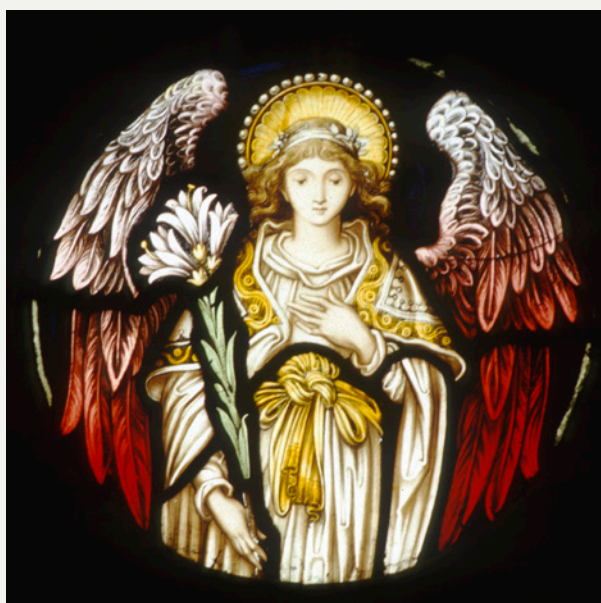
W16 Nave; north aisle; north; west-most

The stained glass is in good condition. This window has no secondary glazing.

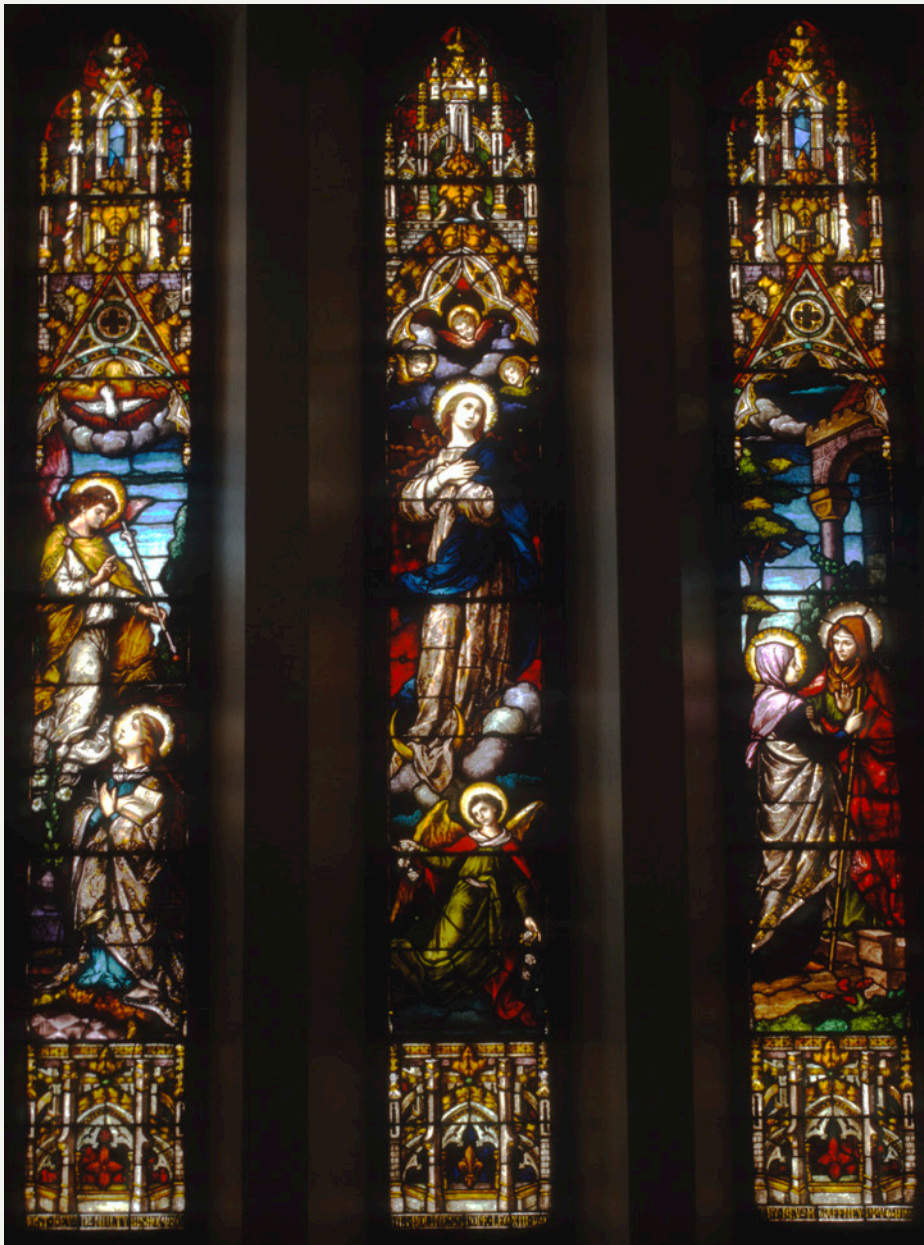
W20 **North transept; north**
 P13, P14 def studio Mayer & Co.; Munich
 insc 1895
 left: *Annunciation*
 centre: *Assumption of the Blessed Virgin*
 right: *Visitation*
 Three lancets.

There is some damage, as follows:

- one piece (inscription) cracked;
- one piece (brown floor tile) cracked;
- one piece (architectural canopy) multiple cracks and holes, possibly due to rusting of saddle-bars;

- one piece (architectural canopy) multiple cracks and holes;

- one piece (stained and painted drapery) hole.
- one piece (architectural canopy) large hole, possibly due to rusting of saddle-bars;

The damaged glass is best left unrepaired. Small holes can be filled in situ.

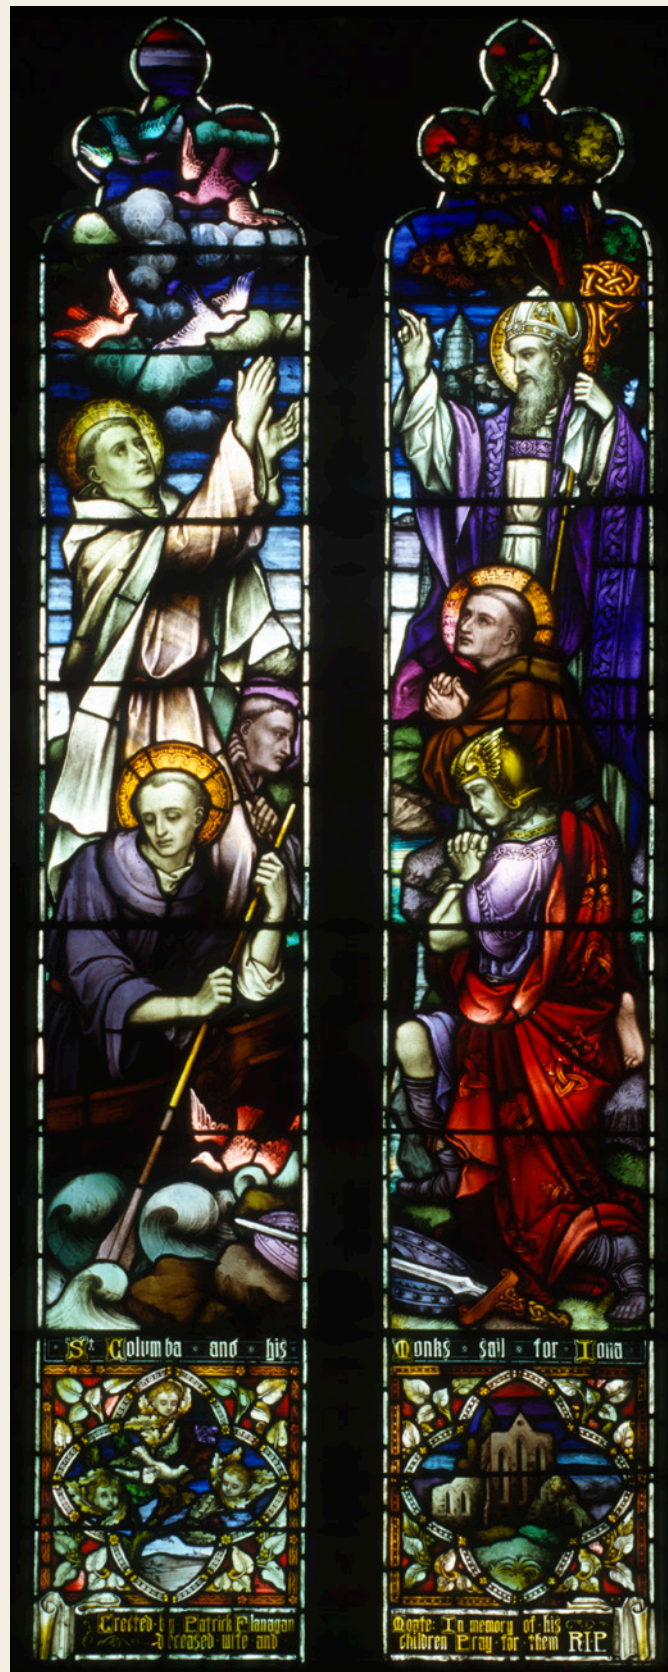
W13 North transept; north; east-most

P13, P14 def studio Mayer & Co.; Munich
St Columba Sails for Iona

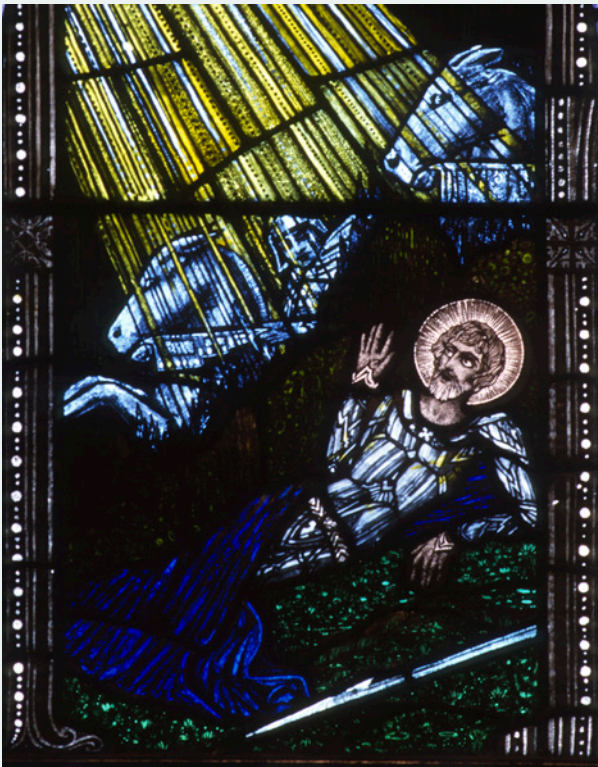
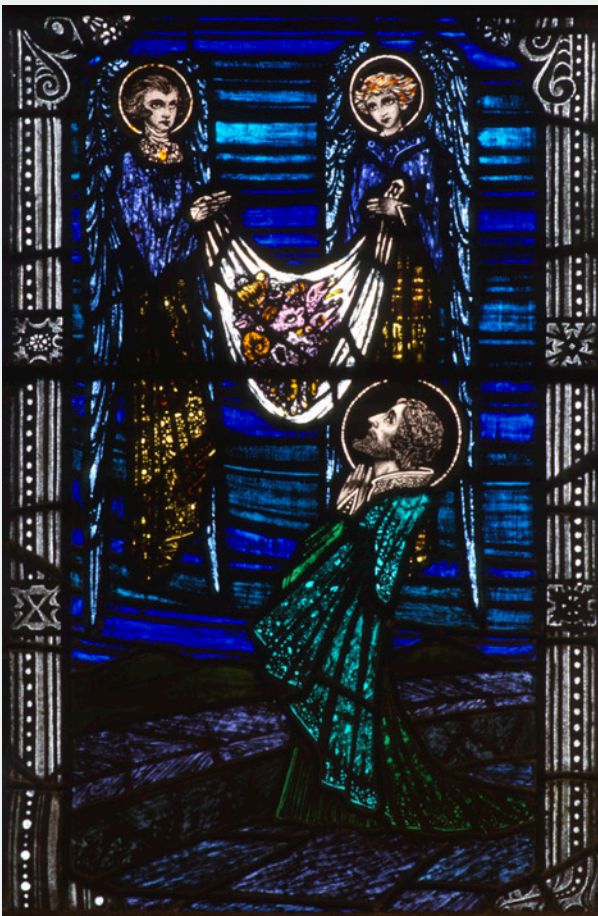
W08 Nave; south; east-most

Stained glass brought in from Rathfarnham Castle. Designed by Clarke but executed by his studio. These are the predella scenes belonging to W21 and W22, extended with unsuitable glass and leaded together in a single lancet.

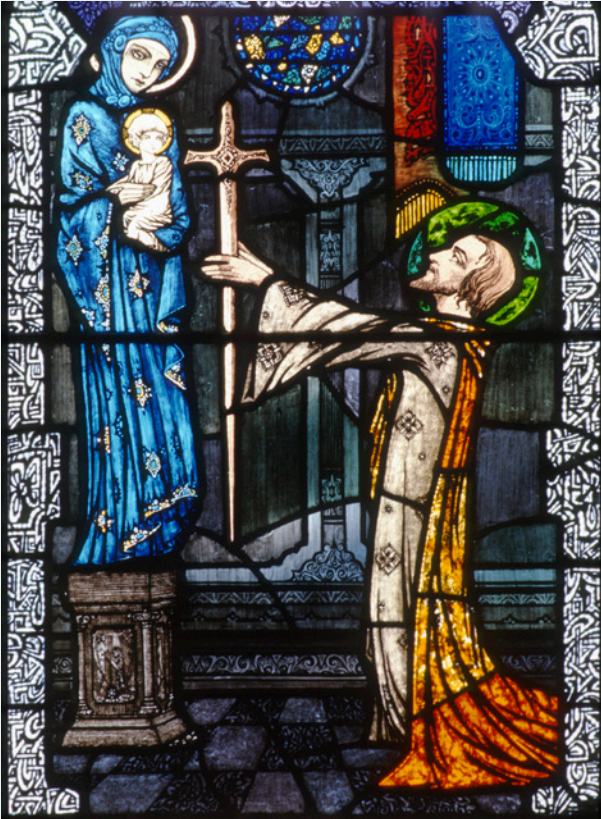
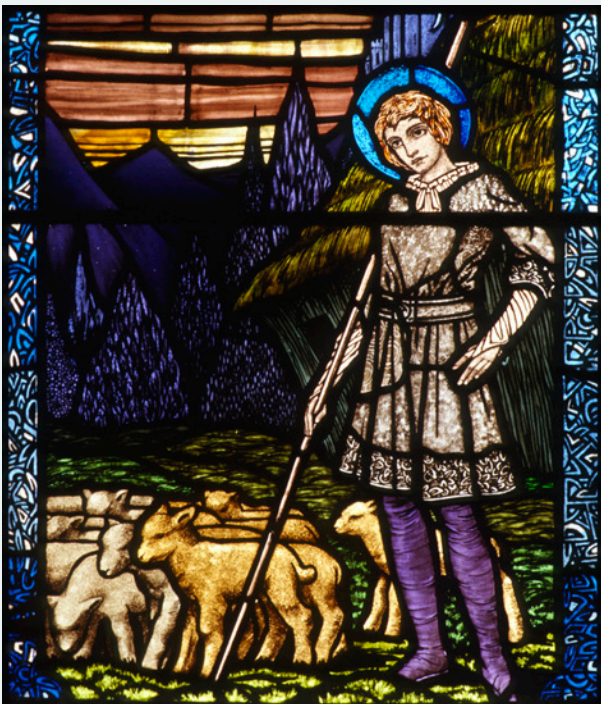
W18 Nave; north; east-most

Stained glass brought in from Rathfarnham Castle. Designed and executed by Clarke.

These are the predella scenes belonging to W19 and W24, extended with unsuitable glass and leaded together in a single lancet.

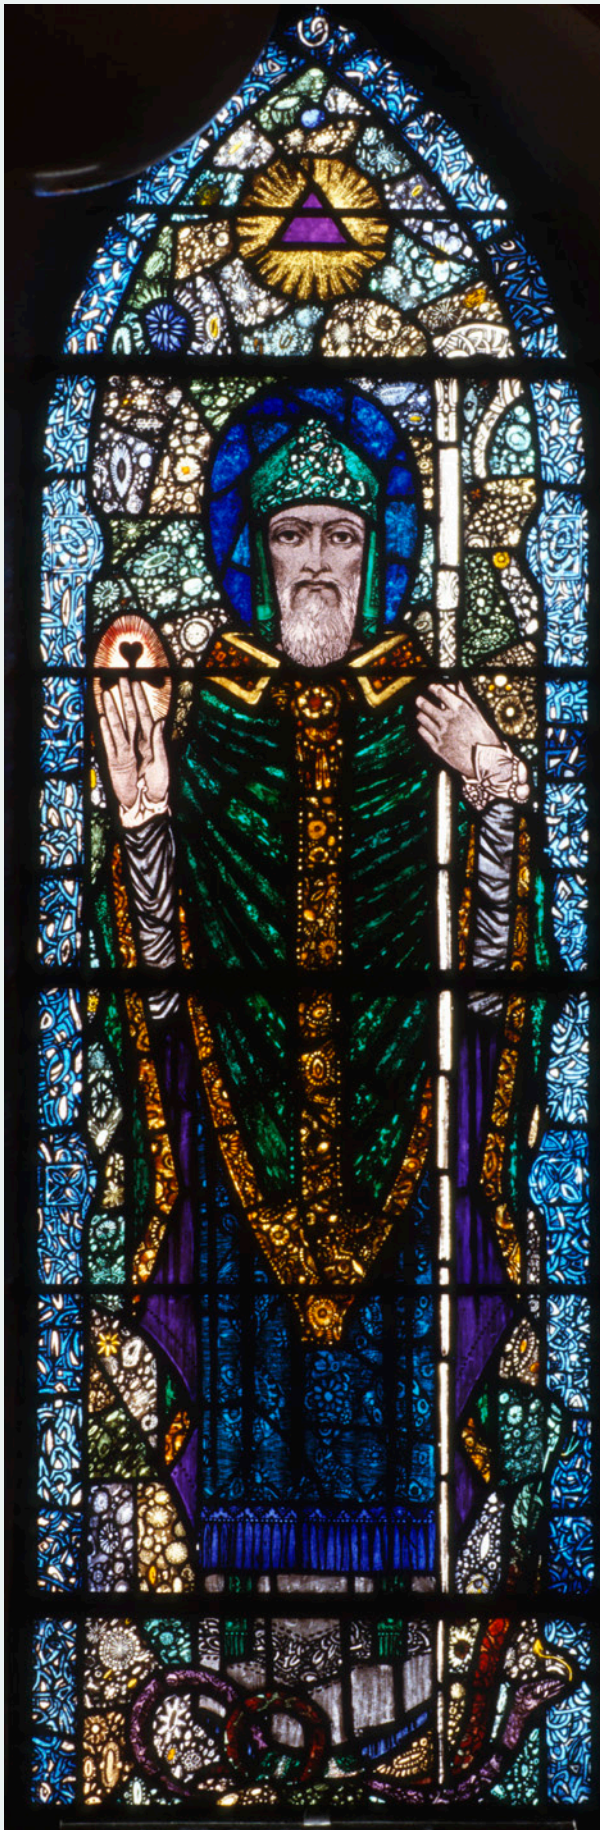
W19 North transept; west; south-most

Stained glass brought in from Rathfarnham Castle. Designed and executed by Clarke. The predella has been removed and placed at W18.

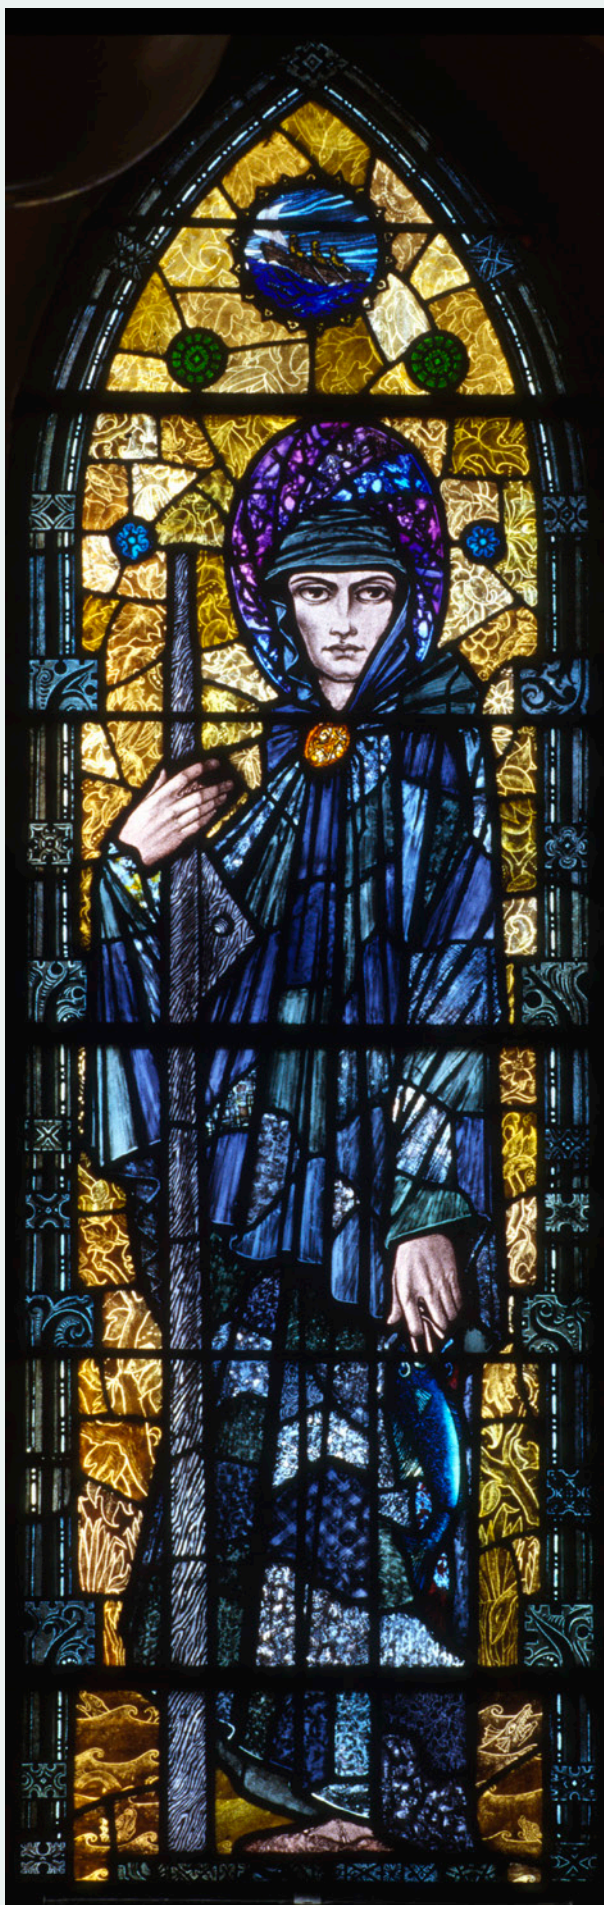
W20 North transept; west; north-most

Stained glass brought in from Rathfarnham Castle. Designed by Clarke but executed by his studio. The predella has been removed and placed, backlit, in a passage.

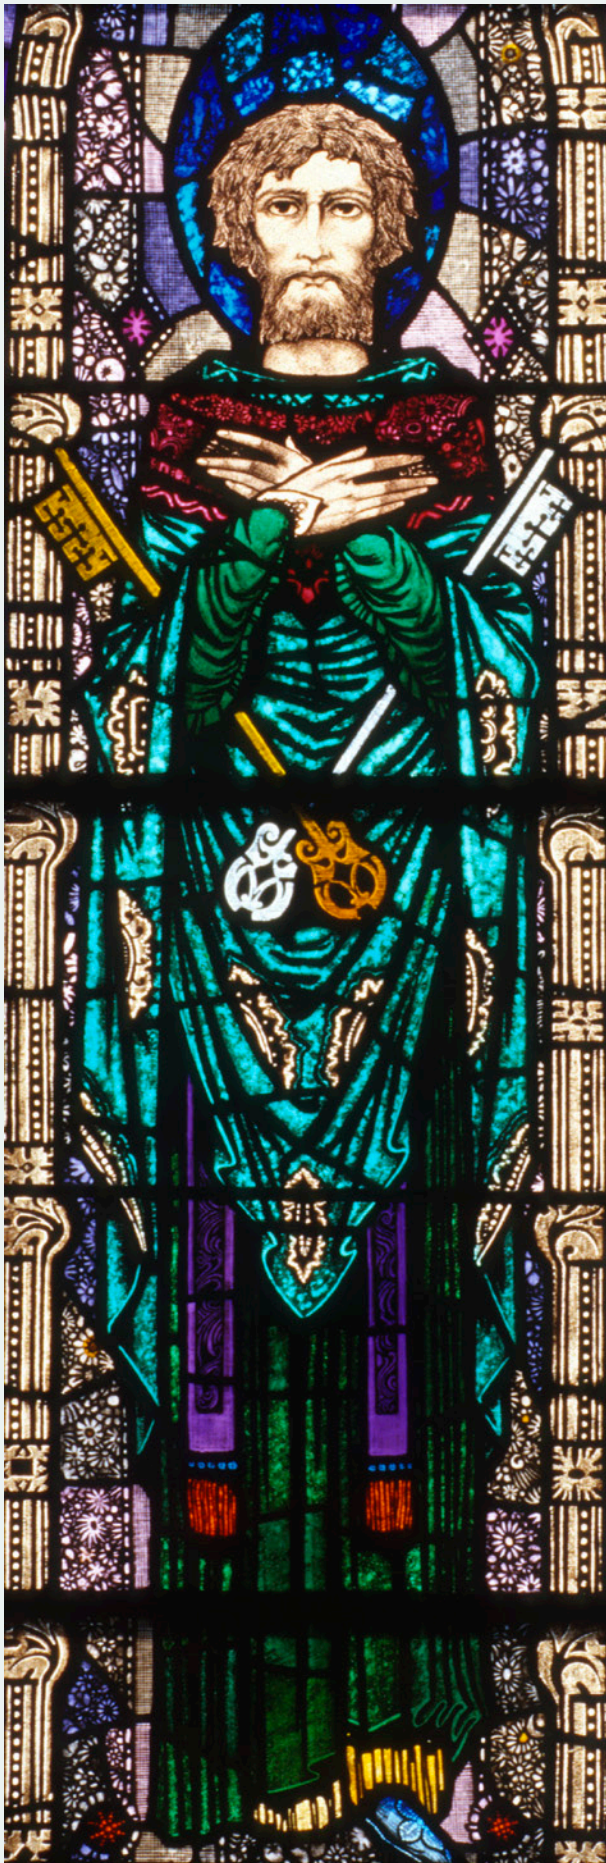
W21 North transept; north; west-most

Stained glass brought in from Rathfarnham Castle. Designed by Clarke but executed by his studio. Extended with unsuitable glass. The predella has been removed and placed at W8.

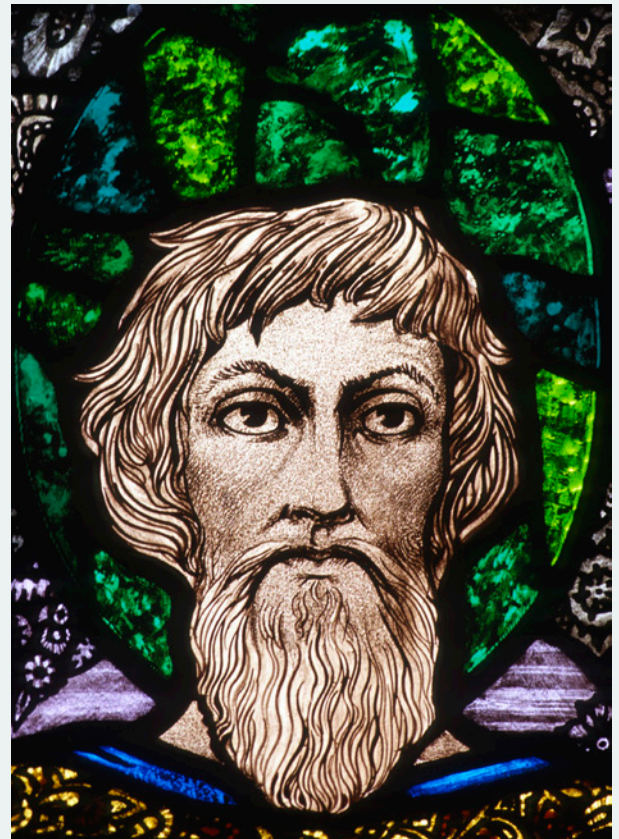
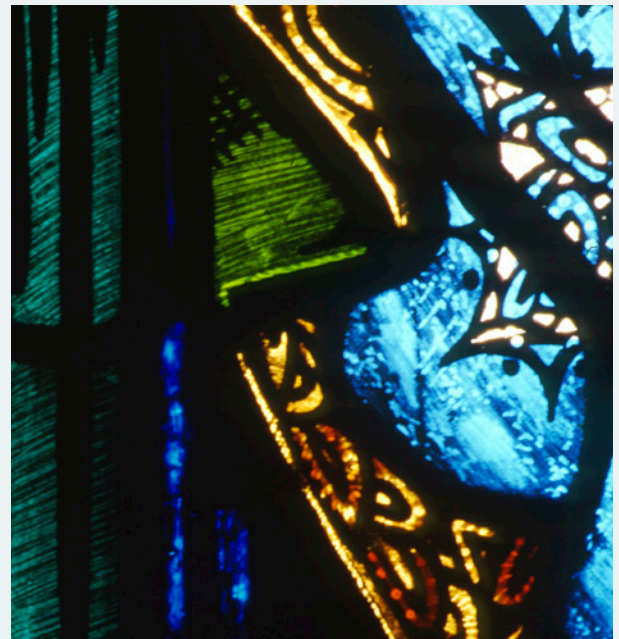
W23 North transept; north; east-most

Stained glass brought in from Rathfarnham Castle. Designed by Clarke but executed by his studio. Extended with unsuitable glass. The predella has been removed and placed at W8.
