**Declaration** Declaration Type: **Partial Declaration** Plan Type: CDP 2021\_2027  
In accordance with Section 57 (2) of the Planning and Development Act 2000 Number: **DEC/23/005**  
**Planning Authority** **NIAH** **14914005**

<b>Applicant Name</b>	John Hickey	<b>Status</b>	Owner
<b>Name of Building</b>	Ballylin Gate Lodge	<b>Former Name</b>	N/A
<b>Townland</b>	Ballylin	<b>OS Map Type</b>	
<b>Address 2</b>	Ballylin	<b>Map Sheet</b>	
<b>Address 3</b>	Ferbane	<b>National Grid co-ordi</b>	
<b>Date of Request</b>	09-Mar-23 01-Jun-23	<b>Date of Inspection</b>	Wednesday 22 March 2023
<b>Previous Declaration</b>	N/A	<b>Date of Declaration</b>	Wednesday 29 March 2023
<b>Protection Status</b>	<input checked="" type="checkbox"/>	<b>Record of Monuments and Places</b>	N/A
<b>Record of Protected Structures</b>	21-01	<b>Archaeological Potential</b>	2 and south OF015-008004
<b>Architectural Conservation Area</b>	N/A	<b>Preservation Order or Temp PO</b>	N/A

2023\_0322 Gate Lodge, Ballyin, Ferbane

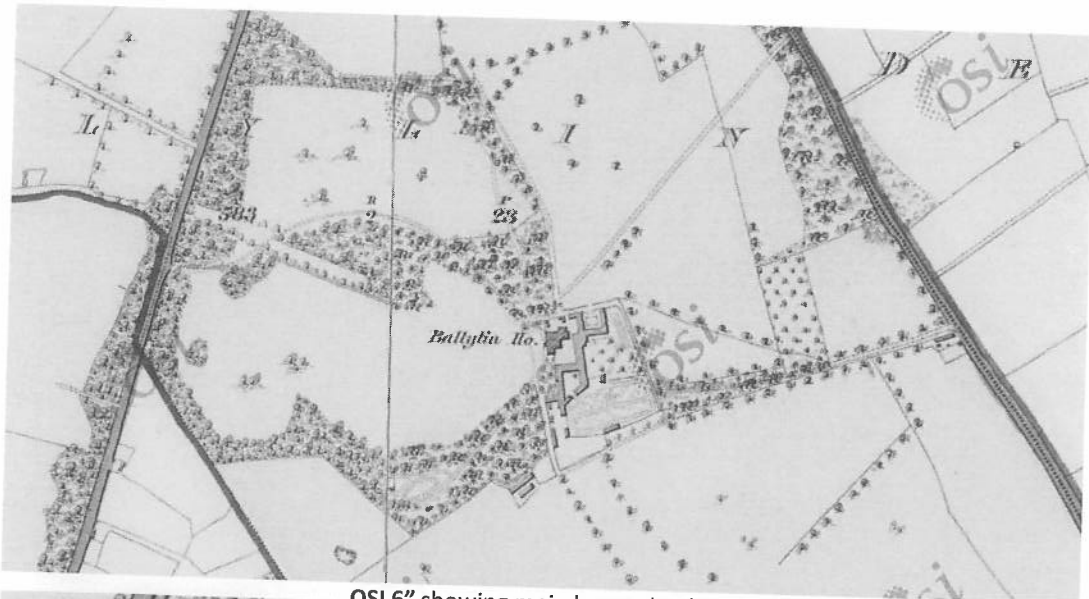
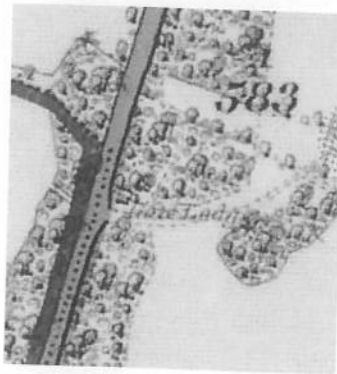
OSI 6" showing main house, landscaped gardens and outbuilding (c.1838). Note only the gate lodge to LHS of avenue entrance is shown at this time. The second gate lodge to the RHS is dated as c.1880 by J.A.K. Dean and built by John Gilbert King (visible on last edition of 6").

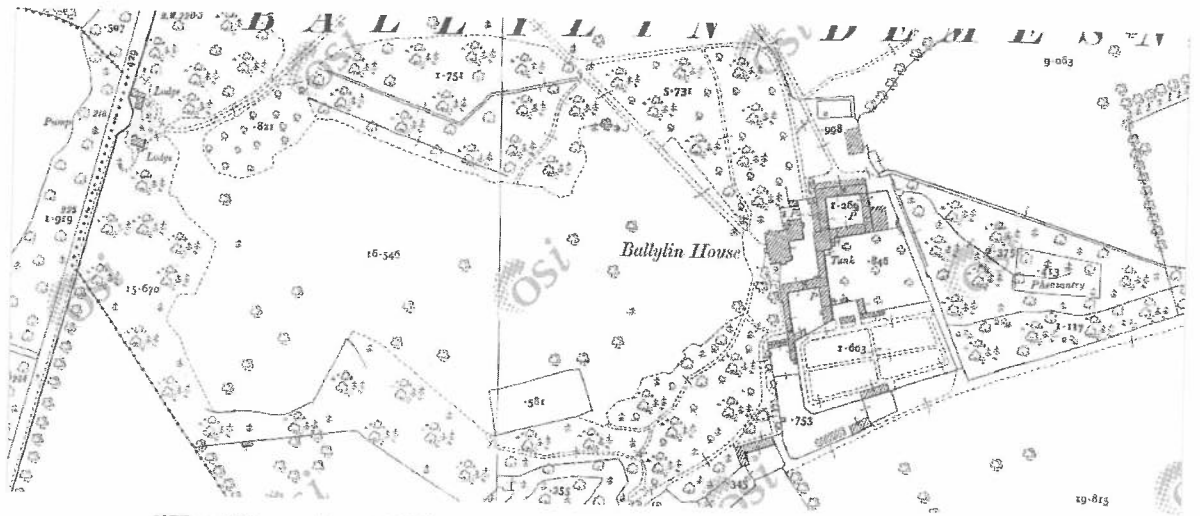
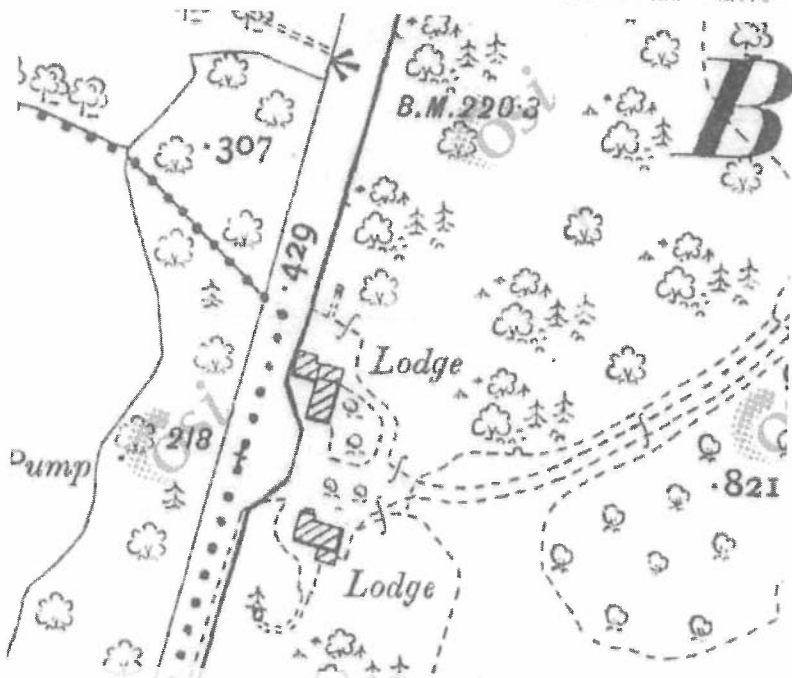
OSI 25" showing first gate lodge to the north of entrance and later lodge to the south, dated as c.1880 by J.A.K. Dean and built by John Gilbert King (visible on last edition of 6"). According to the applicant, this was originally a farm entrance but after a big storm when large trees came down across the main entrance, it was upgraded to become the primary approach to the demesne.

Note the two main forms of the original gate lodge and a small extension to the north.

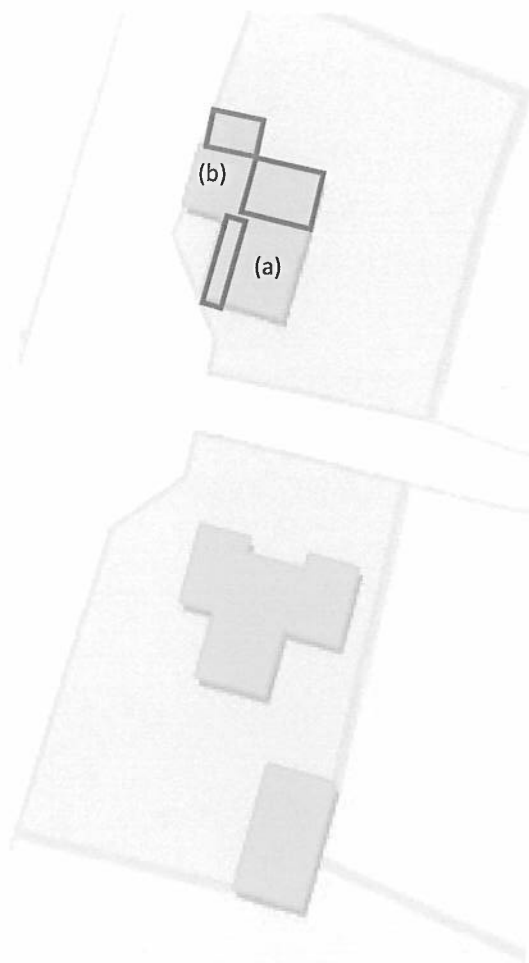
Current OS showing the altered form of the gate lodge which is composed of:

1. A narrow lean-to extension to the west (blue), which provides front door access linking the front section (a) to the rear section (b)
2. A modern flat-roofed extension to the north (green) of the front section
3. A small flat-roofed extension (orange) to the north of the rear section.

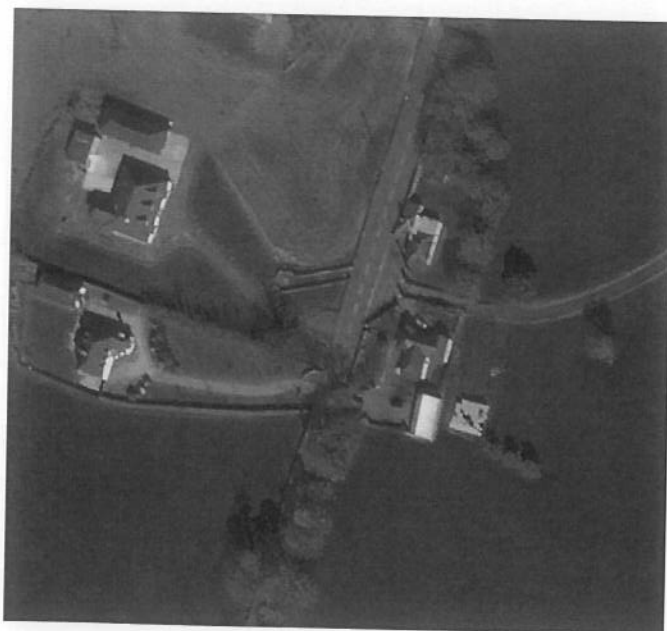
Bing map showing the current layout of original gate lodge (north) later gate lodge (south) and two large new houses on the opposite side of the road.

Current as noted above and Bing map showing the current layout of original gate lodge (north) later gate lodge (south) and two large new houses on the opposite side of the road.
