Creative Ireland 2024 – Vernacular Fund

Aharney Thatch (photo prior to damage)

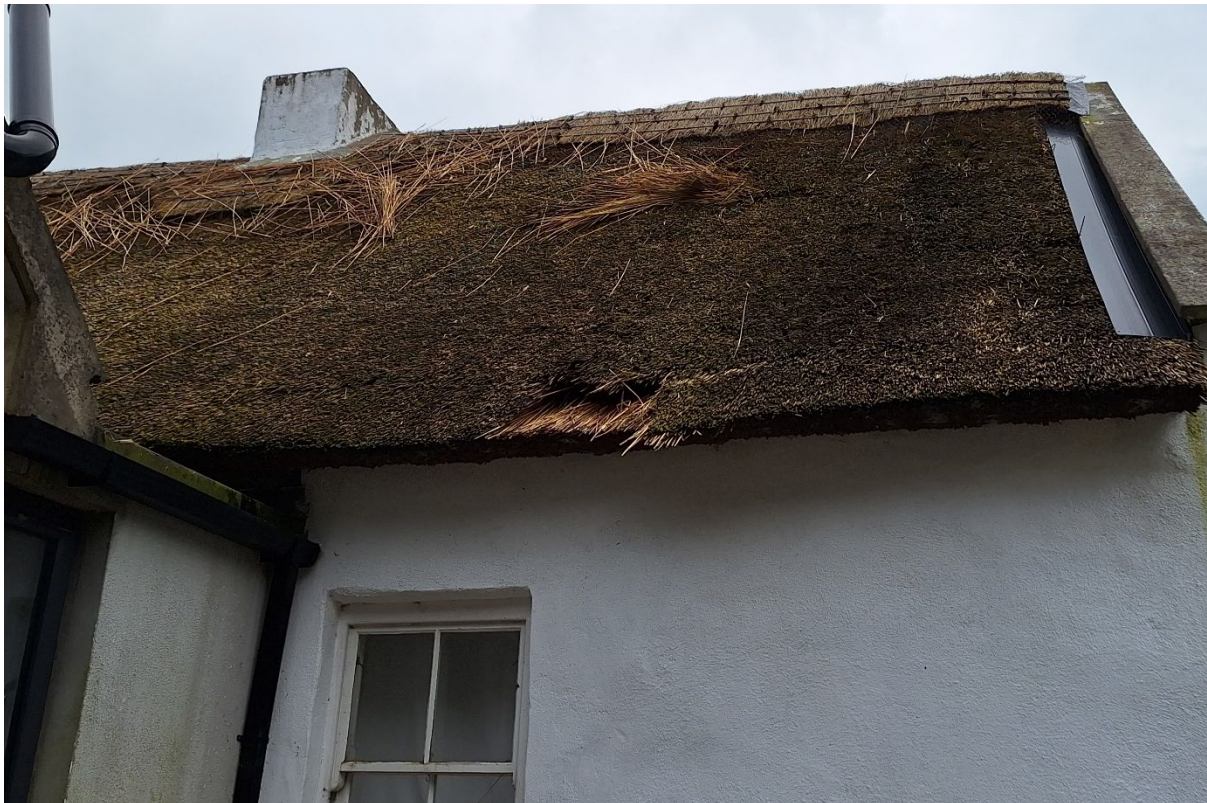
Damaged areas – 2024_0410

Spot repairs required to the rear of the property, where high winds caused swirling damage to one section of the roof. If not repaired urgently, the section would have further opened up, resulting in greater damage to the rear slope. Birds have also started to remove material from the roof.

Repairs were carried out by Phillip Doran, thatcher in May working to refix the ridge detail and any opened sections. Chicken wire applied to prevent further damage.

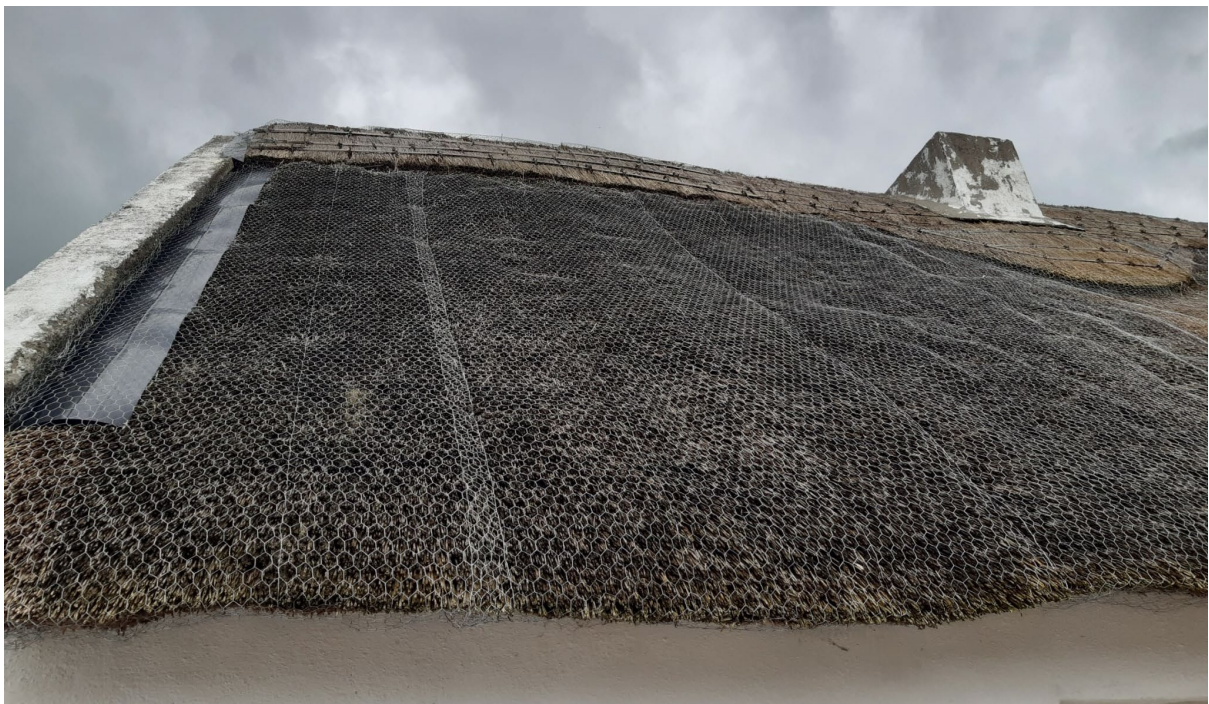
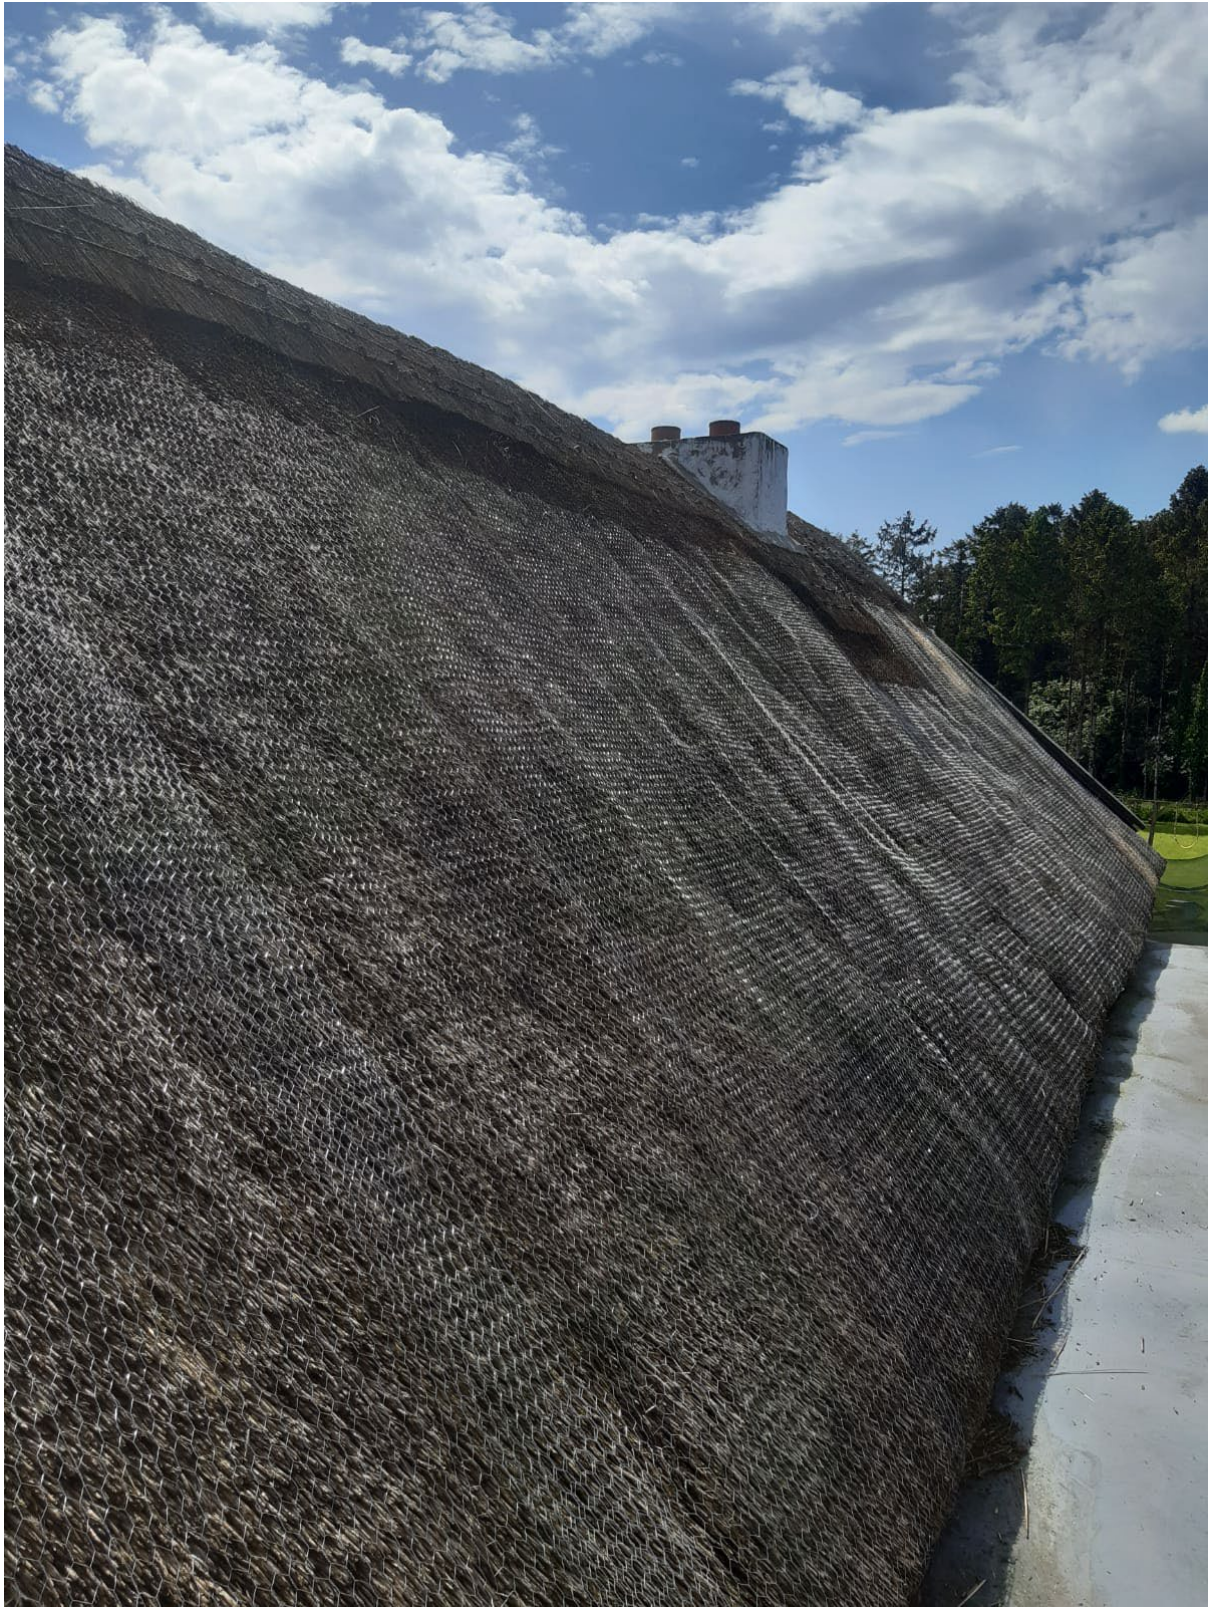
Chicken wire along length of roof, to prevent damage from high winds and birds.
Decorative ridge repaired with hazel scallops.
